Job Stamp 04-0120F4 SFOBB SAS
-------------------------------------

ASSISTANT RESIDENT ENGINEER'S **CONTRACTOR – ABFJV, Subs CMC-RS**

**Description of Operations @ W2 Cap Beam:**

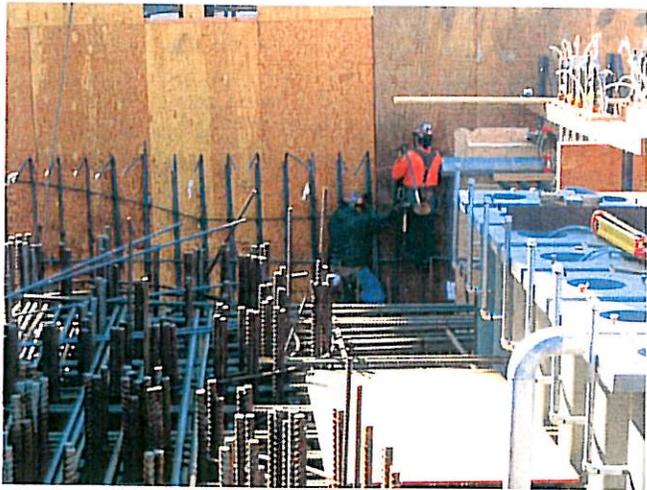
File Name:	Oct-10-2008 W2 Cap 011
Date:	10-10-08
By Int:	M Bruce

Description: Ironworkers adjusting the 25V08 "C" bars in the southwest corner near the deviation saddle. This was done since the bars were all placed at the wrong elevation (top of concrete instead of the bottom of continuity tendon blockout).

- Continued to place grillage and spirals for continuity tendons E-30B through E-44.
- Began to place grillage for CBT-1 through CBT-8 at the south end of the cap beam near W2E.
- Began to place the #25 horizontal ties in the pour 4 area between the void forms to the north side of the W2E column cages, see photo below.
- Began to adjust the 25V08 "C" bars in the southwest corner near the deviation saddle, see photo below.

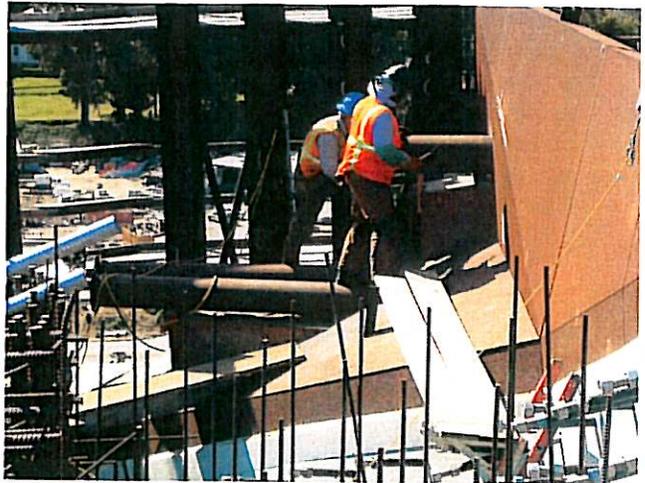
File Name:	Oct-10-2008 W2 Cap 015
Date:	10-10-08
By Int:	M Bruce

Description: Piledrivers installing CBT-5 dead-end sleeve pipe on the north end of the cap beam near W2W.

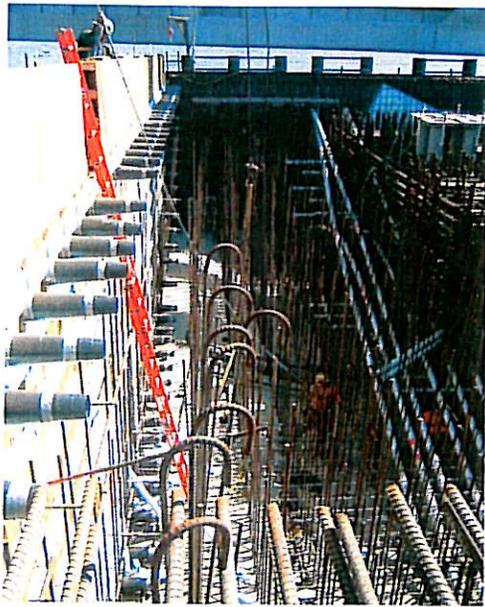
File Name:	Oct-10-2008 W2 Cap 016
Date:	10-10-08
By Int:	M Bruce

Description: Ironworkers placing the #25 horizontal ties in the pour 4 area between the void forms to the north side of the W2E column cages.

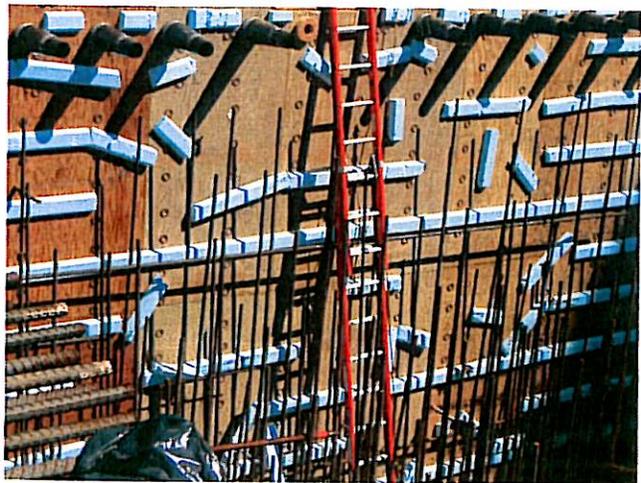
File Name:	Oct-10-2008 W2 Cap 013
Date:	10-10-08
By Int:	M Bruce

Description: While placing the #25 horizontal ties in the pour 4 area the ironworkers damaged/displaced the polystyrene shear keys at the W2E east bulkhead.
