Job Stamp
04-0120F4
SFOBB SAS

ASSISTANT RESIDENT ENGINEER'S **CONTRACTOR – ABFJV, Subs CMC-RS**

Description of Operations @ W2 Cap Beam:

EA	04-0120F4
Co-Rte-KP (PM)	SF-080-13.2/13.9 (8.2/8.7)
Structure Rep.	Rick Morrow

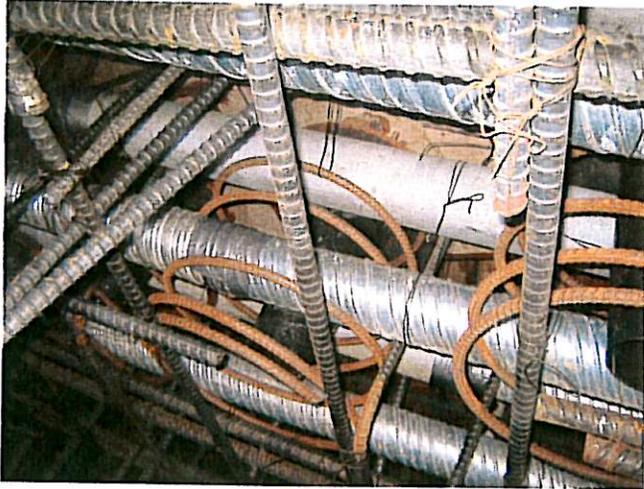
File Name:	Oct-15-2008 W2 Cap 003
Date:	10-15-08
By Int:	M Bruce

Description: Spirals for continuity tendons E-1B through E-8B where the CBT-1 to 8 ducts and X-strong pipes alter the pitch.

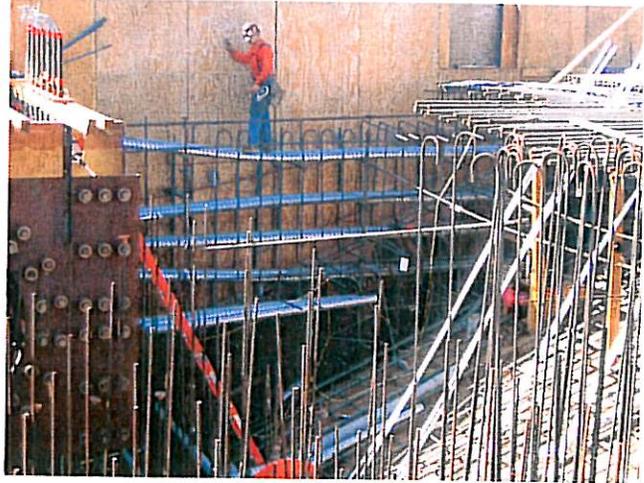
File Name:	Oct-15-2008 W2 Cap 010
Date:	10-15-08
By Int:	M Bruce

Description: CBT-1 through CBT-8 placement between the south pour 3 construction joint and the North W2E Hinge K assembly.

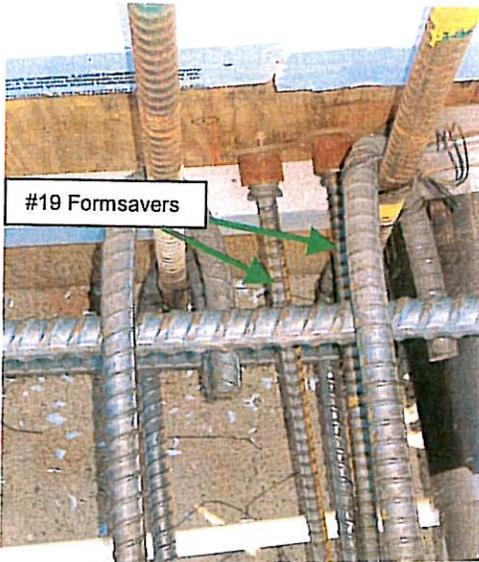
File Name:	Oct-15-2008 W2 Cap 014
Date:	10-15-08
By Int:	M Bruce

Description: #19 formsaver dislodged from the W2E east bulkhead.

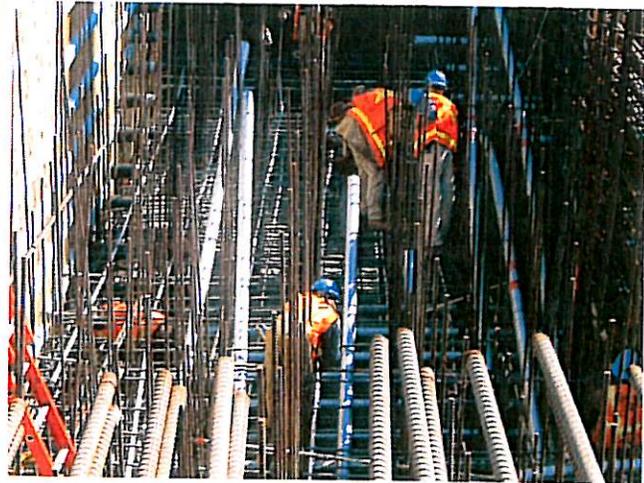
File Name:	Oct-15-2008 W2 Cap 019
Date:	10-15-08
By Int:	M Bruce

Description: E-30B through E-38B duct placement and layout by ABF surveyors.
