Job Stamp 04-0120F4 SFOBB SAS

Description of Operations @ W2 Cap Beam:

EA	04-0120F4
Co-Rte-KP (PM)	SF-080-13.2/13.9 (8.2/8.7)
Structure Rep.	Rick Morrow

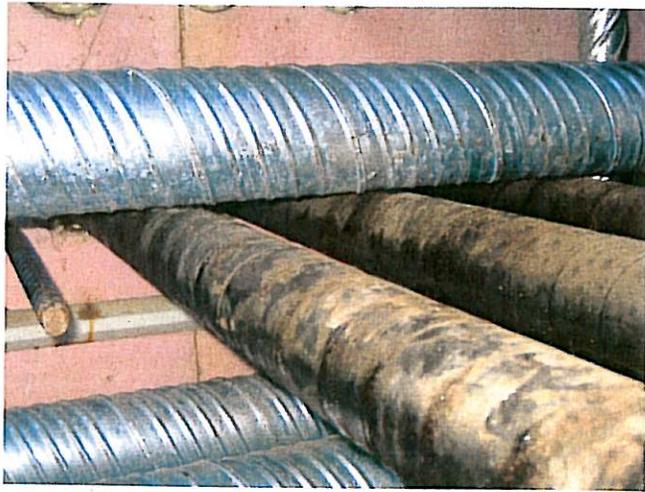
File Name:	Oct-16-2008 W2 Cap 011
Date:	10-16-08
By Int:	M Bruce

Description: CBT-7 rigid duct touching the Macalloy rods at the north W2E Hinge K assembly. The ABF surveyors gave the ironworkers the PI of these tendons on the north and south end of the W2E Hinge K assemblies. This issue was written on the pour 4 punchlist. Also the denso tape on the Macalloy rods needs to be cleaned, ABF has been notified several times to clean the PT materials.

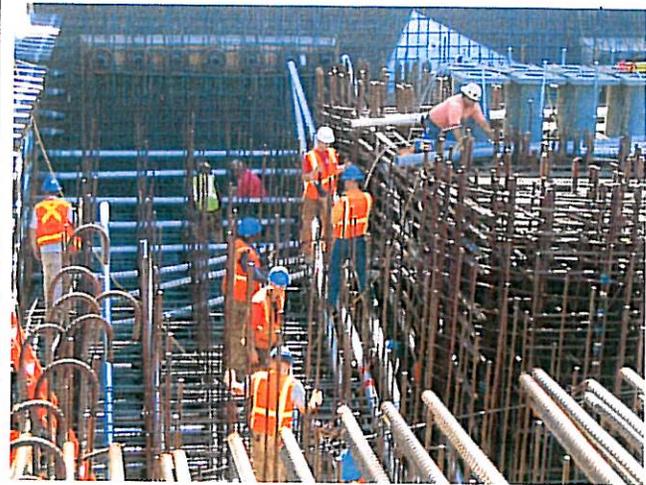
File Name:	Oct-16-2008 W2 Cap 017
Date:	10-16-08
By Int:	M Bruce

Description: E-30B through E-38B duct placement and layout by ABF surveyors. Also ABF piledrivers are seen placing PVC pipes and tie-rods.

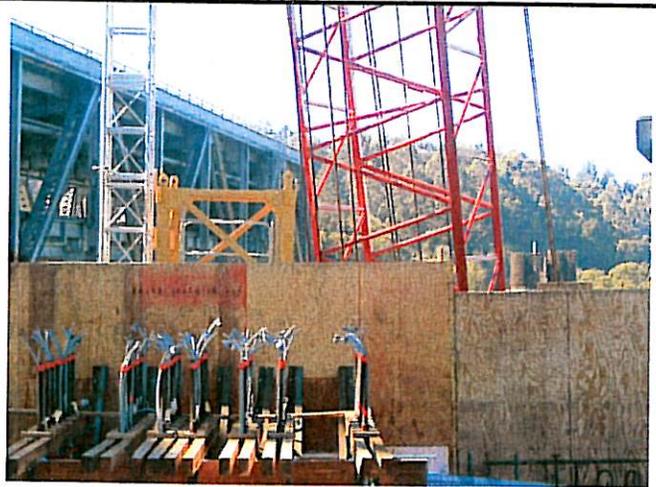
File Name:	Oct-16-2008 W2 Cap 020
Date:	10-16-08
By Int:	M Bruce

Description: Manitowoc crane too close to the elevator frame once again.

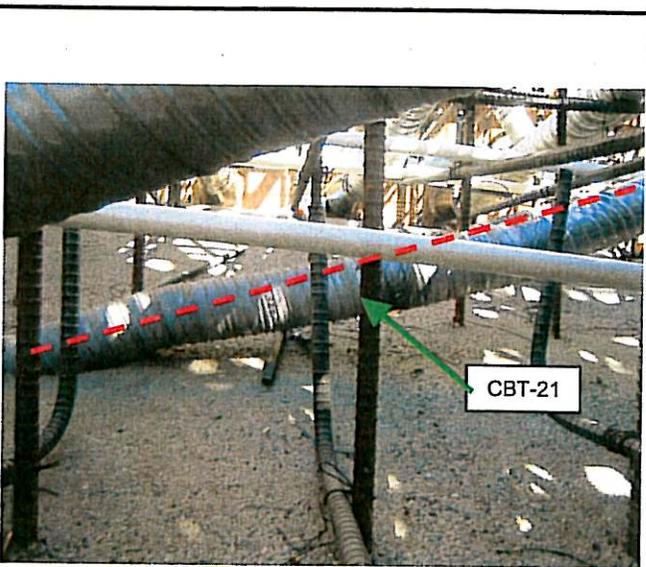
File Name:	Oct-16-2008 W2 Cap 022
Date:	10-16-08
By Int:	M Bruce

Description: Profile of CBT-21 looking east which needs to be straightened out. The dashed red line indicates the theoretical position of the tendon.
