Job Stamp 04-0120F4 SFOBB SAS

ASSISTANT RESIDENT ENGINEER'S **CONTRACTOR – ABFJV, Subs CMC-RS**

Description of Operations @ W2 Cap Beam:

EA	04-0120F4
Co-Rte-KP (PM)	SF-080-13.2/13.9 (8.2/8.7)
Structure Rep.	Rick Morrow

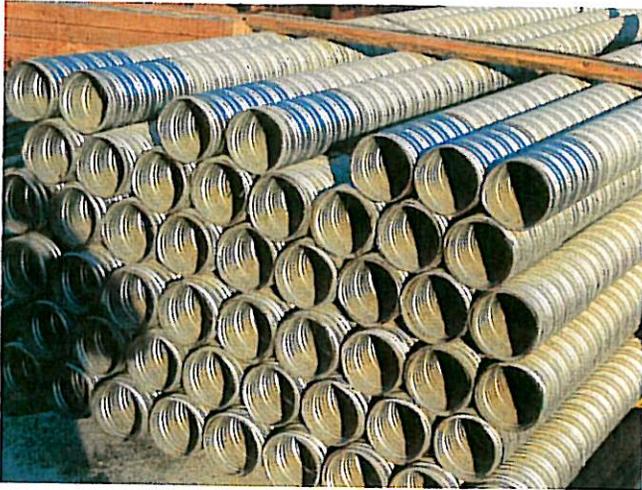
File Name: Oct-17-2008 W2 Cap 004

Description: Stack of rigid ducts on the ground, which are coated with dirt on the outside and inside of duct. Both foreman Nigel Lohse and Tim Greenlee were informed about this issue before the ducts were flown to the top of cap beam.

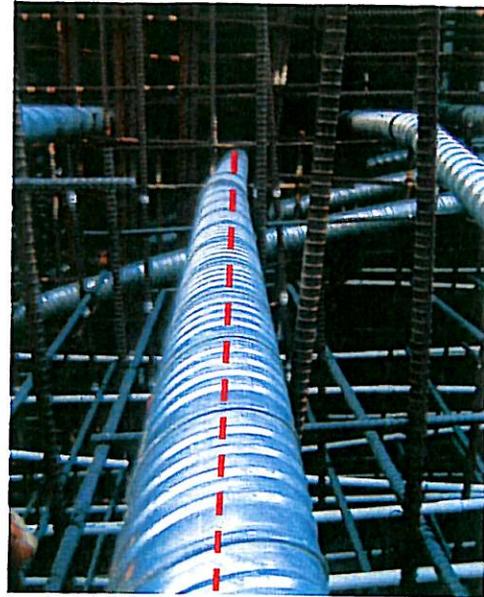
File Name: Oct-17-2008 W2 Cap 008

Description: Duct placement of continuity tendon E-34B coming out of the SE column cage where there is a dramatic change in the horizontal profile. Per submittal 150 this tendon is supposed to be straight. RS foreman Tim Greenlee was informed about this issue.

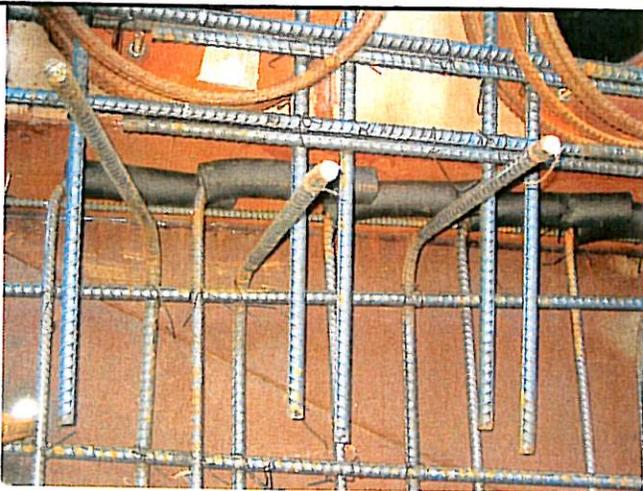
File Name: Oct-17-2008 W2 Cap 009

Description: Placement of the #16 temperature steel at the CBT-9 through CBT-15 blockout at the south end of the cap beam near W2E.

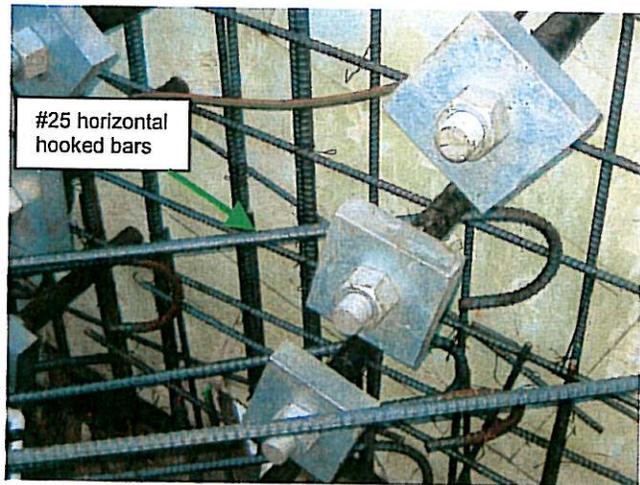
File Name: Oct-17-2008 W2 Cap 010

#25 horizontal hooked bars

Description: Photo of #25 horizontal ties near Panel B of the W2E deviation saddle. These bars should engage the vertical bars near the deviation saddle. RS foreman Tim Greenlee was notified about this issue.

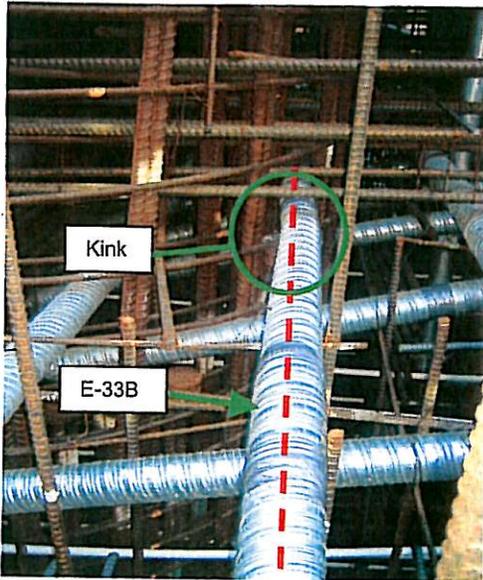
File Name: Oct-17-2008 W2 Cap 013

Description: Duct placement of continuity tendon E-33B where there is a dramatic change in the horizontal profile. Per submittal 150 this tendon veers towards the north. RS foreman Tim Greenlee was informed about this issue.

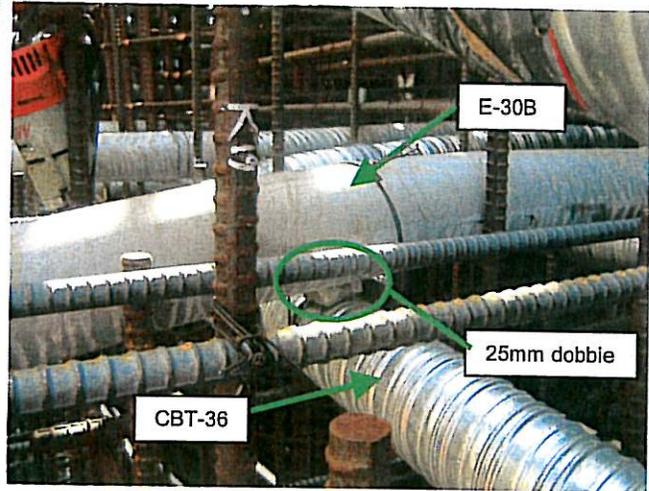
File Name: Oct-17-2008 W2 Cap 016

Description: A 25mm dobbie was placed in between CBT-36 flexi-duct and E-30B X-strong pipe to provide enough clearance for the concrete to encase both ducts.

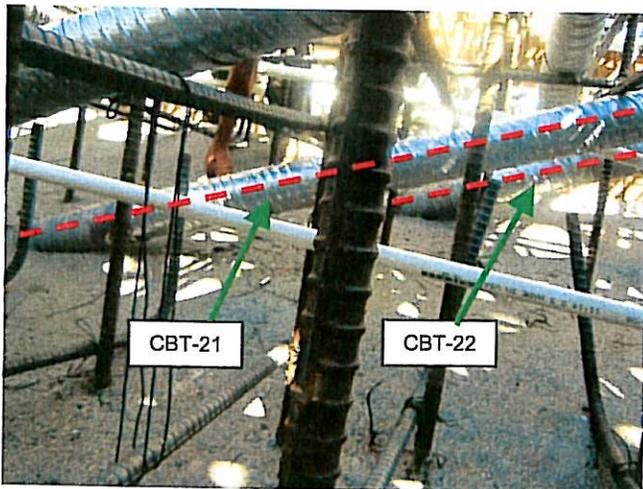
File Name: Oct-17-2008 W2 Cap 021

Description: The ironworkers reprofiled CBT-21/22 coming out of concrete, which were shaped like an "S" yesterday. An inside coupler was used to join the ducts instead of an outside coupler. The dashed red line indicates the theoretical tendon profile.

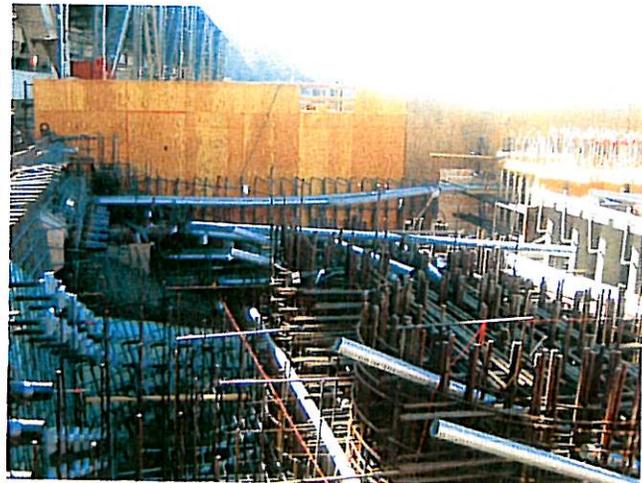
File Name: Oct-17-2008 W2 Cap 024

Description: Placement of CBT-1 through CBT-8 near the deviation saddle looking west.
