Job Stamp 04-0120F4 SFOBB SAS

ASSISTANT RESIDENT ENGINEER'S **CONTRACTOR – ABFJV, Subs CMC-RS**

Description of Operations @ W2 Cap Beam:

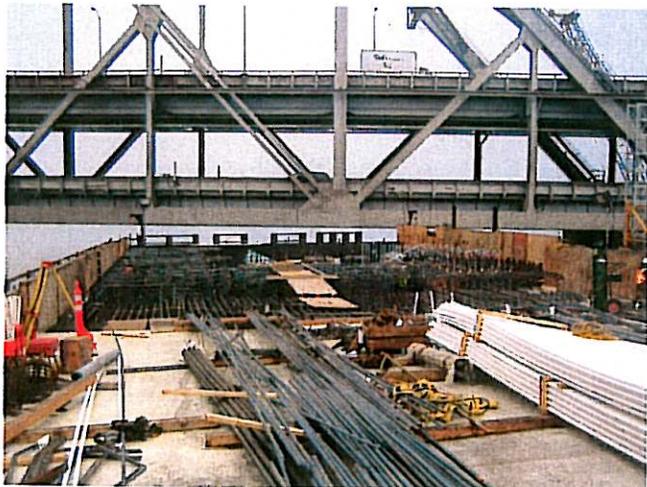
File Name:	Oct-27-2008 W2 Cap 001
Date:	10-27-08
By Int:	M Bruce

Description: Construction progress of the pour 4 reinforcement to date.

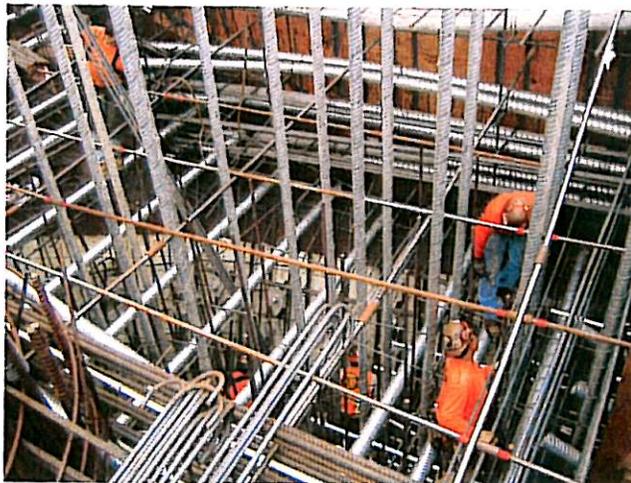
File Name:	Oct-27-2008 W2 Cap 003
Date:	10-27-08
By Int:	M Bruce

Description: Ironworkers placing #25 horizontal hooked bars in the vertical PT (VT) area and placing grillage for E-30B to E-44. Also the vertical PT ducts are in place and plumb for the most part. There are a couple of the ducts that could be plumbed better.

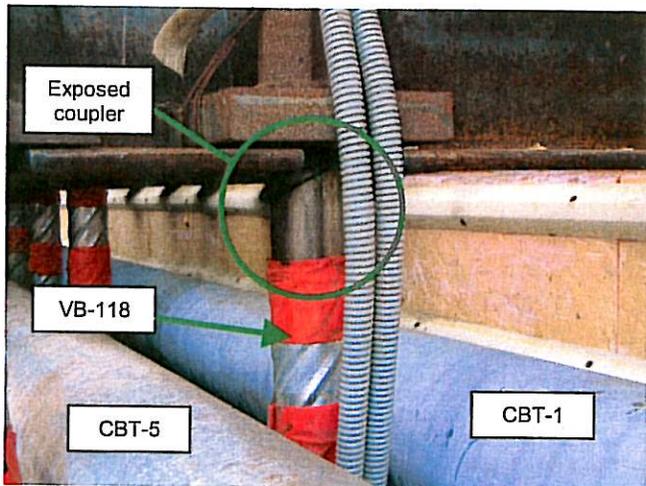
File Name:	Oct-27-2008 W2 Cap 006
Date:	10-27-08
By Int:	M Bruce

Description: Another vertical bar with exposed steel (coupler in this case) for VB118 at the north Hinge K assembly. This issue has been put on the pour 4 punchlist already.

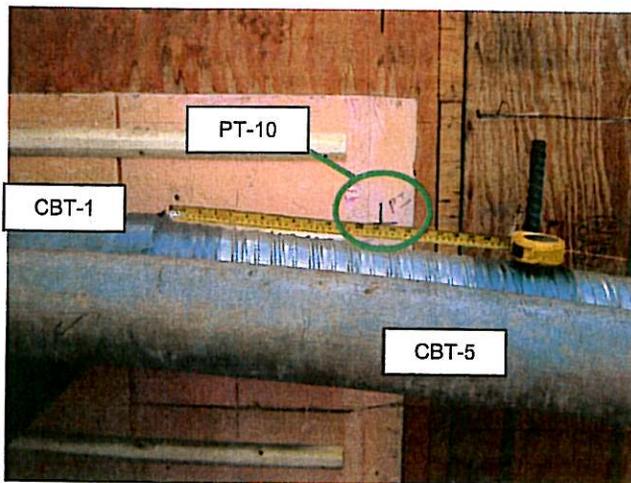
File Name:	Oct-27-2008 W2 Cap 008
Date:	10-27-08
By Int:	M Bruce

Description: The Y-offset for Pt-10 in the PT placing drawings (Submittal 150) is -15.950m from the center of the cap. The end of the pipe is located in between E-13A and E-14A and the calculated Y-offset is -16.191m. Therefore from Pt-10 to the end of the pipe is 241mm. A distance of 340mm was measured in the field.

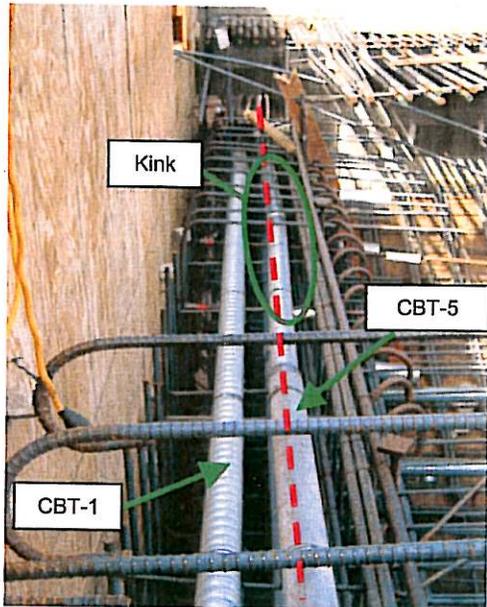
File Name: Oct-27-2008 W2 Cap 010
 Date: 10-27-08 By Int: M Bruce
 Description: Reprofile CBT-5 near the south pour 3 construction joint, as there is a "kink" in plan view.

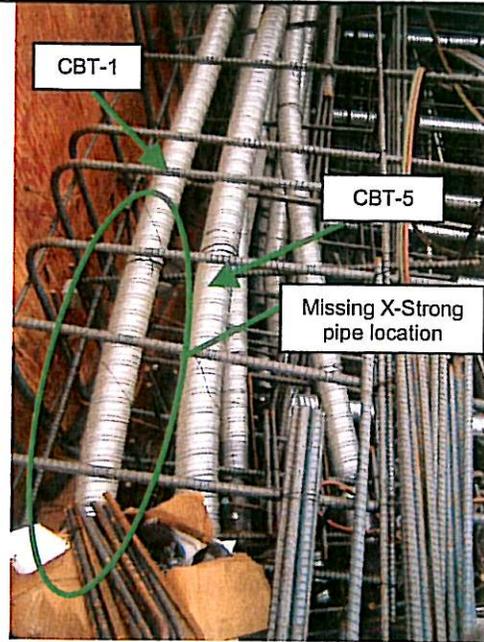
File Name: Oct-27-2008 W2 Cap 016
 Date: 10-27-08 By Int: M Bruce
 Description: Missing X-strong pipe for CBT-1, which should be placed from the trumpet exit to the middle of the E-41A to E-42A continuity tendons. A flexi-duct was placed instead of the X-strong pipe.

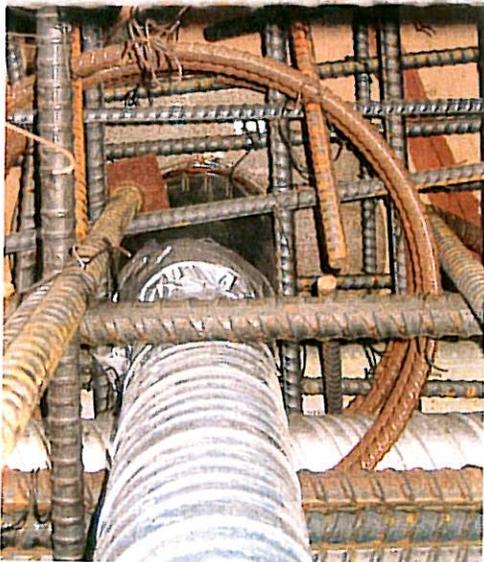
File Name: Oct-27-2008 W2 Cap 017
 Date: 10-27-08 By Int: M Bruce
 Description: Suspect duct to trumpet connection for E-6B at the west end of the cap beam. It appears that the trumpet was cut closer to the bearing plate than it should have been.

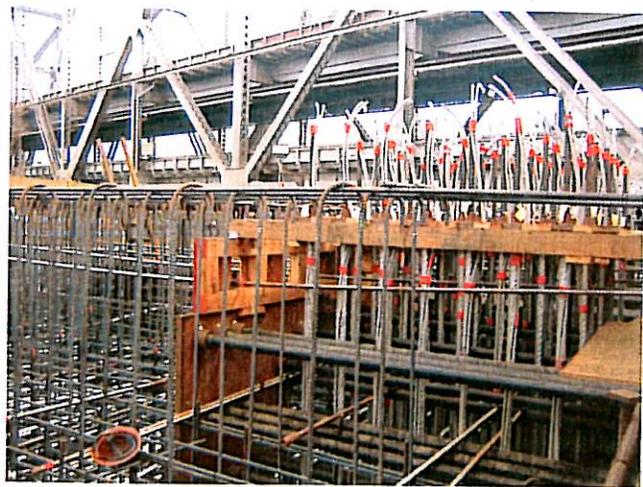
File Name: Oct-27-2008 W2 Cap 019
 Date: 10-27-08 By Int: M Bruce
 Description: Placement of vertical #25 hooked bars around the north W2E Hinge K assembly.
