Job Stamp 04-0120F4 SFOBB SAS

ASSISTANT RESIDENT ENGINEER'S **CONTRACTOR – ABFJV, Subs CMC-RS**

Description of Operations @ W2 Cap Beam:

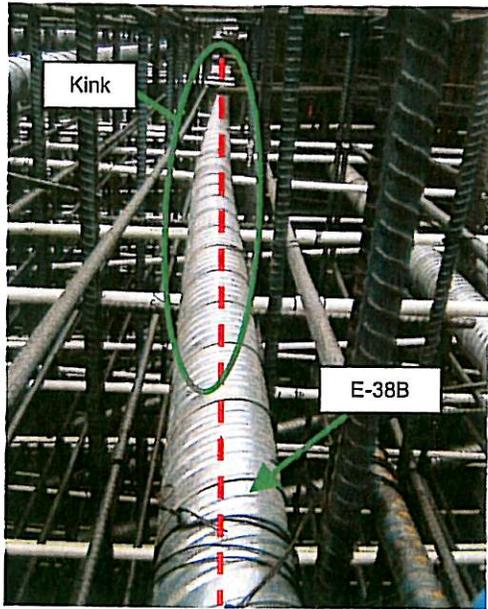
File Name:	Oct-28-2008 W2 Cap 003
Date:	10-28-08
By Int:	M Bruce

Description: Photo of continuity tendon E-38B taken near the east bulkhead looking west. There is a kink in the horizontal plane that needs to be corrected.

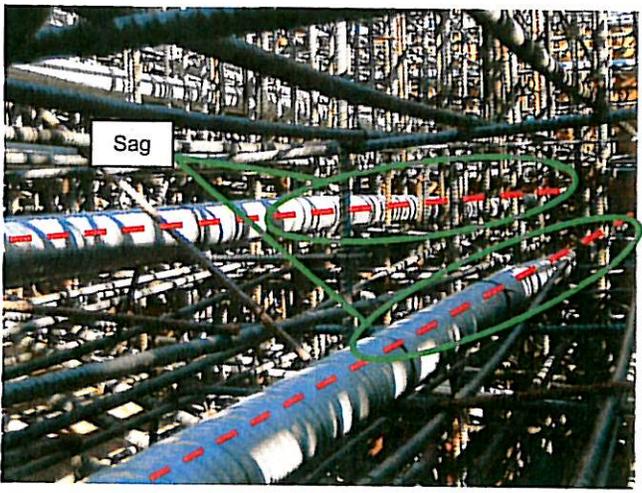
File Name:	Oct-28-2008 W2 Cap 006
Date:	10-28-08
By Int:	M Bruce

Description: Appreciable sags were found in the E-1B to E-11B continuity tendons. This is a photo of ducts for E-7B and E-8B looking east taken near the North W2E Hinge K assembly.

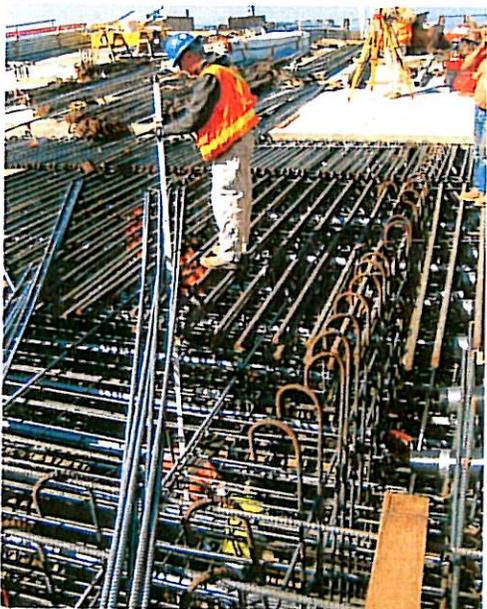
File Name:	Oct-28-2008 W2 Cap 008
Date:	10-28-08
By Int:	M Bruce

Description: ABF surveyors seen assisting the CMC-RS ironworkers with profiling the E-1B to E-11B ducts. Prior to the surveyors help I mentioned to ABF surveyor James Allen that the ducts need to be checked. As they were checking some ducts were off 125mm in elevation.

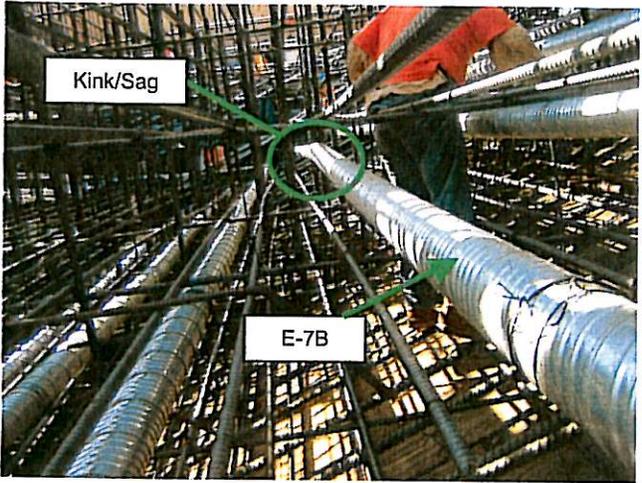
File Name:	Oct-28-2008 W2 Cap 009
Date:	10-28-08
By Int:	M Bruce

Description: Photo taken of E-7B near the east bulkhead looking west prior to the ironworkers reprofiling the duct.

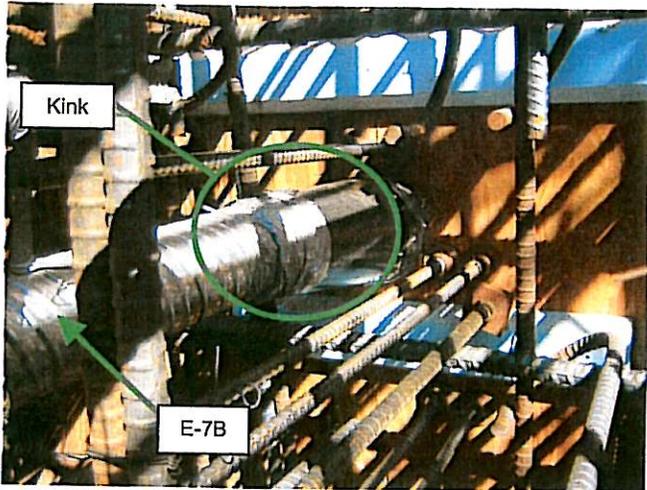
File Name:	Oct-28-2008 W2 Cap 010		
Date:	10-28-08	By Int:	M Bruce

Description: Continuity E-7B trumpet that has a kink at the connection with the rigid duct.

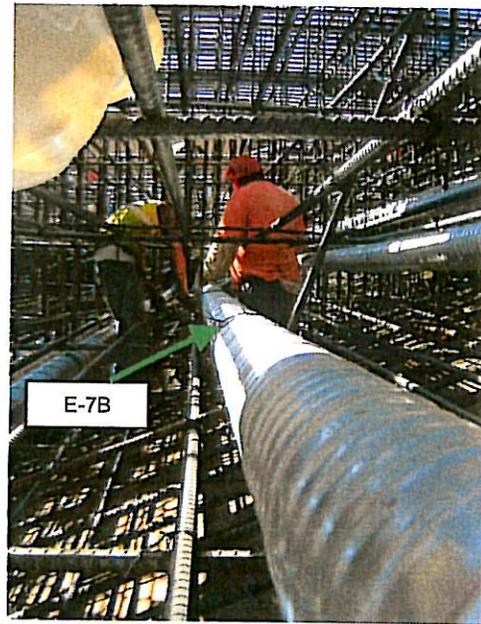
File Name:	Oct-28-2008 W2 Cap 011		
Date:	10-28-08	By Int:	M Bruce

Description: Photo taken of E-7B near the east bulkhead looking west after the ironworkers profiled the duct with the assistance of ABF surveyors.
