Job Stamp 04-0120F4 SFOBB SAS

ASSISTANT RESIDENT ENGINEER'S **CONTRACTOR – ABFJV, Subs CMC-RS**

**Description of Operations @ W2 Cap Beam:**

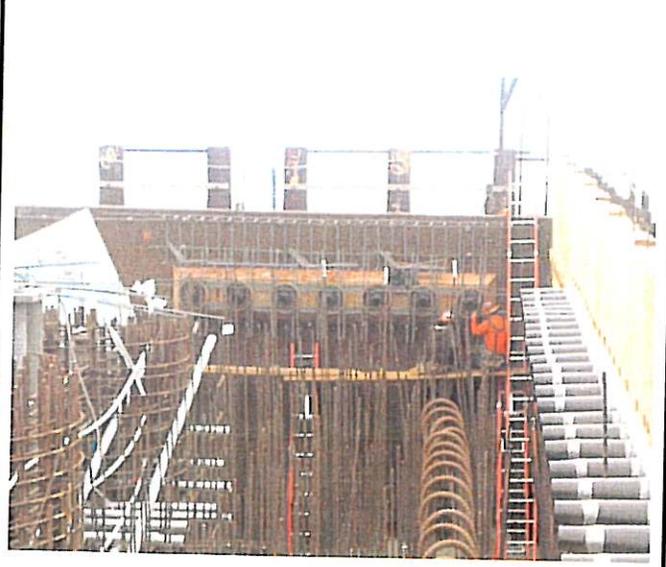
File Name:	Oct-30-2008 W2 Cap 001		
Date:	10-30-08	By Int:	M Bruce
Description: Ironworkers placing grillage at the CBT-16 through CBT-22 blockouts on the north end of the cap beam.

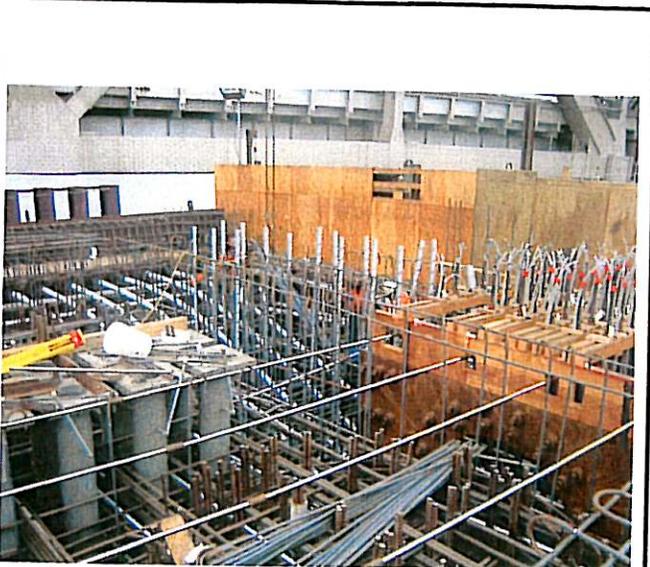
File Name:	Oct-30-2008 W2 Cap 004		
Date:	10-30-08	By Int:	M Bruce
Description: CBT-9 through CBT-15 tendons has been installed. Also the ironworkers are seen mobilizing more #25 horizontal ties near the deviation saddle.
