Job Stamp 04-0120F4 SFOBB SAS

ASSISTANT RESIDENT ENGINEER'S **CONTRACTOR – ABFJV, subs CMC-RS**

Description of Operations @ W2 Cap Beam:

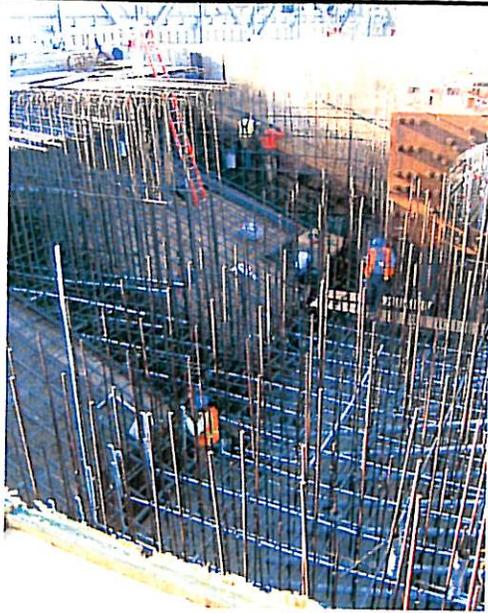
File Name:	Nov-14-2008 W2 Cap 001
Date:	11-14-08
By Int:	M Bruce

Description: Piledrivers seen placing the pour 5 thermal control PVC pipes and the ironworkers are preparing the west wall for 25V07 placement.

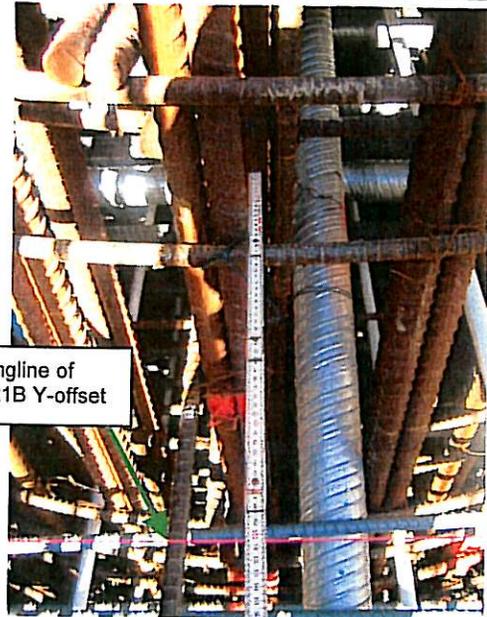
File Name:	Nov-14-2008 W2 Cap 011
Date:	11-14-08
By Int:	M Bruce

Stringline of W-21B Y-offset

Description: A stringline was placed on the W-21B centerline. This was used to locate the centerline of W-22B. The Y-offset between the continuity tendons is 500mm. This photo was taken near the southwest W2W column cage.

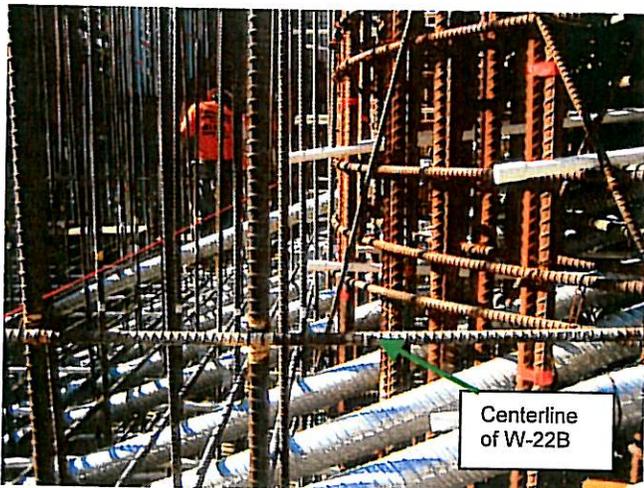
File Name:	Nov-14-2008 W2 Cap 012
Date:	11-14-08
By Int:	M Bruce

Centerline of W-22B

Description: The centerline of W-22B is shown on the support bar outside of the east end of the W2W southeast column cage.

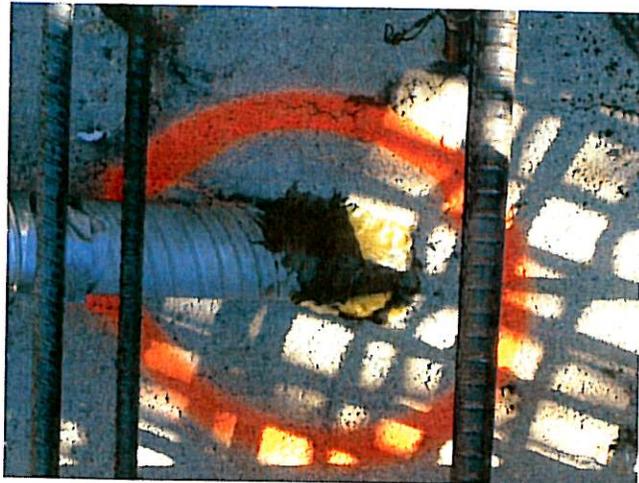
File Name:	Nov-14-2008 W2 Cap 016
Date:	11-14-08
By Int:	M Bruce

Description: The repaired dent/tear in the duct of transverse tendon CBT-20 coming out of concrete.

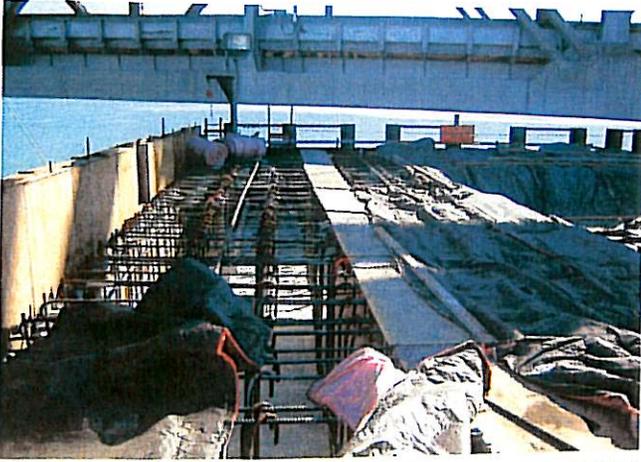
File Name:	Nov-14-2008 W2 Cap 017
------------	------------------------

Description: Curing mats were starting to be removed before the end of the day.

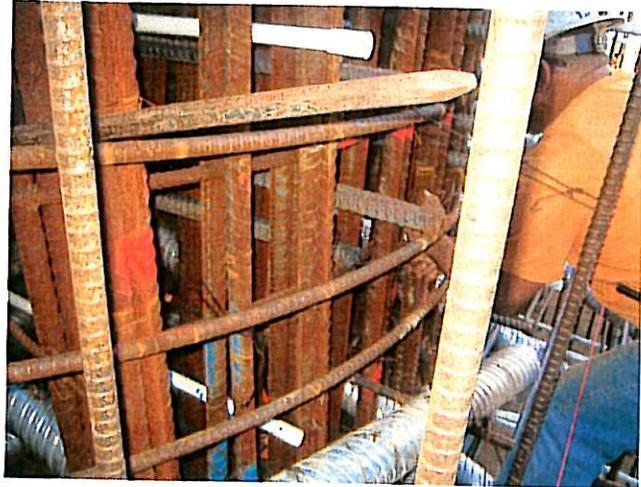
File Name:	Nov-14-2008 W2 Cap 019
------------	------------------------

Description: Ironworker seen in the photo "hogging" back the #43 vertical column bars at the W2W southwest cage. A come-along was used to facilitate duct placement.
