EA	04-0120F4
Co-Rte-KP (PM)	SF-080-13.2/13.9 (8.2/8.7)
Structure Rep.	Rick Morrow

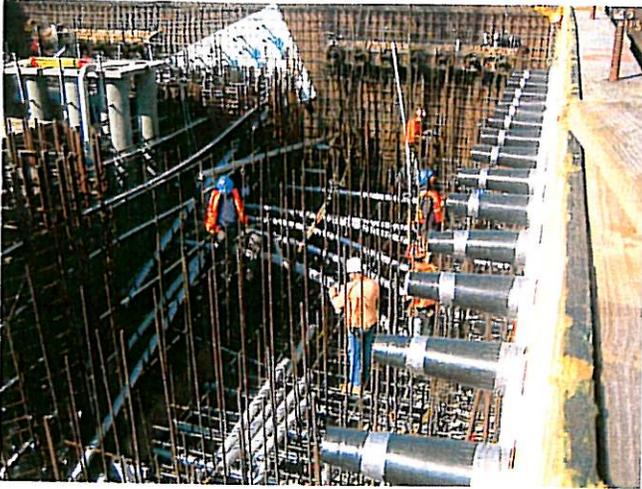
File Name:	Nov-18-2008 W2 Cap 005
Date:	11-18-08
By Int:	M Bruce

Description: Ironworkers installing ducts for W-23B to W-35B at the east bulkhead with the assistance of ABF surveyors.

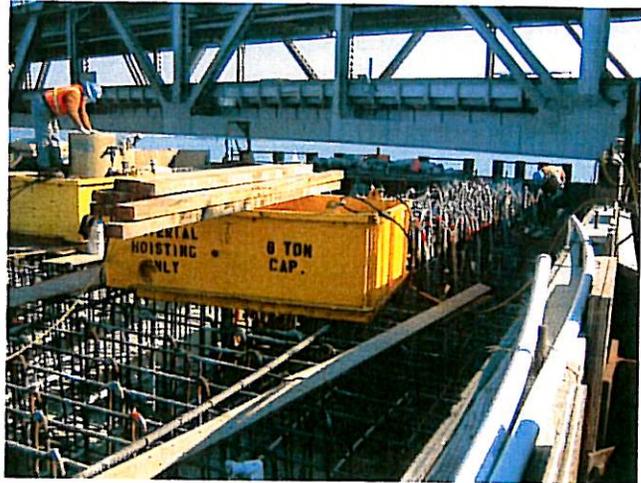
File Name:	Nov-18-2008 W2 Cap 008
Date:	11-18-08
By Int:	M Bruce

Description: Laborers are seen sandblasting the pour 4 construction joint. Also piledrivers are seen removing the templates for the vertical PT bars at the Hinge K assemblies.

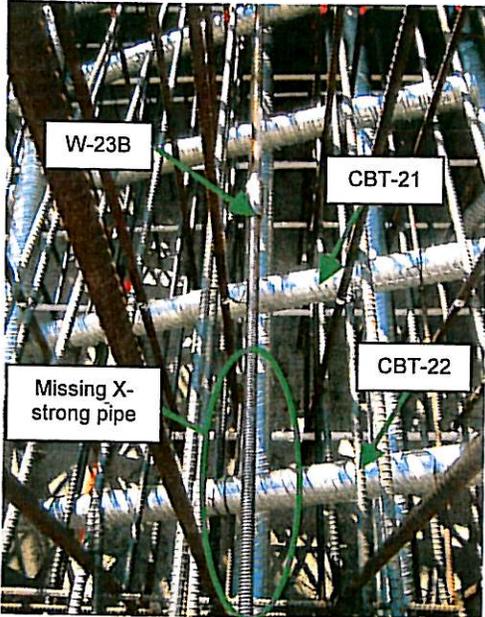
File Name:	Nov-18-2008 W2 Cap 011
Date:	11-18-08
By Int:	M Bruce

Description: The X-strong duct for W-23B was missing near the east bulkhead. I informed RS foreman Tim Greenlee of this issue and ironworkers were seen towards the end of the day installing the X-strong pipe.

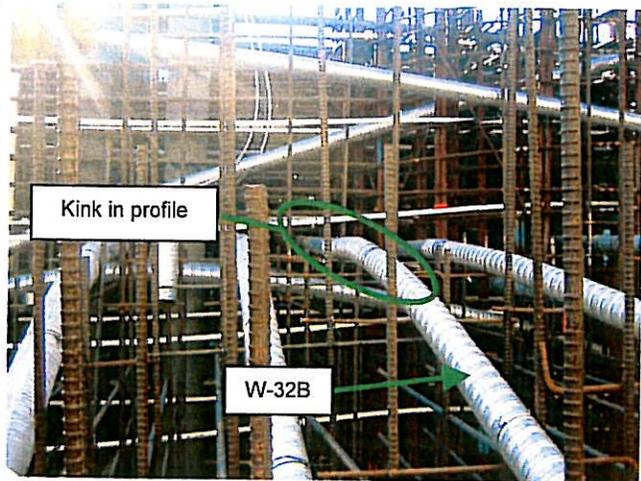
File Name:	Nov-18-2008 W2 Cap 014
Date:	11-18-08
By Int:	M Bruce

Description: The curved ducts for W-23B to W-35B appeared to be adequate. However the ducts in the column cages are still not straight. ABF and RS have been informed about this issue on several occasions. This situation also occurred at W2E with continuity tendons E-30B through E-38B.
