| Job Stamp 04-0120F4 SFOBB SAS |

ASSISTANT RESIDENT ENGINEER'S **CONTRACTOR – ABFJV, Subs CMC-RS**

Description of Operations @ W2 Cap Beam:

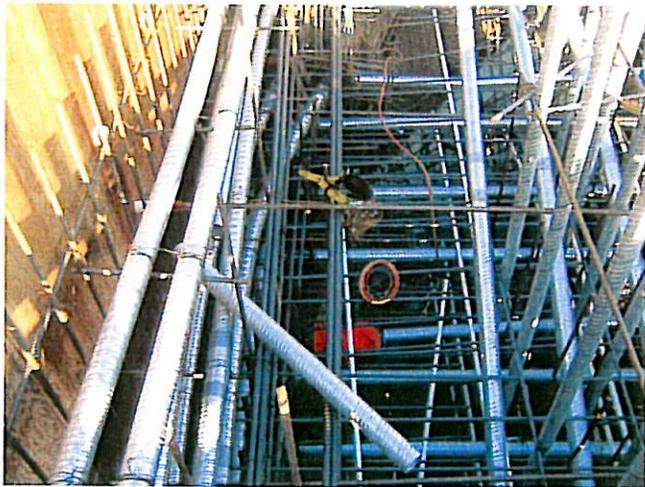
| File Name: | Dec-02-2008 W2 Cap 001 | | |

| Description: | Ironworker seen adjusting the grillage around the W-34B bearing plate/trumpet before installing the rigid duct. | | |

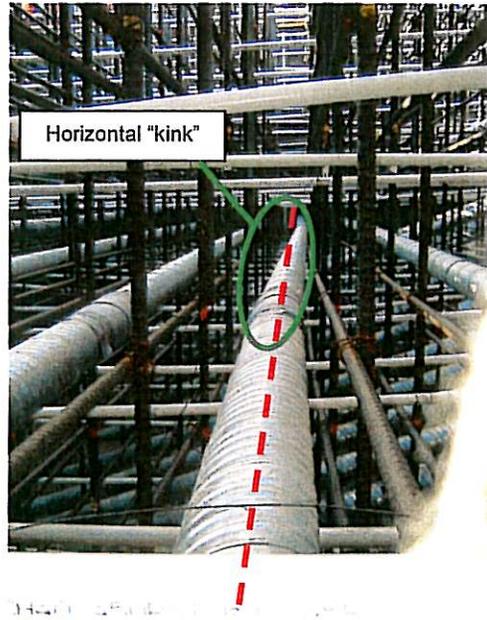
| File Name: | Dec-02-2008 W2 Cap 006 | | |

| Description: | Photo of continuity tendon W-17B looking west near the east bulkhead. The duct needs to be corrected in the horizontal direction and also has to have support bars 4'c.c. | | |

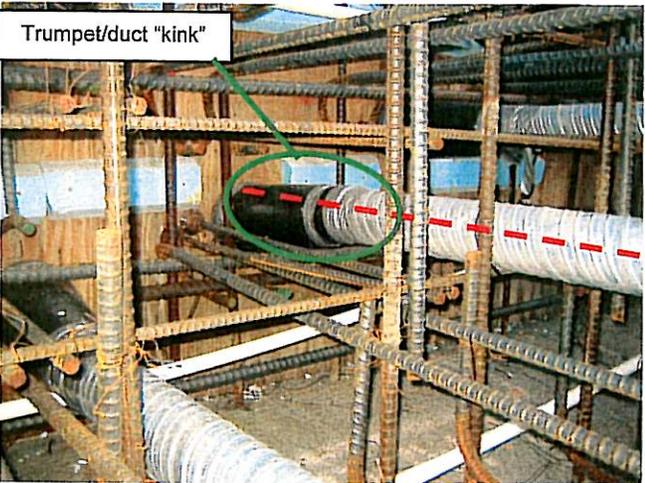
| File Name: | Dec-02-2008 W2 Cap 008 | | |

| Description: | Photo of continuity tendon W-14B looking east. There is a dramatic kink in profile that should be corrected. | | |

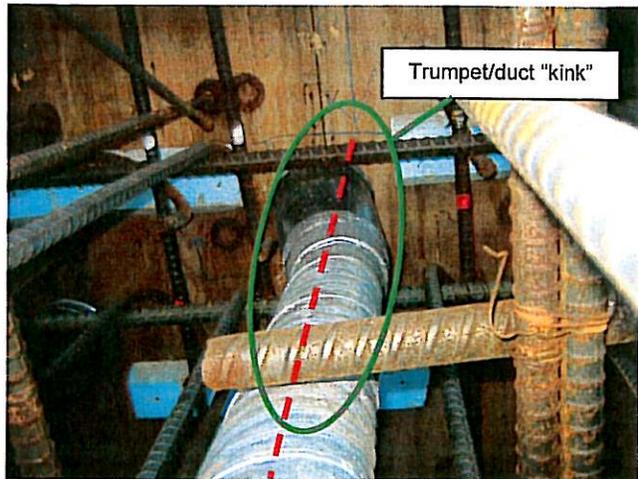
| File Name: | Dec-02-2008 W2 Cap 009 | | |

| Description: | Similar to the previous photo continuity tendon W-12B has a kink in the horizontal direction that should be corrected prior to concrete placement. | | |

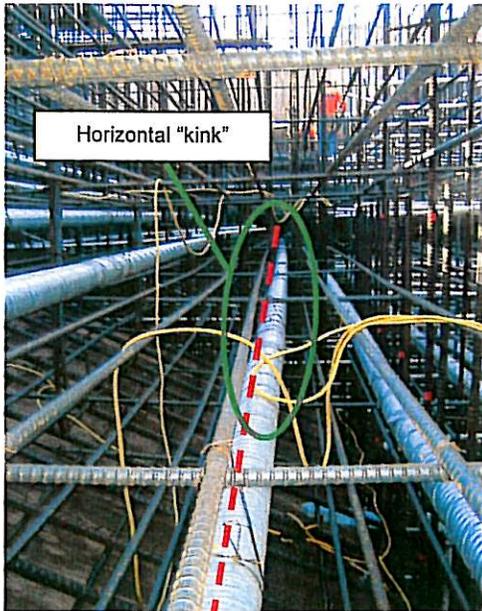
| File Name: | Dec-02-2008 W2 Cap 011 |

Description: Photo of continuity tendon W-10B looking west taken near the east bulkhead. The duct needs to be corrected in the horizontal direction and also has to have support bars 4'c.c.

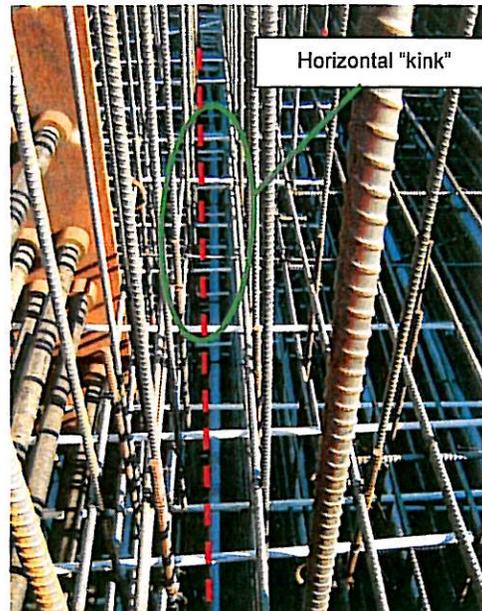
| File Name: | Dec-02-2008 W2 Cap 013 |

Description: Photo of continuity tendon W-13B looking east taken near the south W2W Hinge K assembly. The duct needs to be corrected in the horizontal direction and also has to have support bars 4'c.c.

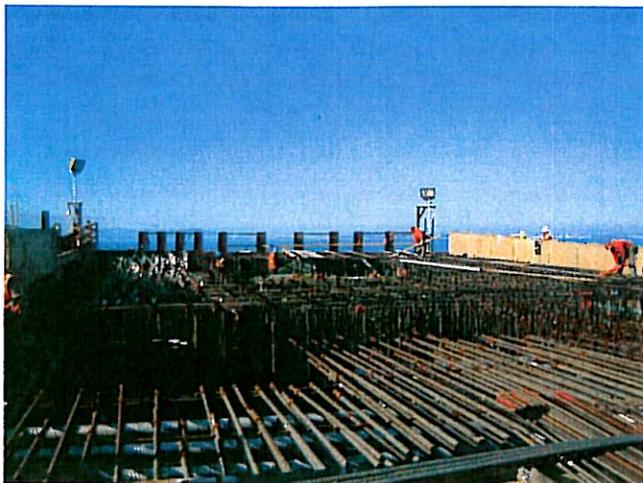
| File Name: | Dec-02-2008 W2 Cap 022 |

Description: Pour 5 progress to date looking in the northeast direction of the W2 cap beam.

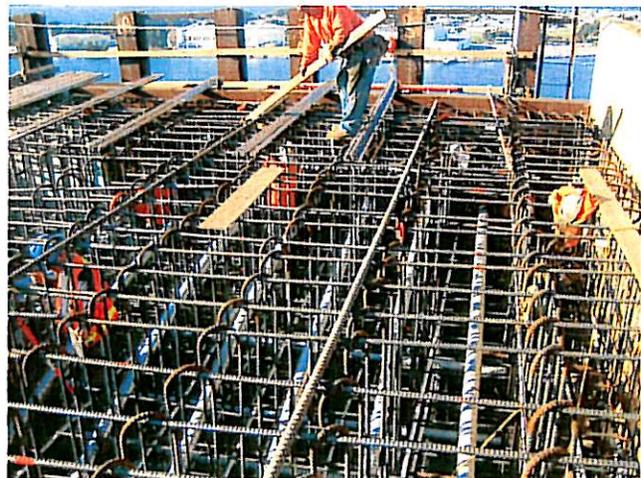
| File Name: | Dec-02-2008 W2 Cap 024 |

Description: Ironworkers seen adjusting the #25 vertical hooked bars near the flexi ducts placed for CBT-16 to 22.
