Job Stamp 04-0120F4 SFOBB SAS

**ASSISTANT RESIDENT ENGINEER'S CONTRACTOR – ABFJV, Subs CMC-RS and Conco**

**Description of Operations @ W2 Cap Beam:**

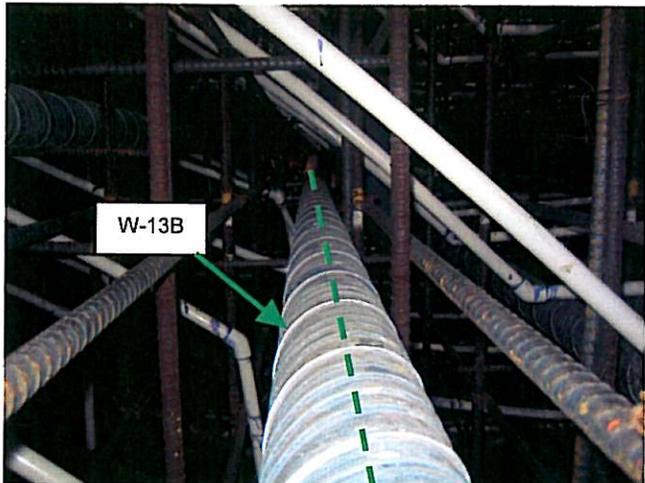
<p>W-13B</p>

<p>Fixed the "kink" in the vertical direction</p> <p>W-14B</p>	
File Name: Dec-12 and 13-2008 W2 Cap 006		File Name: Dec-12 and 13-2008 W2 Cap 009	
Date: 12-12-08	By Int: M Bruce	Date: 12-12-08	By Int: M Bruce
Description: Photo of continuity tendon W-13B taken near the east bulkhead looking west after the ironworkers straightened out the duct.		Description: The trumpet to duct connection for continuity tendon W-14B was fixed in the vertical direction.

20:40	Ironworkers began to address issues on my punchlist which included correcting the profiles of the following ducts: CBT-20, W-13B, W-15B, W-16B, and W-17B. The vertical PT tendon ducts were fixed earlier in the day by ABF piledrivers.

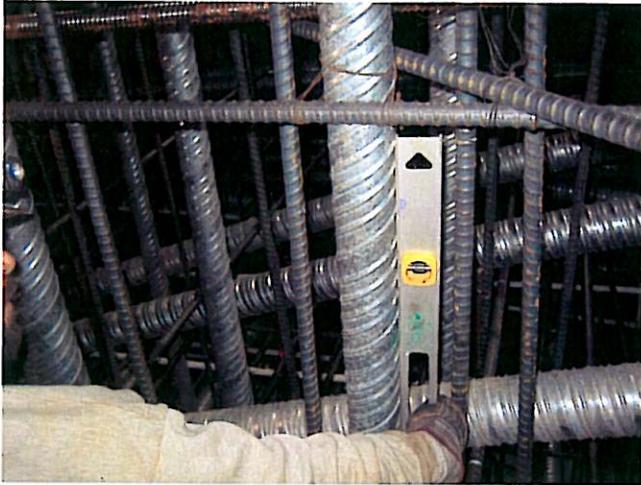
File Name:	Dec-12 and 13-2008 W2 Cap 010		
Date:	12-12-08	By Int:	M Bruce
Description: Vertical PT tendon duct that was plumbed prior to concrete placement.

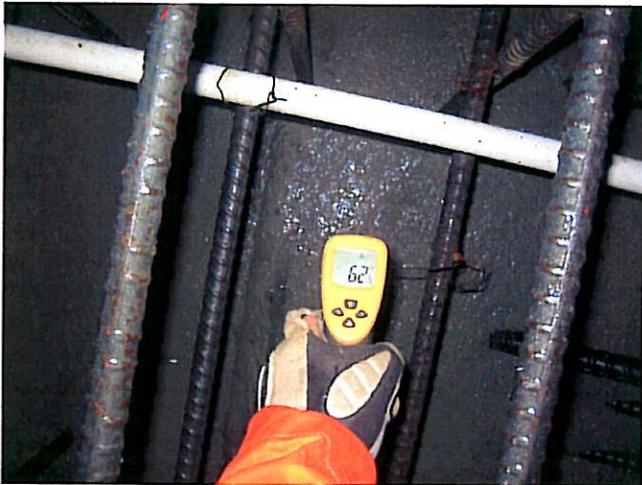
File Name:	Dec-12 and 13-2008 W2 Cap 015		
Date:	12-13-08	By Int:	M Bruce
Description: Temperature taken at 01:00am taken near the north end of the sloped void forms.
