Job Stamp 04-0120F4 SFOBB SAS

ASSISTANT RESIDENT ENGINEER'S **CONTRACTOR – ABFJV, Subs CMC-RS**

**Description of Operations @ W2 Cap Beam:**

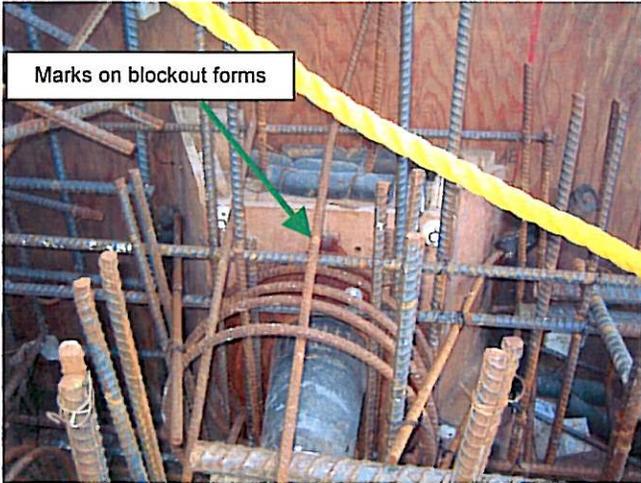
File Name:	Dec-18-2008 W2 Cap 001
Date:	12-18-08
By Int:	M Bruce

Description: The bearing plate for E-44 was lowered as seen by the marks on the blockout forms. The distance change in elevation was approximately 50mm.

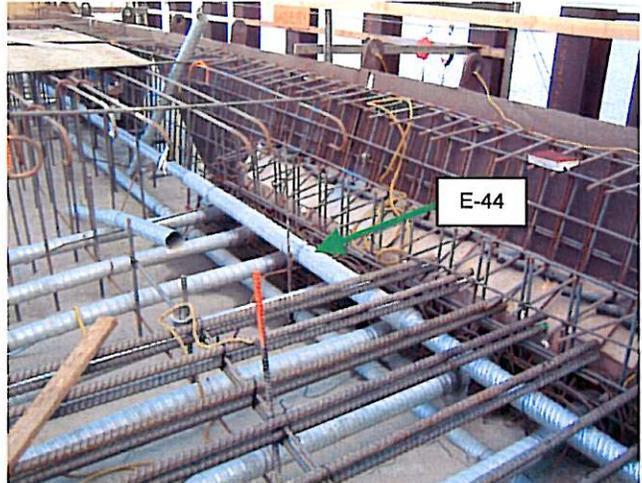
File Name:	Dec-18-2008 W2 Cap 002
Date:	12-18-08
By Int:	M Bruce

Description: Photo of the ductwork for continuity tendon E-44 near the south end of the cap beam.

- Continued to place #43 transverse bars near the Hinge K back plate for pour 6 south.
- Installed the extra strong steel pipe for continuity tendon E-44 and completed the remaining portions of the duct work.

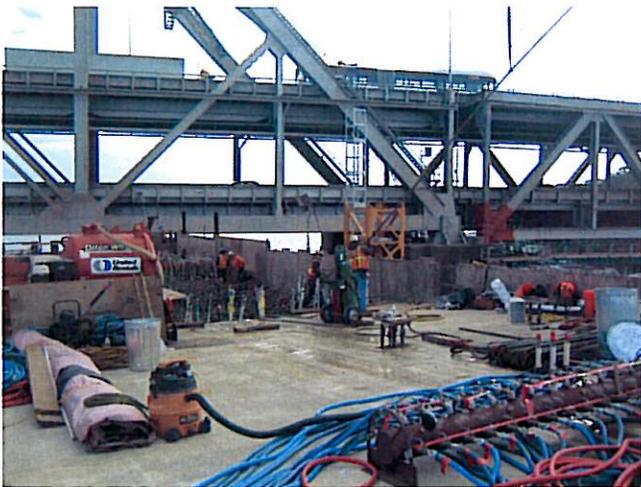
File Name:	Dec-18-2008 W2 Cap 005
Date:	12-18-08
By Int:	M Bruce

Description: Ironworkers placing a #43 transverse bar near the W2E Hinge K assemblies.

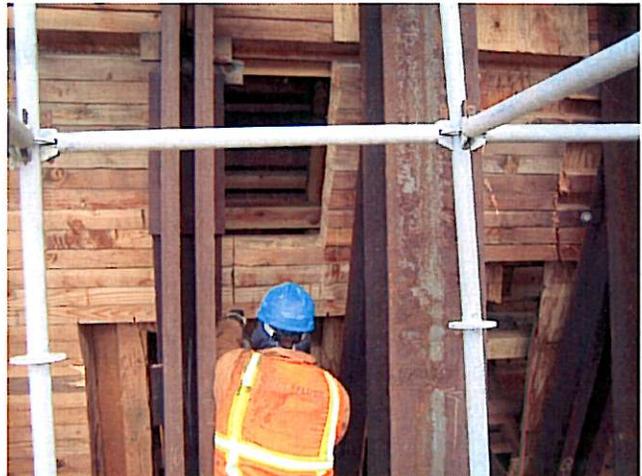
File Name:	Dec-18-2008 W2 Cap 006
Date:	12-18-08
By Int:	M Bruce

Description: Piledriver removing the formwork near the jacking saddle opening.
