Job Stamp 04-0120F4 SFOBB SAS

**ASSISTANT RESIDENT ENGINEER'S CONTRACTOR – ABFJV, Subs CMC-RS and Conco**

**Description of Operations @ W2 Cap Beam:**

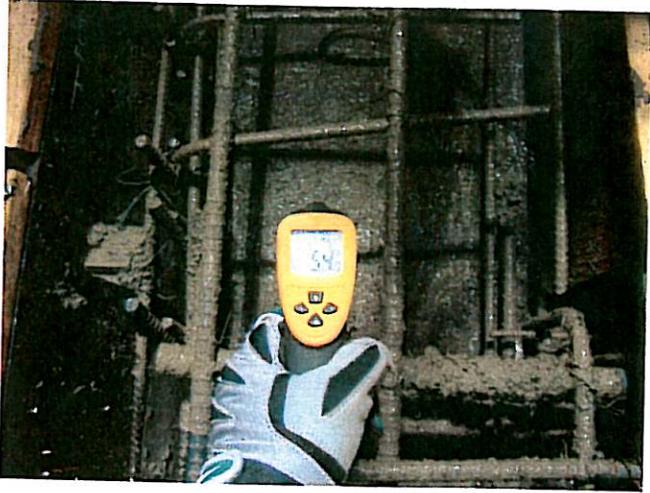
File Name: Jan-30 and 31-2009 W2 Cap 003		File Name: Jan-30 and 31-2009 W2 Cap 004	
Date: 01-30-09	By Int: M Bruce	Date: 01-30-09	By Int: M Bruce
Description: Concrete temperature of 54°F at the southwest corner of the cap beam taken at 11:40pm.		Description: Conco laborers placing concrete in the pour 6 south area. The laborers had to work real hard to vibrate the fresh concrete near the seismic joint blockout as seen on the left side of the photo.

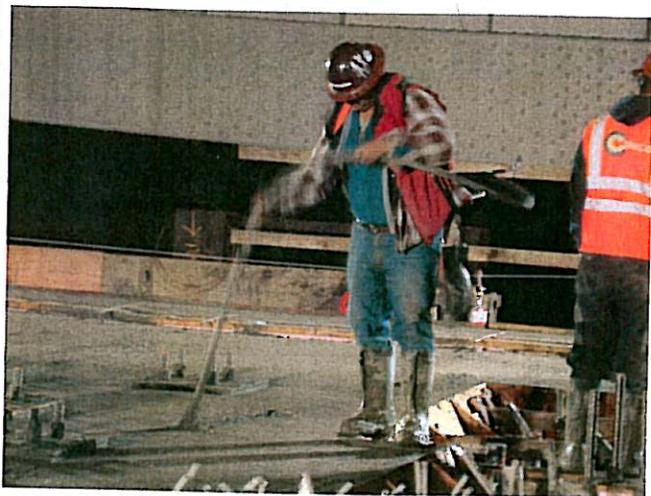
File Name:	Jan-30 and 31-2009 W2 Cap 008
Date:	01-31-09
By Int:	M Bruce

Description: Revibration of the finished concrete began at 2:30am and continued at 20-30 minute intervals.

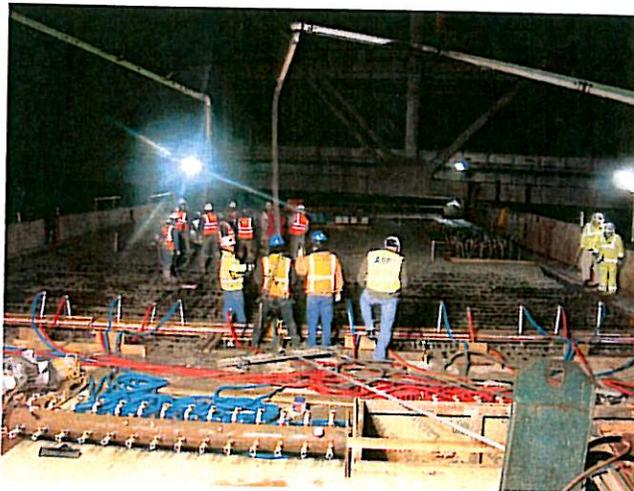
File Name:	Jan-30 and 31-2009 W2 Cap 009
Date:	01-31-09
By Int:	M Bruce

Description: Concrete placement at 4:10am looking south.

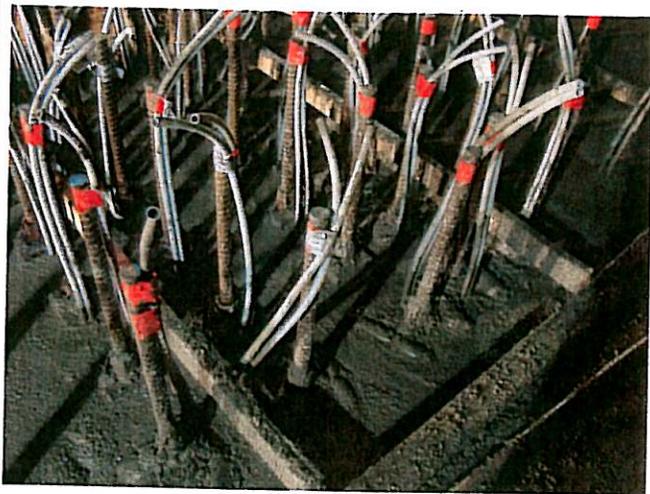
File Name:	Jan-30 and 31-2009 W2 Cap 010
Date:	01-31-09
By Int:	M Bruce

Description: Bearing plates for the vertical PT tendons and bars were covered with concrete. ABF and Conco foremen were notified several times that these plates need to be cleaned for stressing the bars or strands.

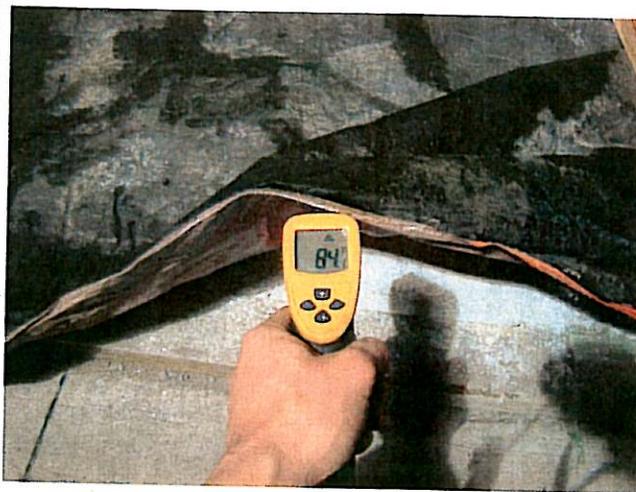
File Name:	Jan-30 and 31-2009 W2 Cap 011
Date:	01-31-09
By Int:	M Bruce

Description: Concrete surface temperature at 10:40pm Saturday night on the west end of the cap, north of the Hinge K assemblies. The east manifold temperature was 40°F and had a pressure of 39psi. The west manifold had a temperature of 44°F.
