Job Stamp 04-0120F4 SFOBB SAS

ASSISTANT RESIDENT ENGINEER'S **CONTRACTOR – ABFJV, Subs CMC-RS**

**Description of Operations @ W2 Cap Beam:**

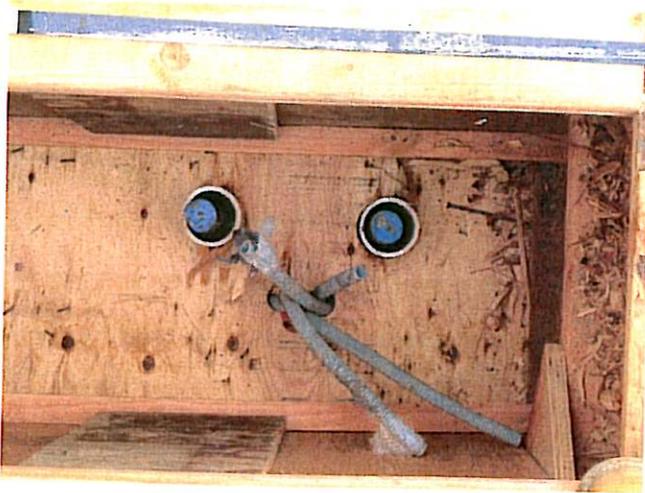
File Name:	Jan-6-2009 W2 Cap 001
------------	-----------------------

Description: Short vertical PT bars with grout tubes at the seismic joint breakout forms.

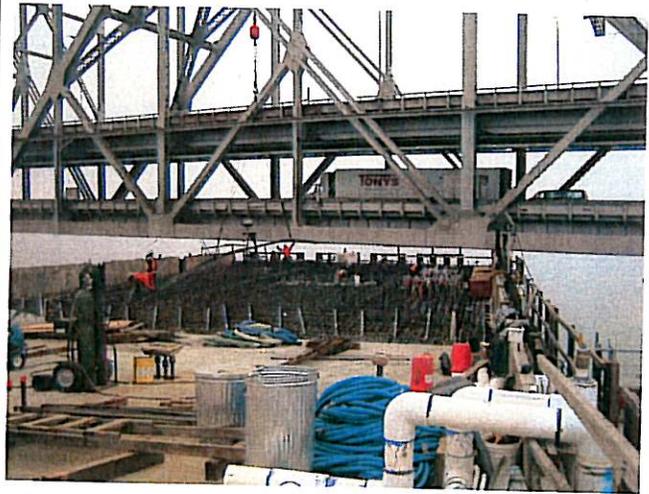
File Name:	Jan-6-2009 W2 Cap 003
------------	-----------------------

Description: Pour 6 south progress to date as the ironworkers are seen placing #43 transverse bars.
