Job Stamp 04-0120F4 SFOBB SAS
-------------------------------------

**Description of Operations @ W2 Cap Beam:**

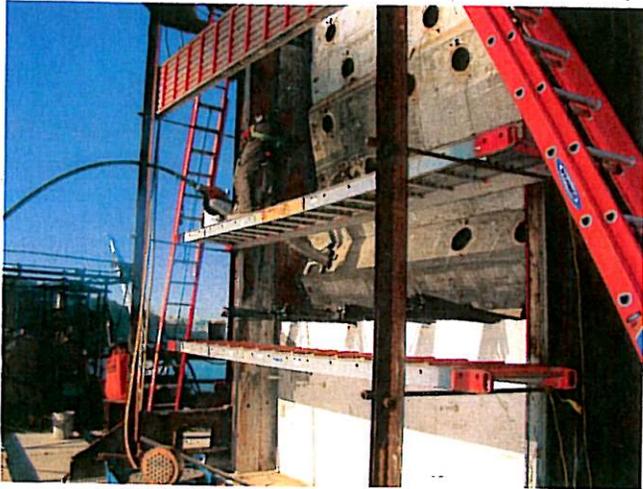
File Name: Jan-13-2009 W2 Cap 002

Description: SDI ironworkers pushing strand at the south end of the E2 cap beam. They pushed a total of 9-37 strand tendons today using 8 strand packs.

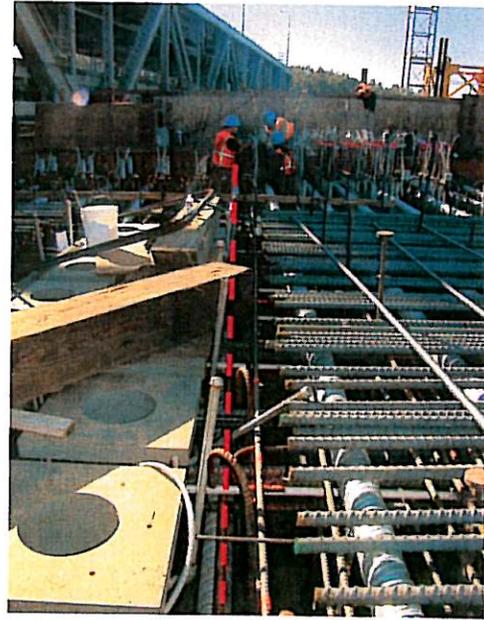
File Name: Jan-13-2009 W2 Cap 013

Description: Continuity tendon E-29A looking west as the duct deviates approximately 50mm in the horizontal direction from the theoretical Y-offset.

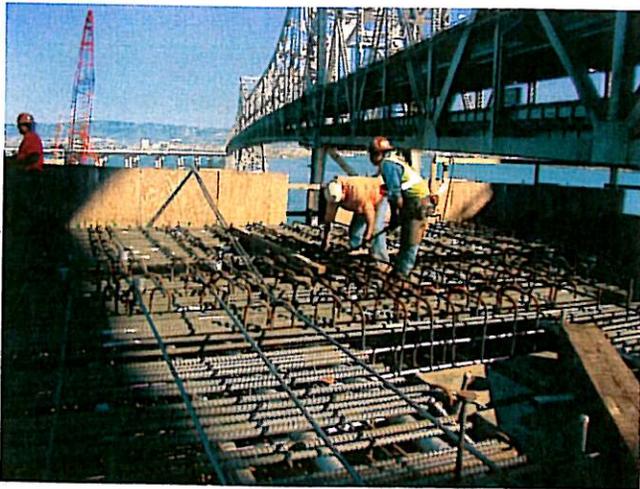
File Name: Jan-13-2009 W2 Cap 014

Description: RS ironworkers lifting #43 transverse bars to tie to the vertical #25 ties and #25 longitudinal bars.

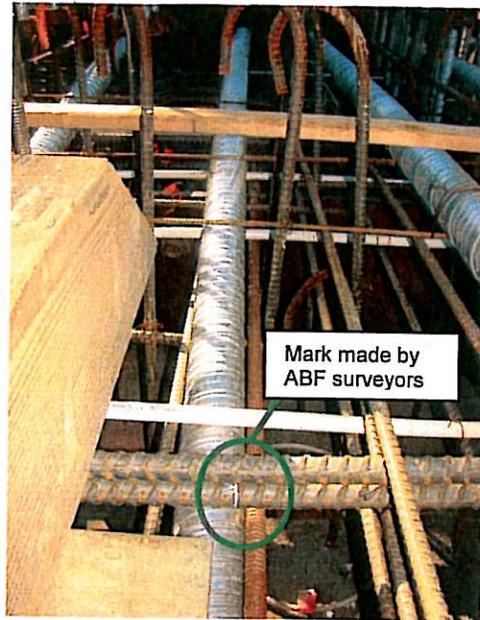
File Name: Jan-13-2009 W2 Cap 015

Description: Close up of continuity tendon E-29A looking west near the furthest cable tie down pipe/plate to the west. There is a tie rod placed preventing the ironworkers from moving the duct in the proper location 50mm to the north. A similar condition exists for this duct near the furthest east cable tie down pipe/plate.

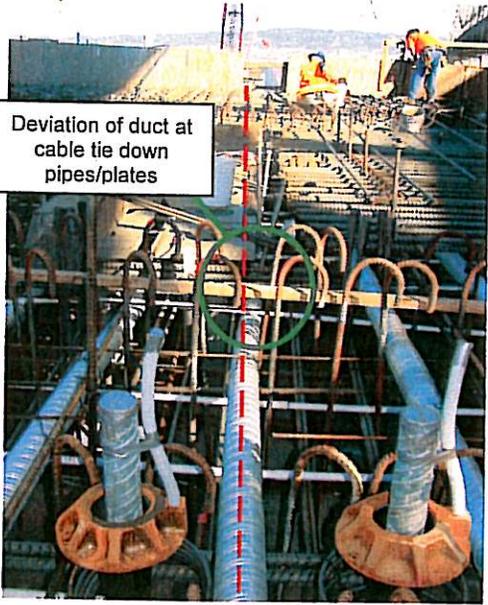
File Name:	Jan-13-2009 W2 Cap 016
Date:	01-13-09
By Int:	M Bruce

Deviation of duct at cable tie down pipes/plates

Description: Continuity tendon E-31A looking east as the duct is pushed towards the south due to future grouting pipes attached to the cable tie downs.

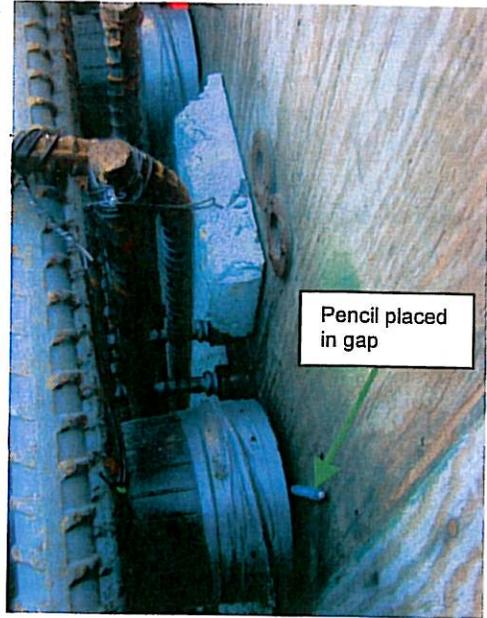
File Name:	Jan-13-2009 W2 Cap 017
Date:	01-13-09
By Int:	M Bruce

Pencil placed in gap

Description: Trumpet for continuity tendon E-39A where there is a gap between bulkhead forms. The trumpet probably needs to be secured better to forms. There are many trumpets similar to this one along the east bulkhead forms.
