Job Stamp 04-0120F4 SFOBB SAS

ASSISTANT RESIDENT ENGINEER'S **CONTRACTOR – ABFJV, Subs CMC-RS**

Description of Operations @ W2 Cap Beam:

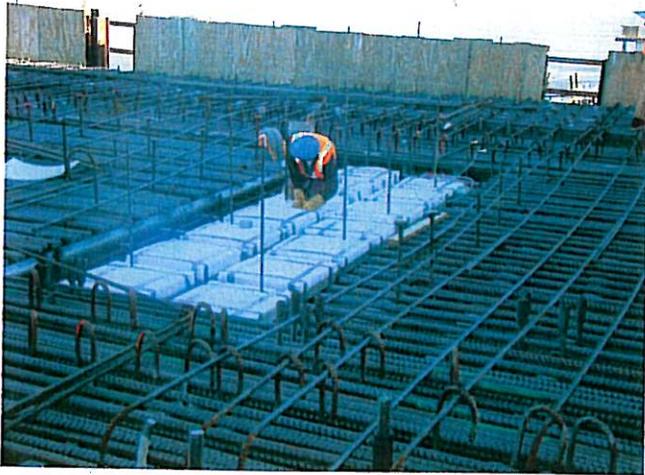
File Name:	Jan-19-2009 W2 Cap 001
Date:	01-19-09
By Int:	M Bruce

Description: ABF laborer preparing the cable tie down bearing plates for blockout placement.

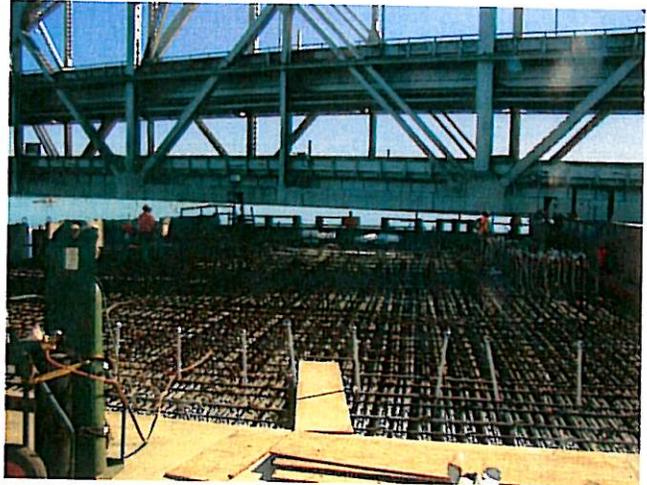
File Name:	Jan-19-2009 W2 Cap 002
Date:	01-19-09
By Int:	M Bruce

- Continued to place #25 longitudinal bars for the top mat of pour 6 south. The ironworkers were cutting the tails of the #25 vertical hooked ties to make it more feasible for them to place the #25 horizontal ties. I told RS foreman Tim Greenlee that this was unacceptable to cut the vertical bars.
- Began to cut the tie wire for the #25 hooked horizontal ties for pour 6 north. The #25 horizontal ties were used in pour 5 to position the #25 vertical hooked ties and for access, see photo below.
- Torqued 14 couplers of the #43 transverse bars to be used in pour 6 south in between the W2E Hinge K anchor plates and the far west end of the cable tie down pipes. Tim Greenlee was the ironworker who torqued the couplers using torque wrenches 2007/253086 and 2008/149470 at a torque of 400lb-ft until two clicking noises were heard. The accepted couplers were spray painted white when completed.

Description: RS ironworkers placing #25 longitudinal bars for the pour 6 south top mat. The ironworker cutting the tails of the #25 vertical hooked ties is seen on the left side of the photo.

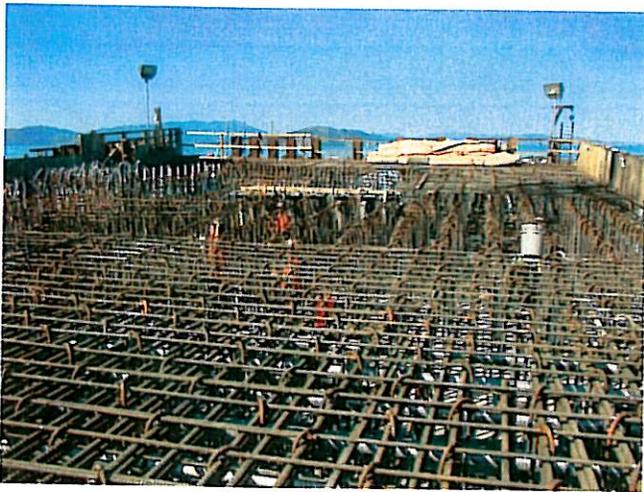
File Name:	Jan-19-2009 W2 Cap 003
Date:	01-19-09
By Int:	M Bruce

Description: RS ironworkers cutting the #25 horizontal ties from the #25 vertical ties for pour 6 north.
