Job Stamp 04-0120F4 SFOBB SAS

Description of Operations @ W2 Cap Beam:

Description of Operations @ E2 Cap Beam:

EA	04-0120F4
Co-Rte-KP (PM)	SF-080-13.2/13.9 (8.2/8.7)
Structure Rep.	Rick Morrow

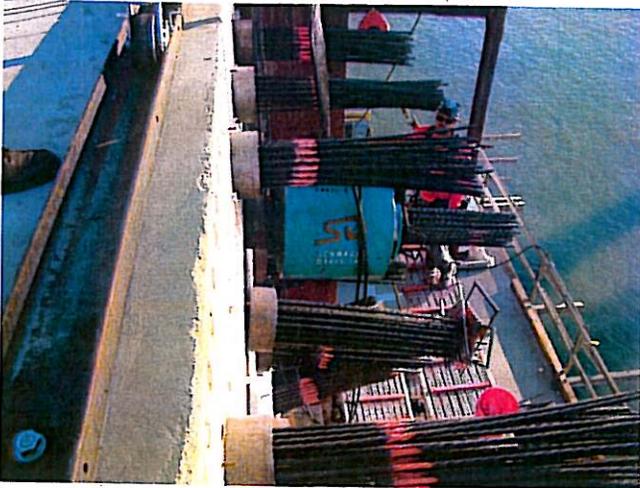
File Name:	Feb-10-2009 W2 Cap 001		
Date:	02-10-09	By Int:	M Bruce

Description: Single-end stressing operation in progress looking towards the east from the top of the E2 cap beam.

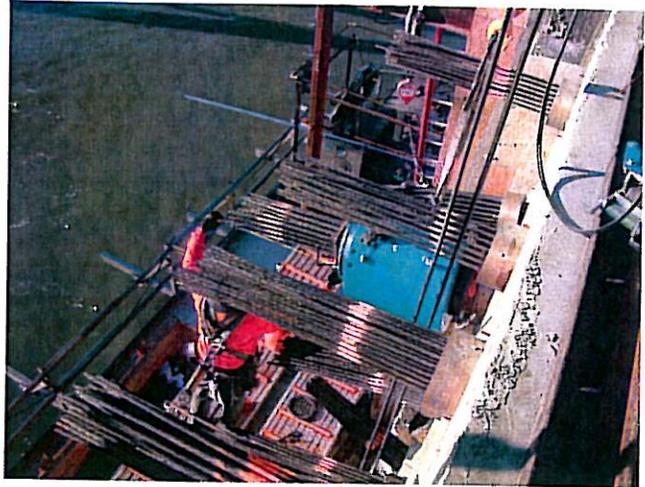
File Name:	Feb-10-2009 W2 Cap 004		
Date:	02-10-09	By Int:	M Bruce

Description: Ironworker measuring the elongation of the strands at 100% P_{jack} . To my knowledge all of the elongations were within the specified tolerance of $\pm 7\%$. The strands were measured while the ram was extended and when it was retracted to measure the anchor set of the wedges.

- Stressed 7 tendons starting with #6 in the sequence on the south end looking north while I was in the field. Massoud, Gil and myself were monitoring the stressing operations which were completed today. See Massoud's diary for details regarding the elongations as he recorded the numbers read by the ironworkers after measuring. To my knowledge the stressing operation went well as the wedges seated properly, the strand didn't slip, and the elongations were within the $\pm 7\%$ tolerance as 100% P_{jack} was achieved every time.

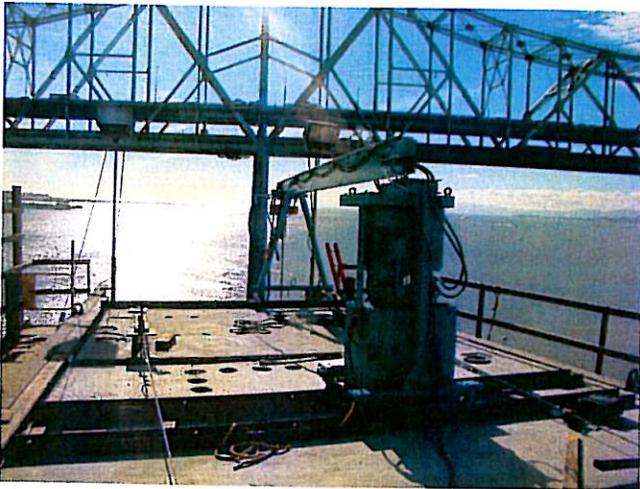
File Name:	Feb-10-2009 W2 Cap 007		
Date:	02-10-09	By Int:	M Bruce

Description: SDI "A" frame with pump used to support the ram looking south.

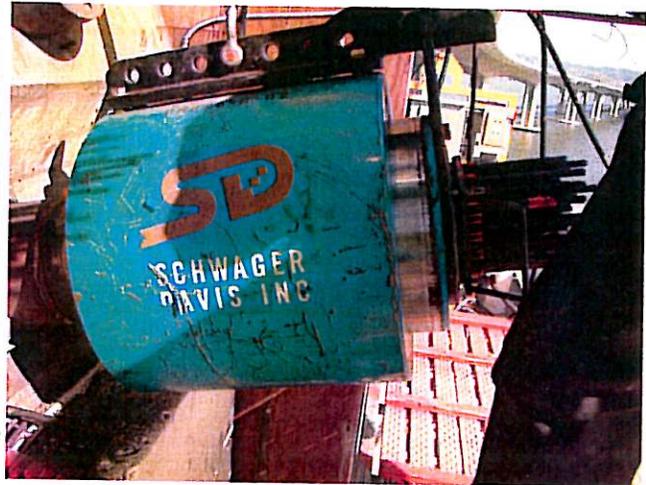
File Name:	Feb-10-2009 W2 Cap 013		
Date:	02-10-09	By Int:	M Bruce

Description: The ram piston had to be retracted and the wedges on the gripper plate reset to achieve the calculated elongation. Also multiple guide plates had to be used to position the ram to avoid the concrete.

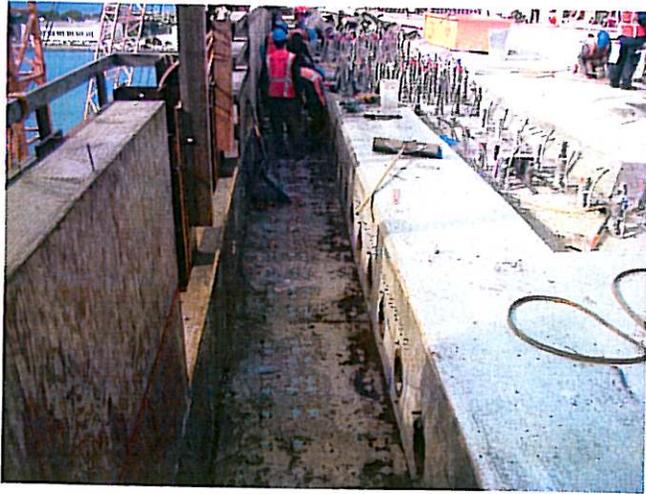
File Name:	Feb-10-2009 W2 Cap 019		
Date:	02-10-09	By Int:	M Bruce

Description: ABF piledrivers removing the seismic joint breakout forms near W2E. Also the standing water on the surface of the vertical PT tendon breakout was pumped out.

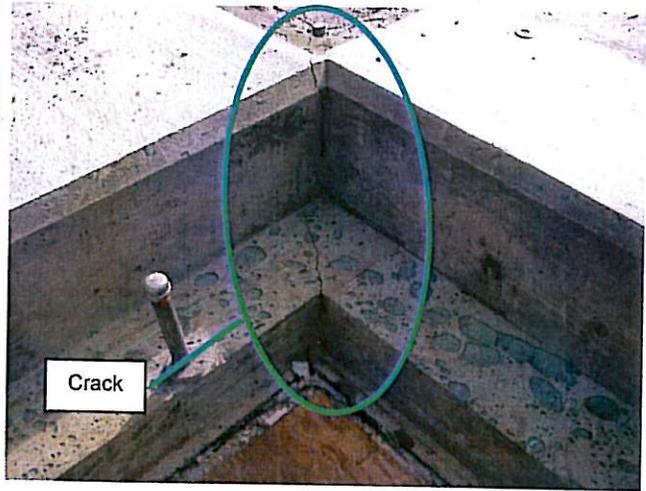
File Name:	Feb-10-2009 W2 Cap 020		
Date:	02-10-09	By Int:	M Bruce

Description: Cracks were found at the cable tie down breakout concrete especially in the corners.
