04-0120F4
SFOBB SAS

ASSISTANT RESIDENT ENGINEER'S

Description of Operations @ W2 Cap Beam:

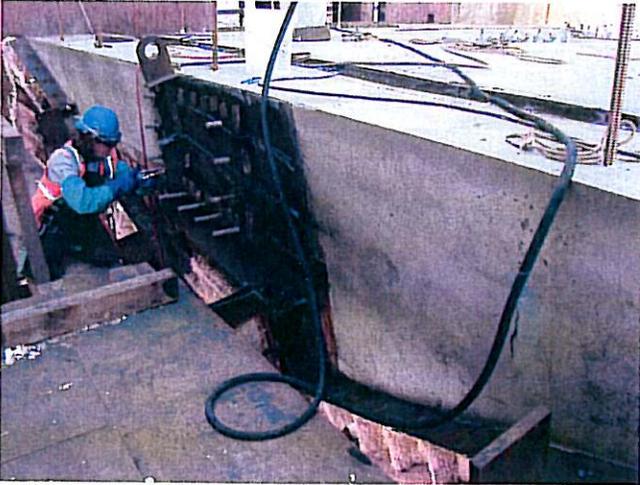
File Name:	Feb-20 and 21-2009 W2 Cap 002		
Date:	02-20-09	By Int:	M Bruce
Description: Pile driver removing steel forms near the bikepath attachment on the southwest end of the W2 cap beam.

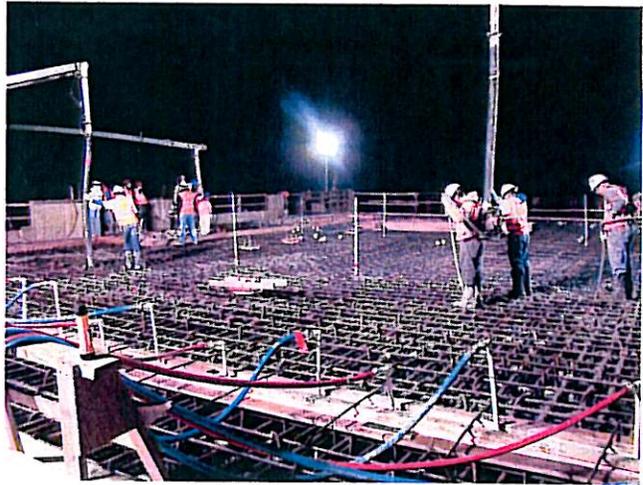
File Name:	Feb-20 and 21-2009 W2 Cap 006		
Date:	02-21-09	By Int:	M Bruce
Description: Conco placing concrete with three pumps in the pour 6 north area.

2. Overall the placement of concrete went well as the flow looked consistent with no segregation. ABF and Conco foreman were consistently told to vibrate underneath the seismic joint blockout forms, cable tie down forms and barrier blockout forms. Revibration was done approximately 30-40 minutes after the concrete was "topped off" starting from the south end of pour 6 north.

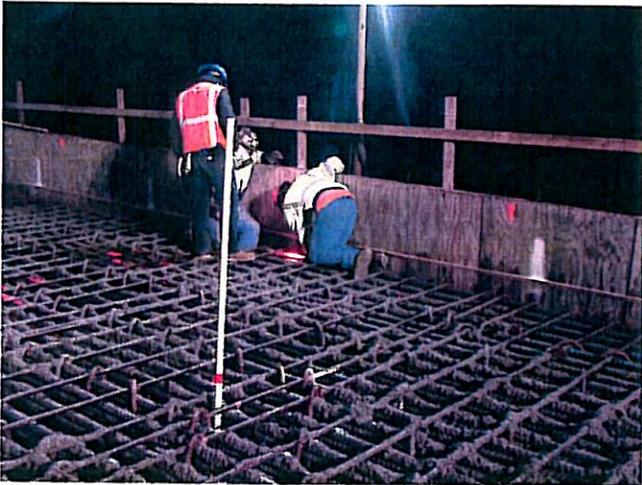
File Name:	Feb-20 and 21-2009 W2 Cap 007		
Date:	02-21-09	By Int:	M Bruce
Description: Ironworkers securing the #19 formsavers at the east bulkhead.

- Two ironworkers were available during the concrete placement of pour 6 north. See Pamela's diary for the names of the ironworkers onsite. The ironworkers addressed a few items on her puchlist during the 1st hour or so of the pour. I noticed some #19 formsavers at the east bulkhead that were coming loose during the pour and the ironworkers fixed them. However there might have been some other loose couplers during the pour as ABF and RS was made aware of this issue.

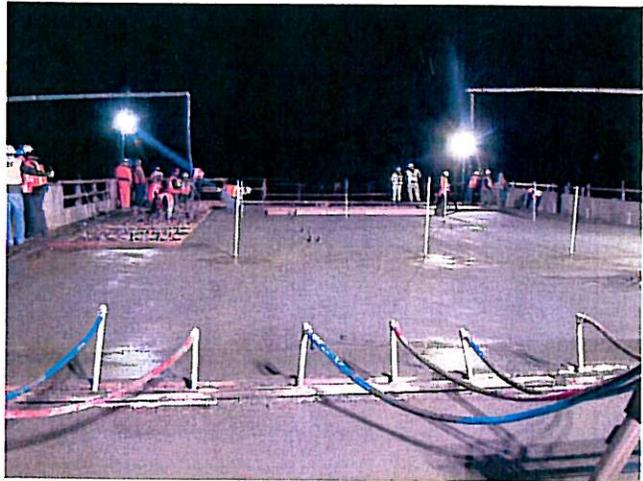
File Name:	Feb-20 and 21-2009 W2 Cap 010		
Date:	02-21-09	By Int:	M Bruce
Description: Top of concrete for pour 6 north as the water cooling system was not turned on at this point.

- Shot the elevations for the top of concrete for pour 6 north and ducts for continuity tendons W-2A to W-28A, and W-32A to W-41A with the assistance of Ron Matin. Most of the points (30 out of 35) for the top of concrete were within ± 10 mm of the theoretical values, the worst case deviation from the theoretical was -24mm. Similarly for the ducts of the continuity tendons the worst case deviation from the theoretical was -29mm with most deviations under 15mm.
