Job Stamp
04-0120F4
SFOBB SAS

Const. Calendar:	813
Project Work Day No.:	1023
Date	03/05/2009
Inspectors Hours	Start 11:40 Stop 12:40
Shift Hours	07:00 15:30

**Description of Operations @ W2 Cap Beam:**

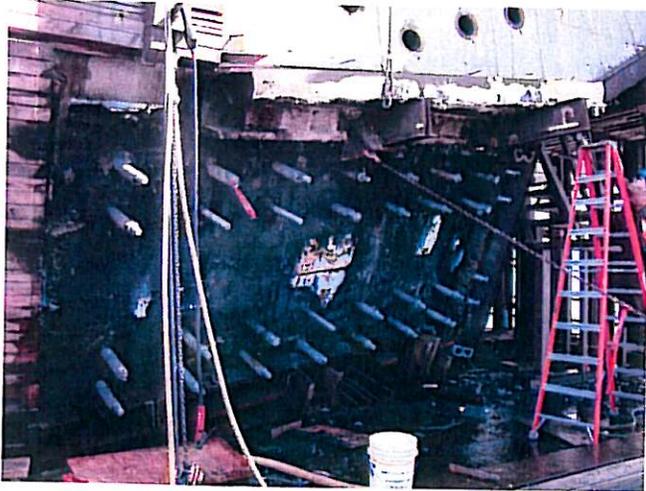
File Name:	Mar-05-2009 W2 Cap 001
Date:	03-05-09
By Int:	M Bruce

Description: Steel formwork removal of Panel A at the W2E deviation saddle. Using a torch to cut the steel forms has burned the polystyrene grout pad blockout.

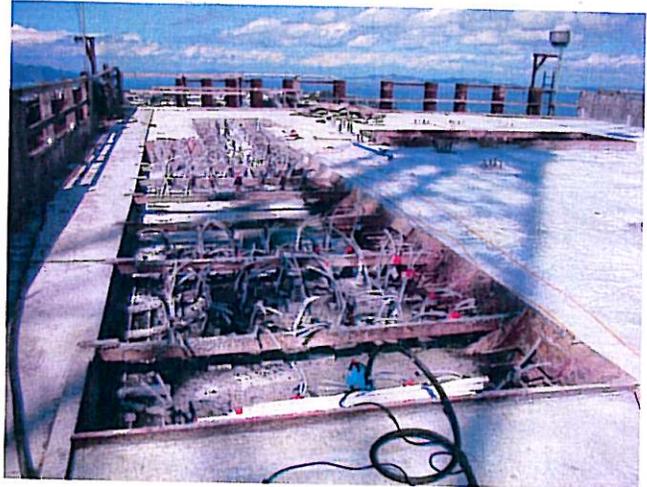
File Name:	Mar-05-2009 W2 Cap 002
Date:	03-05-09
By Int:	M Bruce

Description: W2W vertical PT blockout form removal in progress. Note that the surface water is being pumped out of this blockout.

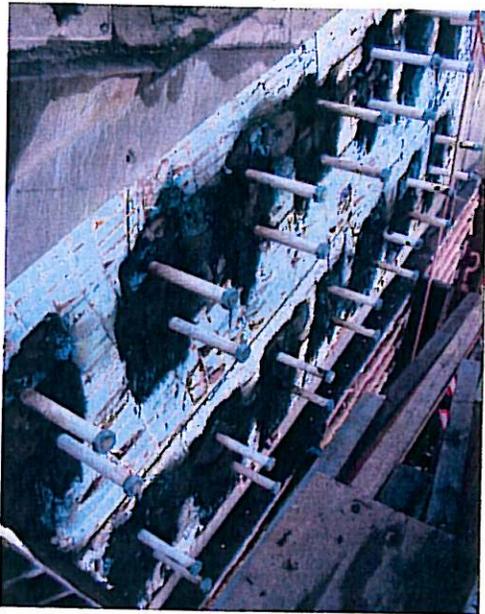
File Name:	Mar-05-2009 W2 Cap 003
Date:	03-05-09
By Int:	M Bruce

Description: Steel formwork removal of Panel C at the W2E deviation saddle.

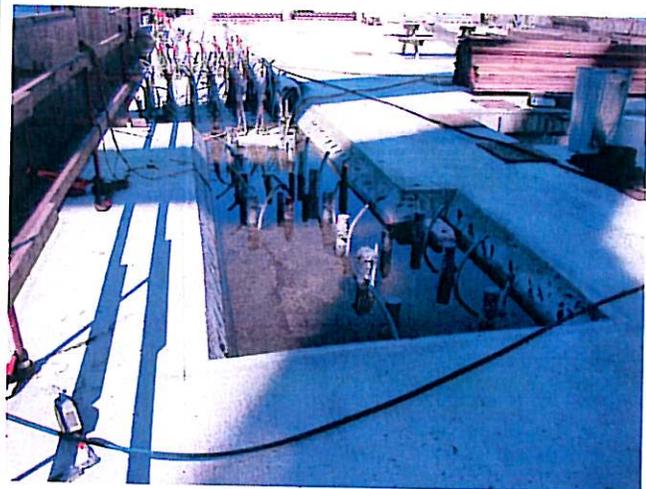
File Name:	Mar-05-2009 W2 Cap 004
Date:	03-05-09
By Int:	M Bruce

Description: Surface water in the W2E vertical PT blockout needs to be drained. ABF has been informed to constantly drain the water from these blockouts.
