Job Stamp
04-0120F4
SFOBB SAS

ASSISTANT RESIDENT ENGINEER'S **CONTRACTOR – ABFJV**

Description of Operations @ W2 Cap Beam:

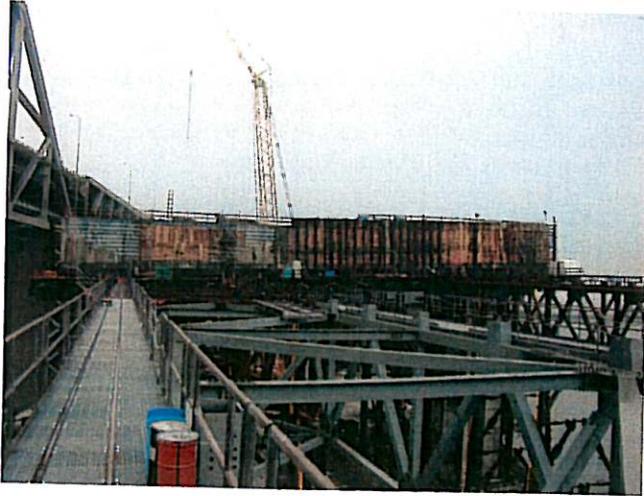
File Name:	Mar-16-2009 W2 Cap 002
Date:	03-16-09
By Int:	M Bruce

Description: Formwork removal of the east bulkhead looking west.

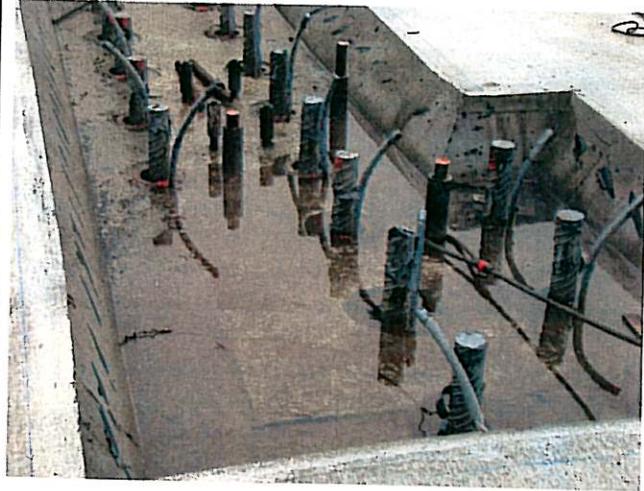
File Name:	Mar-16-2009 W2 Cap 003
Date:	03-16-09
By Int:	M Bruce

Description: Water is still on the surface of the vertical PT tendons near the W2E pier. The water has filled up these ducts and the bearing plates have started to rust. ABF foreman Nigel Lohse has been made aware of this issue several times over the last couple of weeks.

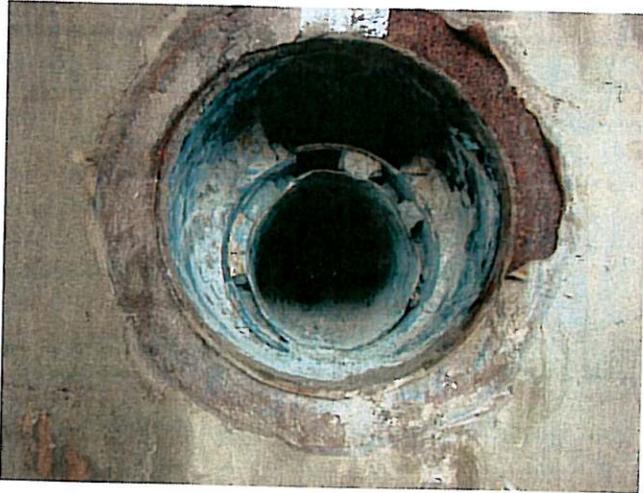
File Name:	Mar-16-2009 W2 Cap 005
Date:	03-16-09
By Int:	M Bruce

Description: Concrete was found in the duct/trumpet of CBT-35 at the south end of the cap beam. It is unknown how much concrete has filled up this duct. All of the trumpets on the south end of the cap for CBT-28 to CBT-36 bended due to the weight of the liquid concrete during pour 4. As a result the trumpets have an oval shape now, however stressing will still be feasible.

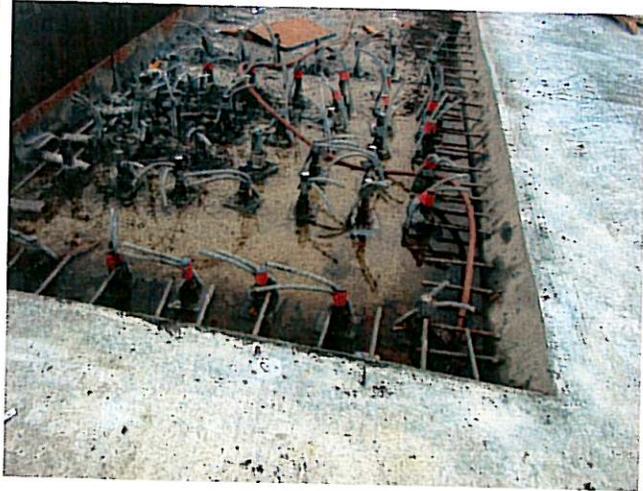
File Name:	Mar-16-2009 W2 Cap 006
Date:	03-16-09
By Int:	M Bruce

Description: Water was found on the surface of the vertical bars near the W2W pier.
