04-0120F4
SFOBB SAS

Date: 04/22/2009

ASSISTANT RESIDENT ENGINEER'S

Description of Operations @ W2 Cap Beam:

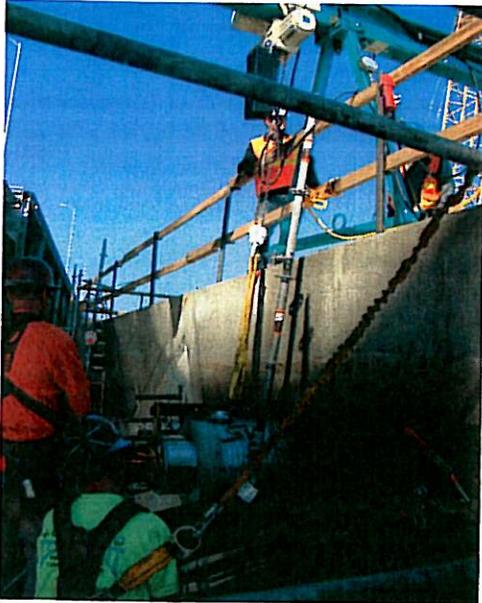
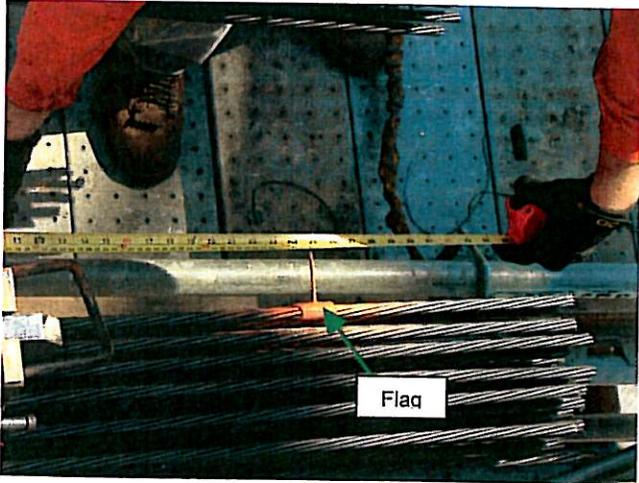
File Name:	Apr-22-2009 W2 Cap 002		
Date:	04-22-09	By Int:	M Bruce
Description:	Stressing CBT-15 on the south end of the cap beam.		
File Name:	Apr-22-2009 W2 Cap 003		
Date:	04-22-09	By Int:	M Bruce
Description:	Elongation measurement of 627mm prior to releasing the jack pressure and before wedges (anchor) set for CBT-12. The first end elongation measurement is done by stressing to 20% P_{jack} and setting a flag, this takes out the "slack" in the cable and also sets the wedges on the dead end. The strand is then stressed to 100% P_{jack} . The measurement is taken at 80% of the total elongation since the flag was set at a specified point (300mm).

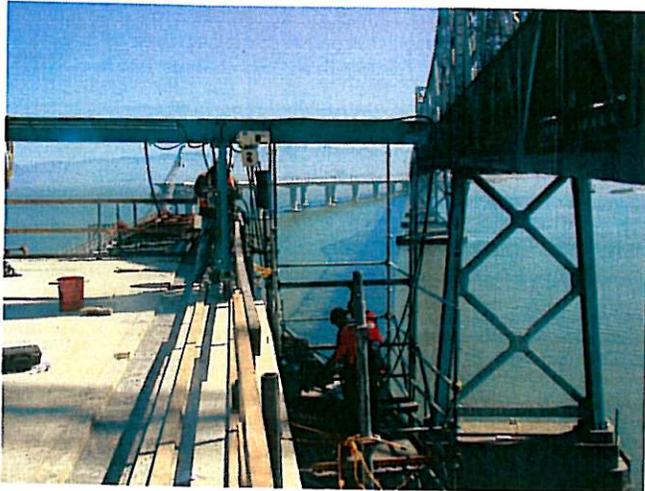
File Name:	Apr-22-2009 W2 Cap 004
Date:	04-22-09
By Int:	M Bruce

Description: SDI stressing operation on the south end of the cap beam at CBT-20 looking east.

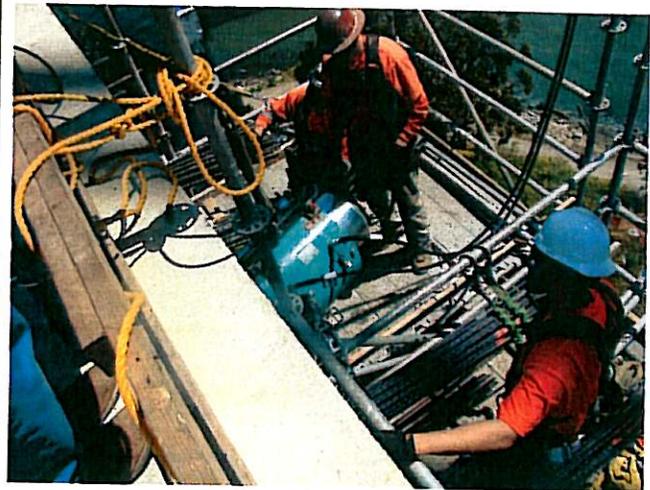
File Name:	Apr-22-2009 W2 Cap 005
Date:	04-22-09
By Int:	M Bruce

Description: There were numerous occasions where the scaffold members made it difficult to place the ram on the anchor head for CBT-11 to 22. ABF foreman Nigel Lohse was made aware of this situation numerous times. Also the horizontal restraint wasn't adequate as yellow rope was tied from the scaffold to the handrail.

- 3) A strain indicator (serial number 59432) was used to monitor the 100% P_{jack} (1183 kips) load on CBT-15, 14, and 16
- 4) Saman and myself witnessed this entire operation for every tendon to monitor elongation measurements, anchor set, and the load/pressure being applied by the jack. To our knowledge no strand/wire failed or slipped.
- 5) Mike Schwager was onsite for stressing tendons CBT-15, 14, and 16.
- 6) See Saman's diary for details for the safety issue with the scaffolds while stressing.

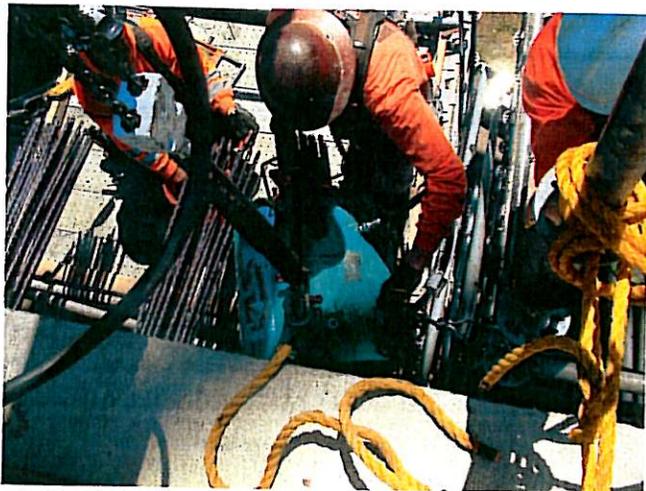
File Name:	Apr-22-2009 W2 Cap 006
Date:	04-22-09
By Int:	M Bruce

Description: Ironworkers used a winch to pry the scaffold posts away from the ram body to enable access. Both ABF and SDI were informed that this situation was unsafe and a better solution was needed for performing this work.

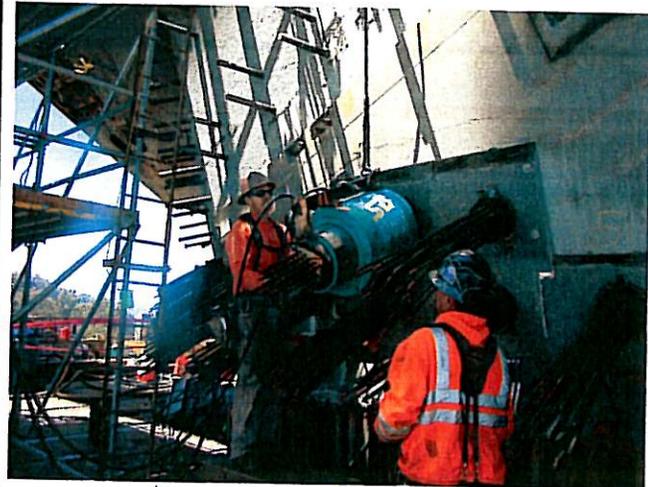
File Name:	Apr-22-2009 W2 Cap 008
Date:	04-22-09
By Int:	M Bruce

Description: Ironworkers positioning the 600-ton ram on the south end of CBT-23. This task includes putting the strand through the ram, aligning the ram normal to the anchorhead/bearing plate, and re-gripping the strand after each piston stroke limit of the jack. One ironworker was on the dead end checking for slip and notifying the ram operator that the wedges and anchorhead were engaged at 20% P...
