04-0120F4
SFOBB SAS

Date: 04/23/2009

ASSISTANT RESIDENT ENGINEER'S

Description of Operations @ W2 Cap Beam:

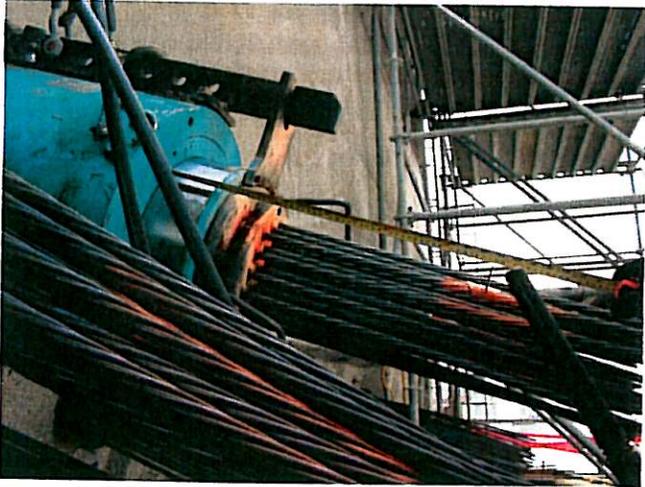
File Name:	Apr-23-2009 W2 Cap 002		
Date:	04-23-09	By Int:	M Bruce
Description: Elongation measurement of 577mm prior to releasing the jack pressure and the wedges (anchor) setting for CBT-24.			
File Name:	Apr-23-2009 W2 Cap 003		
Date:	04-23-09	By Int:	M Bruce
Description: Stressing the first end of CBT-31 on the south end of the cap beam.

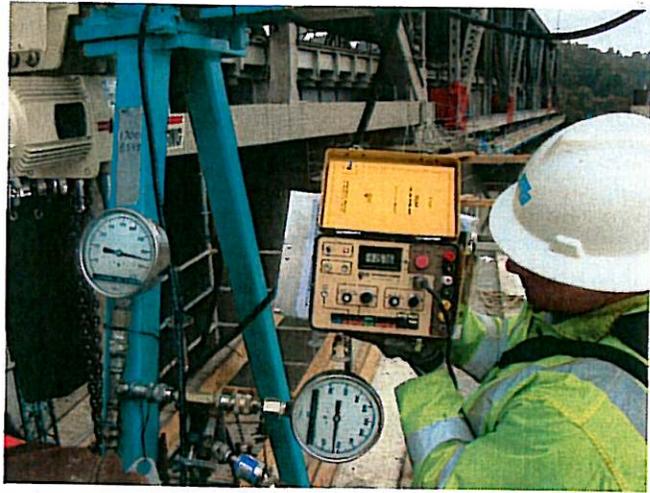
File Name:	Apr-23-2009 W2 Cap 010
Date:	04-23-09
By Int:	M Bruce
Description: A load of 1157.6 kips was measured with strain indicator 59432 approaching P_{jck} . This was compared to the calibrated pressure for gauge CH600-8-110A of 8,500psi and CH600-8-110B pressure of 8,300psi while stressing CBT-33.

- A strain indicator (serial number 59432) was used to monitor the 100% P_{jack} (1183 kips) load on CBT-33, 32 and 100% P_{jack} (165 kips) load on VB-54E and VB-75E. I spoke to Glen Weldon in the Sacramento Translab to obtain the Numerical Display and the Gauge Factor numbers for the B-36 and B-117 rams since it wasn't posted on OSC's RCC.

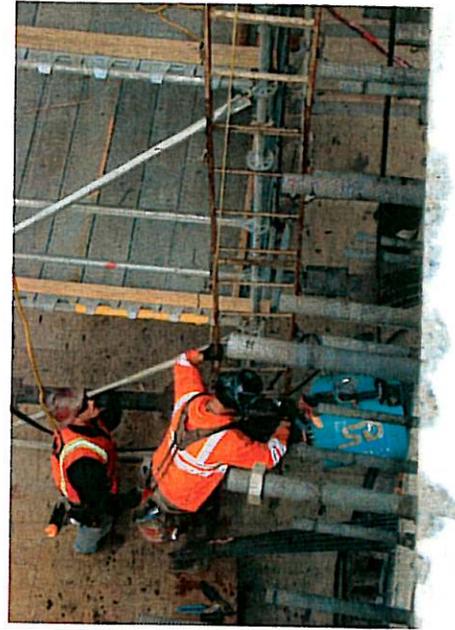
File Name:	Apr-23-2009 W2 Cap 011
Date:	04-23-09
By Int:	M Bruce
Description: SDI Ironworkers maneuvering the ram around the ladder of this scaffold to stress CBT-28 at the south end. Eventually ABF piledrivers had to remove the ladder fixed to the scaffold.

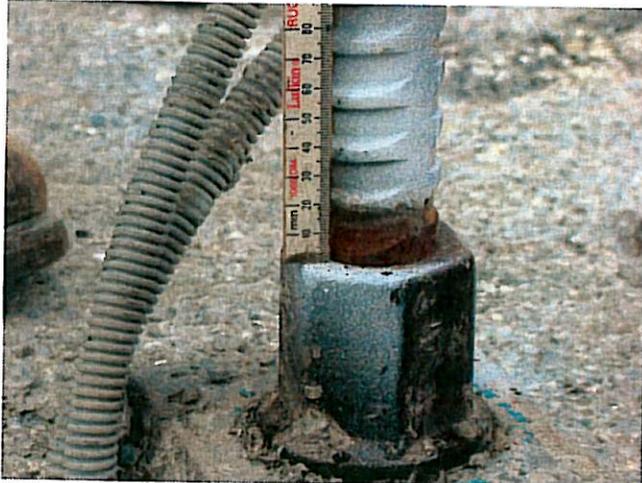
File Name:	Apr-23-2009 W2 Cap 013
Date:	04-23-09
By Int:	M Bruce
Description: Elongation of 21mm for the first long vertical bar stressed VB-57E.

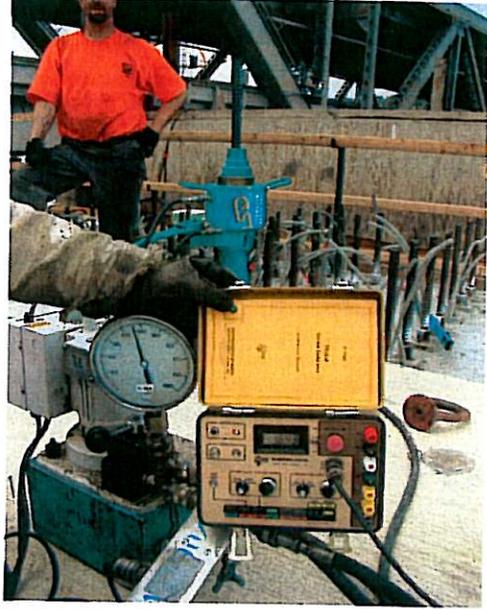
File Name:	Apr-23-2009 W2 Cap 017
Date:	04-23-09
By Int:	M Bruce
Description: P_{jck} load of 164.3 kips measured with strain indicator 59432 compared to the calibrated pressure of 4,600psi for gauge B-36A while stressing VB-54E.
