04-0120F4
SFOBB SAS

Date **05/01/2009**

ASSISTANT RESIDENT ENGINEER'S

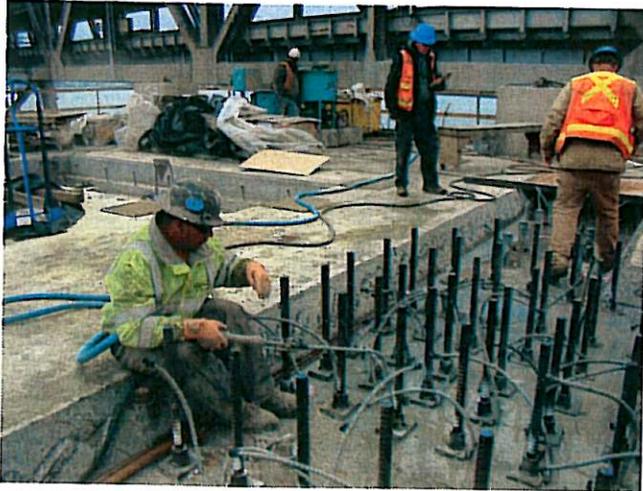
File Name:	May-01-2009 W2 Cap 004
Date:	05-01-09
By Int:	M Bruce

Description: SDI ironworkers grouting vertical bar VB-52 at W2E. It took 43 seconds on average to grout these ducts. After the pressure from the pump was released and the grout valve was closed the grout head dropped roughly 50 to 80mm from the hexnut grout vents.

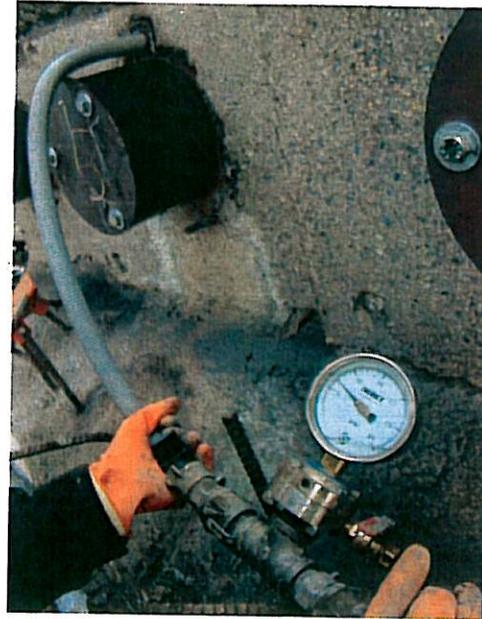
File Name:	May-01-2009 W2 Cap 005
Date:	05-01-09
By Int:	M Bruce

Description: Placing grout into CBT-29 under pressure of 70psi from the south end of the cap beam.

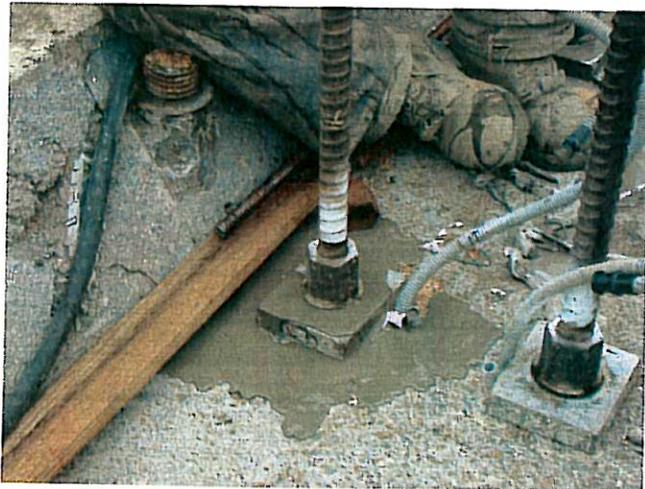
File Name:	May-01-2009 W2 Cap 006
Date:	05-01-09
By Int:	M Bruce

Description: Grout coming out of the hexnut vents and provisional grout tube that was cut near the bearing plate for VB-54.

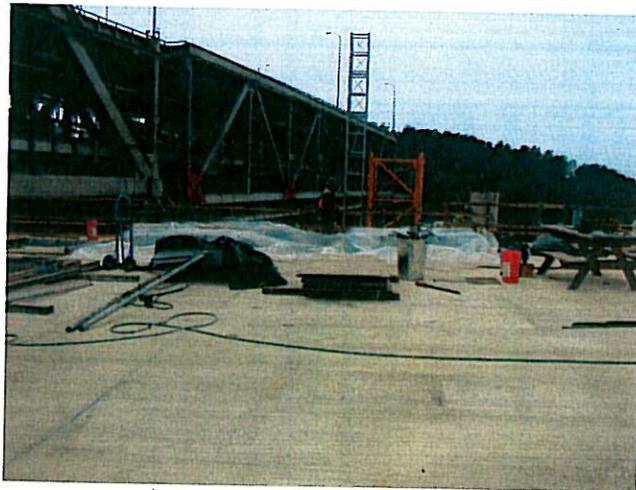
File Name:	May-01-2009 W2 Cap 008
Date:	05-01-09
By Int:	M Bruce

Description: SDI ironworkers covered the grouted vertical bars at W2E. The bars were covered at W2W as well since a significant rainstorm was forecasted. This was done in an attempt to prevent water from getting into the hexnut vents.
