04-0120F4
SFOBB SAS

ASSISTANT RESIDENT ENGINEER'S

**Description of Operations @ W2 Cap Beam:**

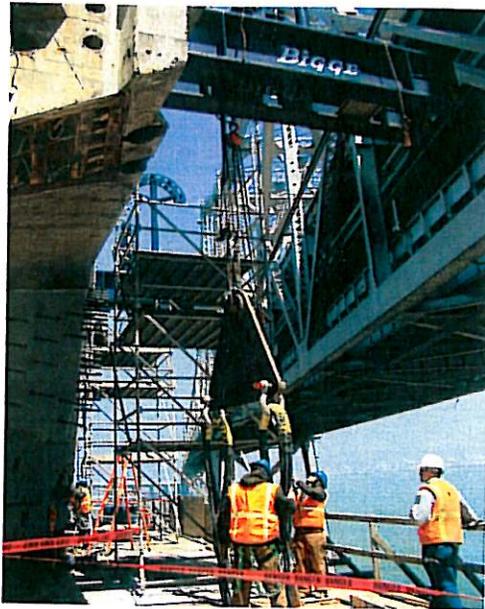
File Name:	May-21-2009 W2 Cap 001
Date:	05-21-09
By Int:	M Bruce

Description: ABF piledrivers positioning a spreader plate and braided slings near the southwest strand jack.

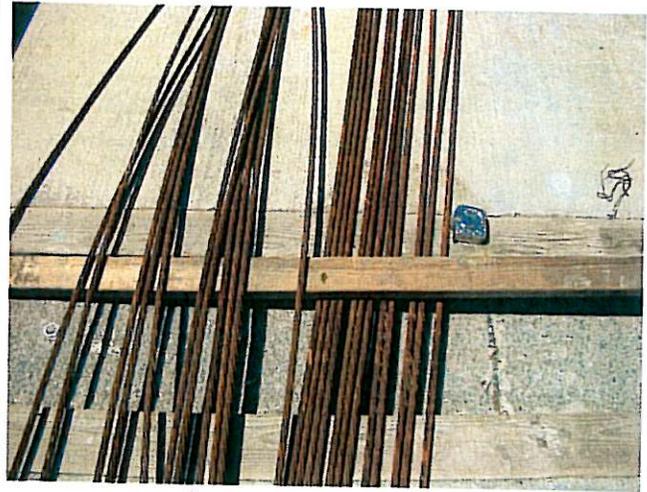
File Name:	May-21-2009 W2 Cap 004
Date:	05-21-09
By Int:	M Bruce

Description: Rusted strand to be used for supporting the soffit beams (caps and stringers). Even though the strands were rusty I didn't find any pitting but still feel uncomfortable with using these strands. I asked ABF foreman Terry Cronk about the age of these strands and all he told me that they were used at E2. He also mentioned that he wasn't comfortable using them and that the Bigge representative would make the call.

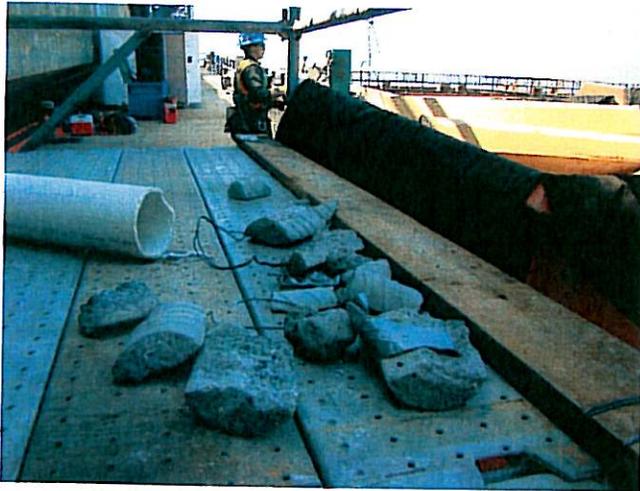
File Name:	May-21-2009 W2 Cap 011
Date:	05-21-09
By Int:	M Bruce

Description: Concrete chunks removed from the E-10B to E-11B ducts. These chunks were predominantly cement with very little aggregate. I spoke with AWJ foreman Doug Zeier and he told me that the concrete was lodged roughly 30ft in the two ducts. Also that a camera (footage wasn't recorded) was run through the length of the duct.

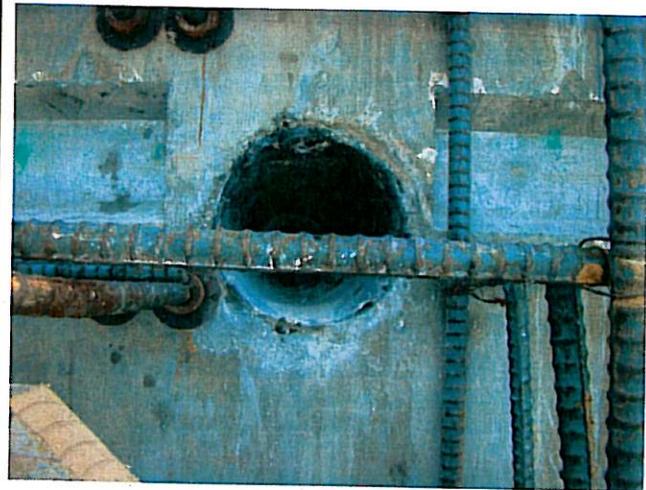
File Name:	May-21-2009 W2 Cap 012
Date:	05-21-09
By Int:	M Bruce

Description: Continuity tendon E-10B looking from the east end. I could see to the other end of the cap. Also note the closure pour rebar in conflict with the inflatable mandrels to be placed.
