04-0120F4
SFOBB SAS

Date: 08/18/2009

ASSISTANT RESIDENT ENGINEER'S

Description of Operations @ W2 Cap Beam:

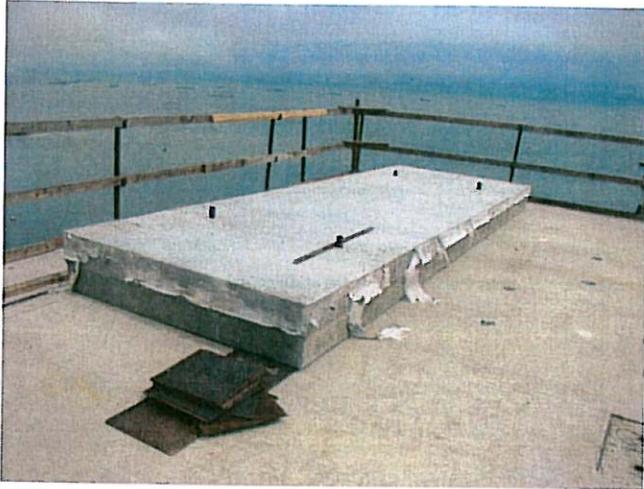
File Name:	Aug-18-2009 W2 Cap 002
Date:	08-18-09
By Int:	08-13-09

Description: W2W cable tie-down precast slab removed from final location to enable SDI access for stressing.

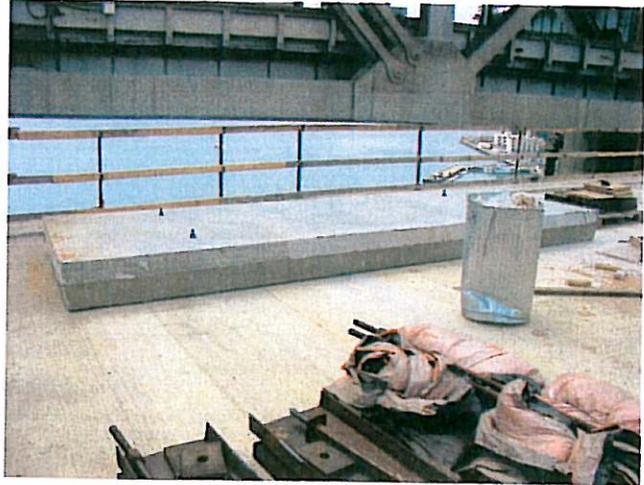
File Name:	Aug-18-2009 W2 Cap 003
Date:	08-18-09
By Int:	M Bruce

Description: W2E cable tie-down precast slab removed from final location to enable SDI access for stressing.

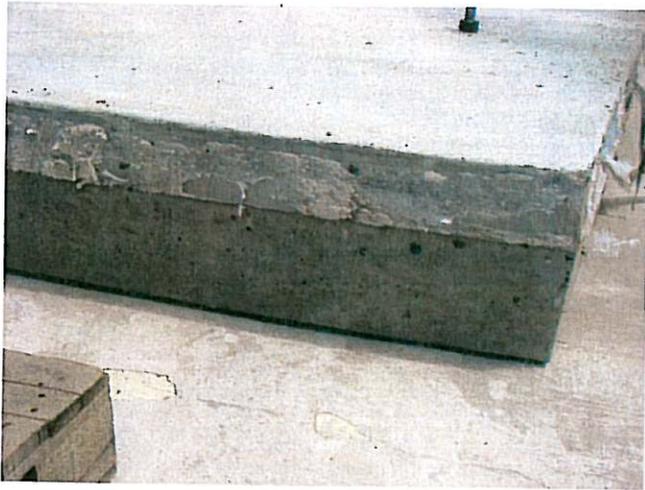
File Name:	Aug-18-2009 W2 Cap 005
Date:	08-18-09
By Int:	08-13-09

Description: W2W concrete surface on the side of the precast slab. The concrete didn't appear to have a smooth surface around the vertical faces.

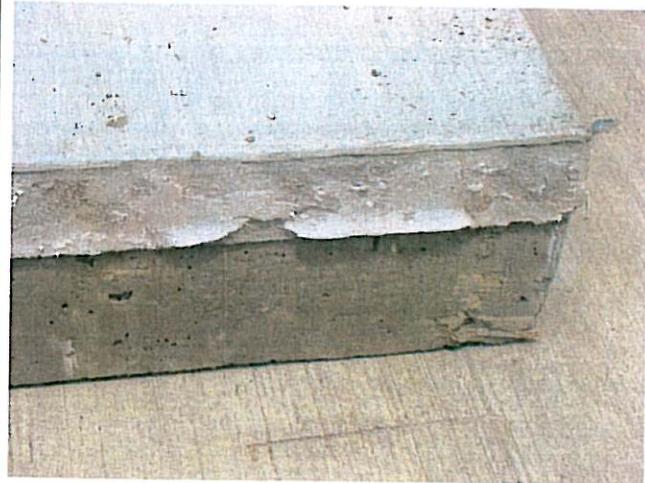
File Name:	Aug-18-2009 W2 Cap 006
Date:	08-18-09
By Int:	M Bruce

Description: W2E concrete surface on the side of the precast slab. The concrete didn't appear to have a smooth surface around the vertical faces.
