Job Stamp:
04-SF-80-13.2/13.9 04-0120F4
SFOBB SAS
San Francisco Co. in San Francisco
Fm 0.6 km to 1.3 km East of Yerba Buena
Tunnel East Portal

ASSISTANT RESIDENT ENGINEER'S DAILY BRIDGE REPORT

Description of Operation: Grouting of the Vertical Bars (North of the cap)

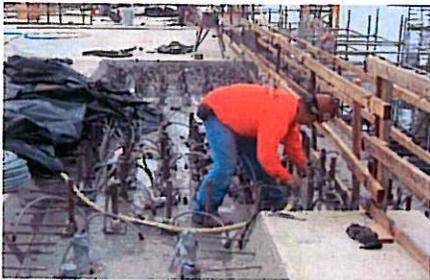
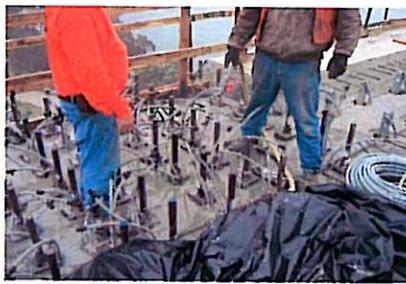
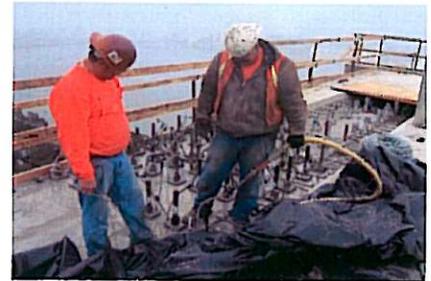
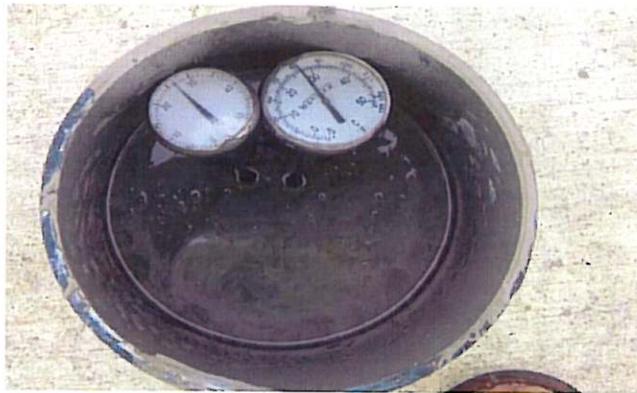
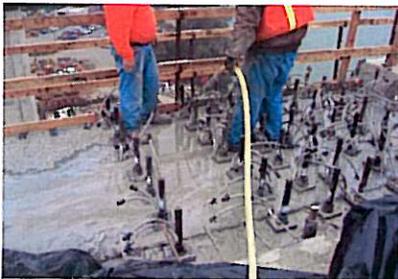
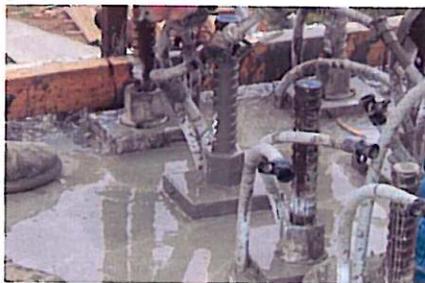
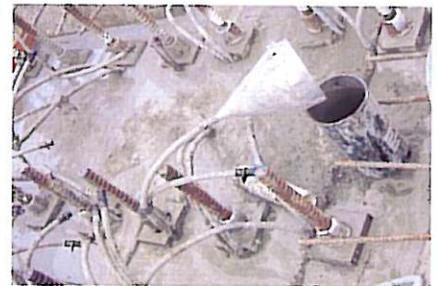
Today marked the 3rd day of grouting as this operation was focused on the grouting of the Vertical Bars (VB) located on the North side of the cap beam.

Grouting operation began at 7:30 and the grout seemed much more dilute than the mix used on Friday. Once the grout came out of the first VB, it was preceded by water and for a short while one could not detect much grout in the mix. The Efflux Time = 17sec is the evidence of the higher water content in this mix. However, the mix is in adherence with the manufacturer's recommendations and the Standard Specifications. Other parameters determined on the first test on the grout for which cubes were made were as follows:

The high temperature of grout was a concern that I discussed with Ralph Craig. On the second test we ran at 8:05, the results on the grout were as follows:

Efflux Time: 17sec Tgrout: 94F & 92F (Matt's & Mine) Temp. in the holding tank: 90F & 92F (Matt's & mine)

At this point, I told Ralph that he has to cool off the grout, otherwise the operation has to cease. They realized that there was an operator oversight (Erin Craig) in the opening and closing of a certain mixing blade that cause the grout temperature to rise.
