04-0120F4  
SFOBB SAS

ASSISTANT RESIDENT ENGINEER'S

**Description of Operations @ W2 Cap Beam:**

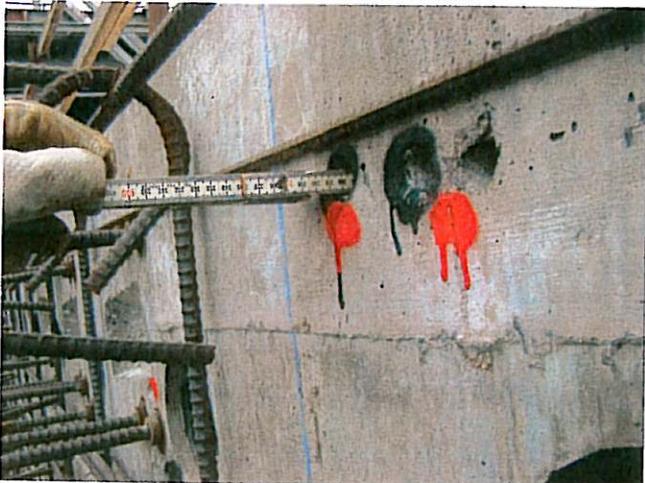
File Name:		Aug-26-2009 W2 Cap 004	
Date:	08-26-09	By Int:	M Bruce
Description: A few holes were measured prior to epoxy and dowel installation to the proper depth. This length seen in the photo is 260mm.			
File Name:		Aug-26-2009 W2 Cap 005	
Date:	08-26-09	By Int:	M Bruce
Description: Roller frame installed to the falsework soffit near W2E.

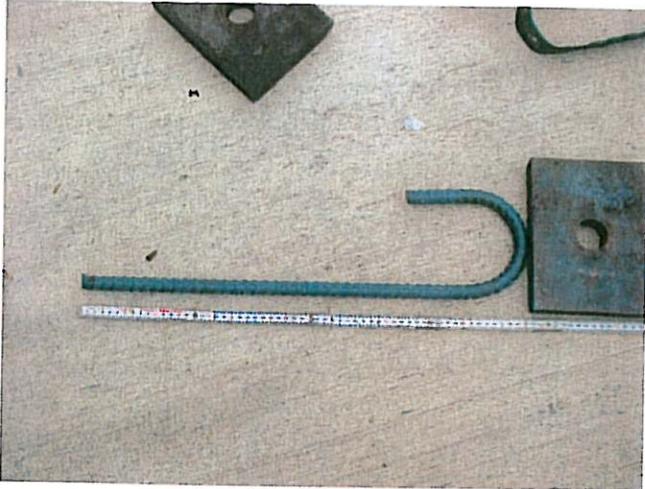
File Name:	Aug-26-2009 W2 Cap 010
Date:	08-26-09
By Int:	M Bruce

Description: The measured length of the dowels sent to the jobsite today was 585mm. Some bars had to be cut since the theoretical distance from the end of the drilled hole to the end of #19 vertical bar is 570mm. The ironworkers did have the Hilti Hit-RE 500-SD anchorage system tools and materials. The expiration date found on the epoxy cartridge was March 2010.

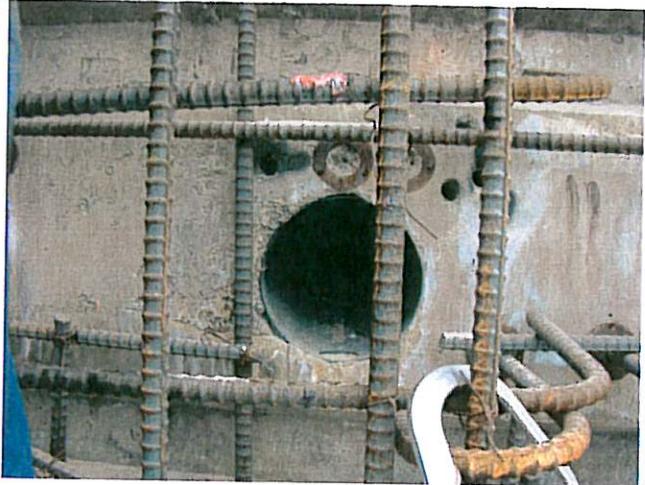
File Name:	Aug-26-2009 W2 Cap 012
Date:	08-26-09
By Int:	M Bruce

Description: reinforcement in conflict with the continuity tendon path at W2E. Nigel, Terry, Ralph, and the CMC-RS ironworkers have been made aware of this issue. In addition there was a water bottle found in a duct.

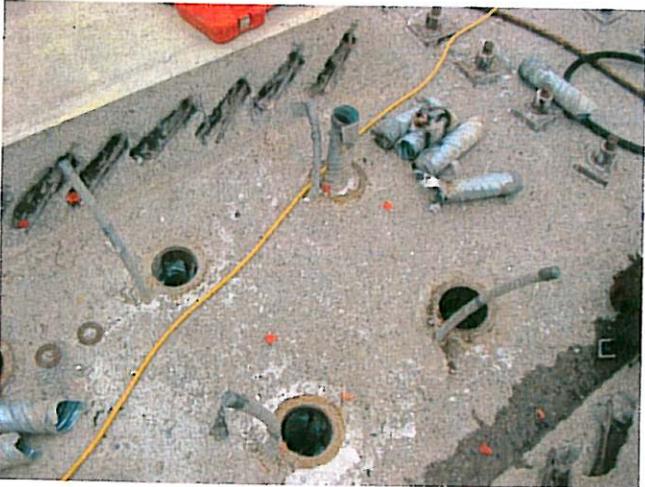
File Name:	Aug-26-2009 W2 Cap 015
Date:	08-26-09
By Int:	M Bruce

Description: Cut ducts at W2E for the vertical PT tendons. The duct was cut with a sawzaw then cut down the sides and then splayed. This was done since it was too hard to cut the duct at the beginning of the trumpet. Initially the SDI ironworkers tried to use a torch to cut the duct. I stopped them since this is a safety/quality issue by melting the trumpet and heating the bearing plate.

- Continued to stage/mobilize equipment for the upcoming installation/stressing of the vertical PT tendons and the cable tie-downs on top of the cap beam.
- Installed roller frame to the falsework soffit near the W2E cable tie-downs. This frame will facilitate erection of the HDPE pipe sheathing for the cable tie down strands.
- Cut the duct protruding above the bearing plate for the vertical PT tendons at W2E and W2W, see photos.

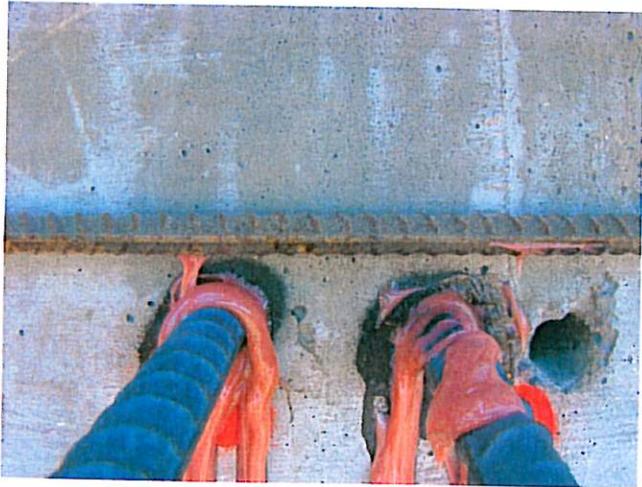
File Name:	Aug-26-2009 W2 Cap 019
Date:	08-26-09
By Int:	M Bruce

Description: CMC-RS ironworkers followed the procedure specified by Hilti for this operation. However as the ironworkers slowly twisted the bar in place epoxy air bubbles would be created. I was unsure whether or not voids were created between the annular gap and the rebar. I expressed my concern to Gil and had him watch one bar be installed and he didn't have a problem with this issue. Ernesto tried to install the bar as slow as possible trying not force out any epoxy air bubbles. Also epoxy was smeared around the annular edge to seal any void at the face of concrete.

- Epoxied dowels into the holes drilled by ABF at the W2E construction joint and 3 dowels at the W2W construction joint. A complete As-Built has yet to be done as I wanted to observe mixing/placing the epoxy and placement of the dowels. Also I was unable to keep a running count due to the fact I was watching the SDI ironworkers in conjunction to the RS ironworkers. Ernesto operated the gun and Andrew cleaned the holes. The crew began work at 10:00am due to not having the proper brushes specified by Hilti.
