04-0120F4  
SFOBB SAS

Date: 08/28/2009

ASSISTANT RESIDENT ENGINEER'S

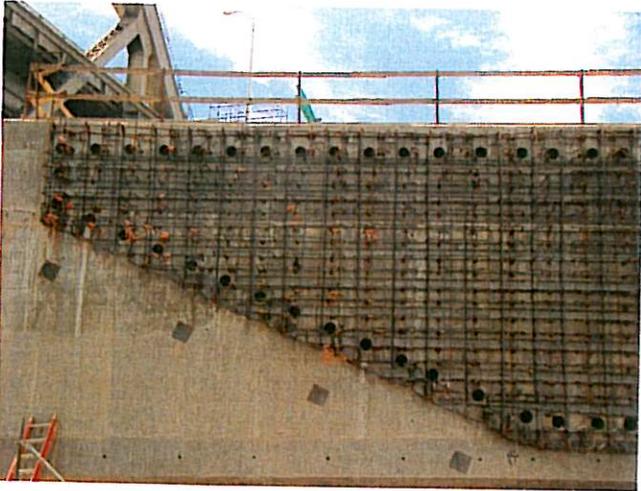
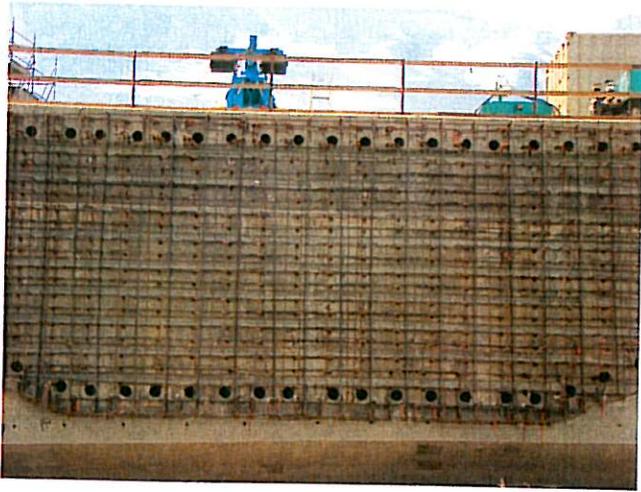
File Name:	Aug-28-2009 W2 Cap 008		
Date:	08-28-09	By Int:	M Bruce
Description: Photo of the south end of the W2E construction joint reinforcement. This photo was printed on an 11x17 sheet to try and count the horizontal #19 bars.			
File Name:	Aug-28-2009 W2 Cap 009		
Date:	08-28-09	By Int:	M Bruce
Description: Photo of the center section of the W2E construction joint reinforcement. This photo was printed on an 11x17 sheet to try and count the horizontal #19 bars.

- Began to As-Built the #19 horizontal hooked bars (dowel or coupled bar) placement at the W2E construction joint. My initial count yielded 875 (904 total per RFI 1721R00) #19 bars installed at W2E by using photographs of the rebar. I informed Gil that ABF may not have drilled all of the holes. I have yet to fully inspect this work due to watching SDI's current operations of fusing the HDPE pipe and preparing for stressing of the vertical PT tendons. It is likely that an accurate count can't be done by photo or standing on the soffit and therefore climbing is necessary, which takes time. I also asked Andrew Baumberger of TY-LIN if they ever verified the total number of #19 hooked bars in the construction joint per the RFI, he said they didn't.
- Wrote Tuesdays diary and began to write Wednesdays diary.

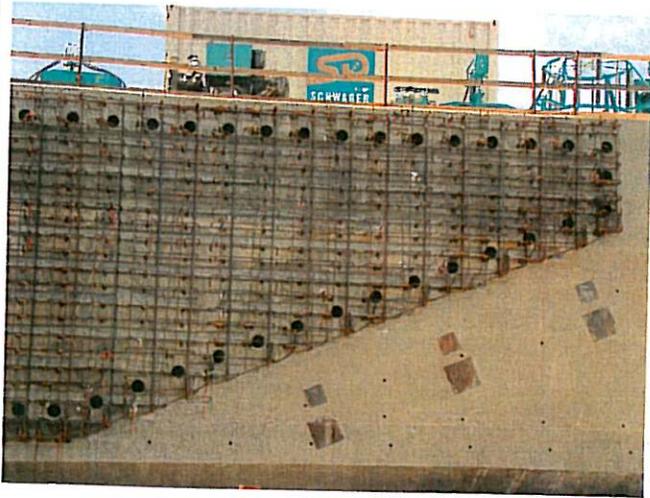
File Name:	Aug-28-2009 W2 Cap 010
Date:	08-28-09
By Int:	M Bruce

Description: Photo of the north end of the W2E construction joint reinforcement. This photo was printed on an 11x17 sheet to try and count the horizontal #19 bars.

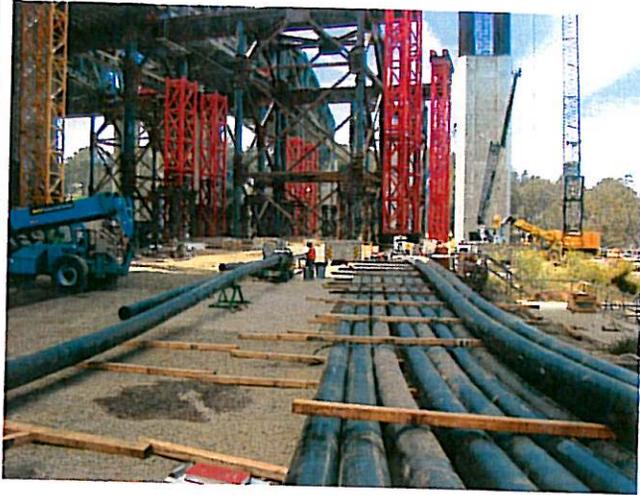
File Name:	Aug-28-2009 W2 Cap 005
Date:	08-28-09
By Int:	M Bruce

Description: SDI fusing together the HDPE pipes for the cable tie down sheathing.

- Continued to fuse together the HDPE pipe into three sections (2 fused butt splices) for the cable tie-down sheathing which encases the cable tie down strands. A total of 10 approximately 120ft long pipes were completed today with the assistance of P&F Distributor technician Dan Desmond. I watched this operation intermittently as it appeared that the procedure was followed to fuse the HDPE pipe together. The technician was training the SDI ironworkers on how to do the procedure. The hot plate was placed in between the pipes for 4 to 4.5 minutes and was held under pressure for approximately 20 minutes until the pipe joint was fully "cured". A few of the joints were visually inspected after the 120ft section was lifted by forklift (rented by SDI) and placed on dunnage. There appeared to be no damage/deformation to the joint. Mike Schwager was on site for the last two days.

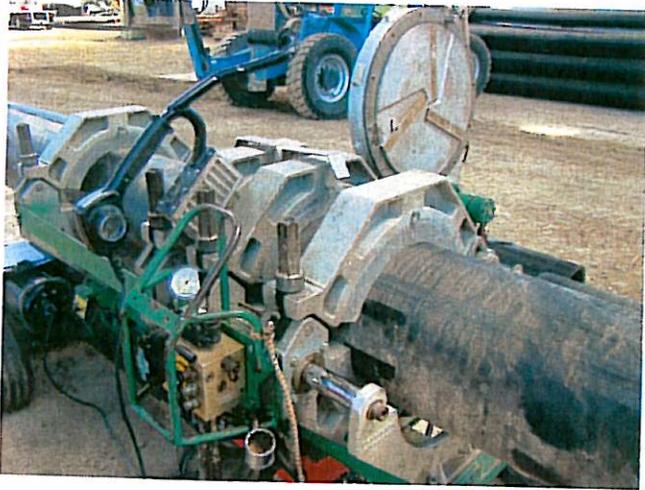
File Name:	Aug-28-2009 W2 Cap 006
Date:	08-28-09
By Int:	M Bruce

Description: HDPE pipe jig used to fuse the pipe and hold it under pressure until the joint is fully cured.

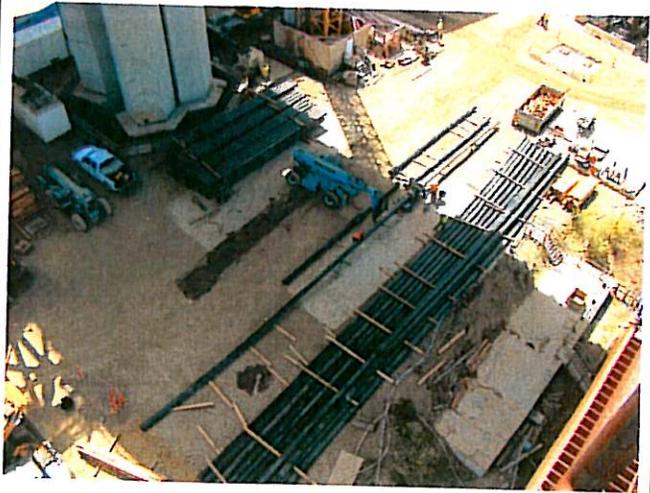
File Name:	Aug-28-2009 W2 Cap 014
Date:	08-28-09
By Int:	M Bruce

Description: SDI operation of fusing the HDPE pipe seen from the "W" line temporary towers.
