04-0120F4
SFOBB SAS

Date 09/28/2009

ASSISTANT RESIDENT ENGINEER'S

Description of Operations @ W2 Cap Beam:

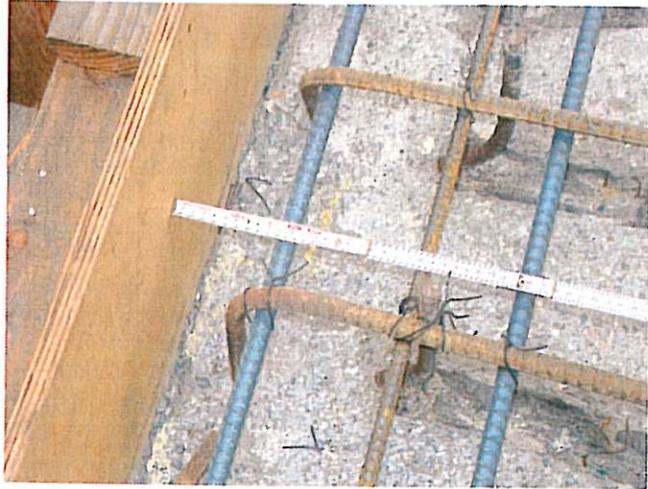
File Name:	Sept-28-2009 W2 Cap 002
Date:	09-28-09
By Int:	M Bruce

Description: A 140mm gap was discovered between the vertical dowel and the tail of the #16 horizontal bar. Per plan sheet 509R2 these bars need to have a contact splice. This condition exists predominately at the W2E blockout. There are a few areas at the W2W blockout that are similar but not as bad. ABF and RS foreman were put on notice that this condition is not acceptable and that other bars will likely be added.

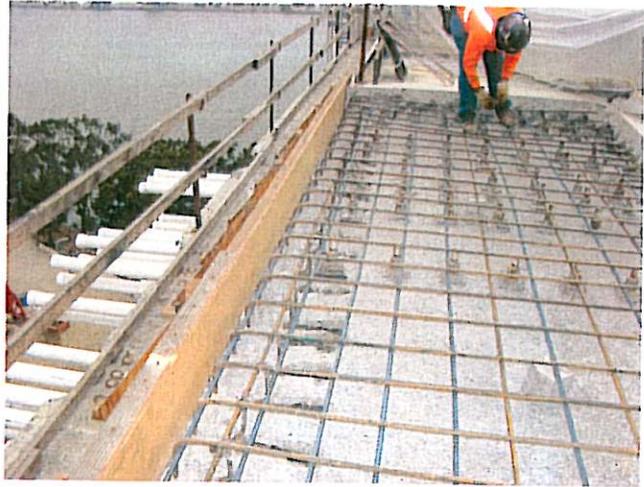
File Name:	Sept-28-2009 W2 Cap 003
Date:	09-28-09
By Int:	M Bruce

- Placed the rebar for the W2E vertical PT blockout as specified on plan sheet 509R2, see photo below for comments and details. The ironworkers left early as they thought their work was complete.

Description: Rebar placement for the W2E vertical PT blockout done today. As a result of the condition in the previous photo the splice length was too short at the east face. ABF and RS foreman were put on notice that this condition is not acceptable and that other bars will likely be added.

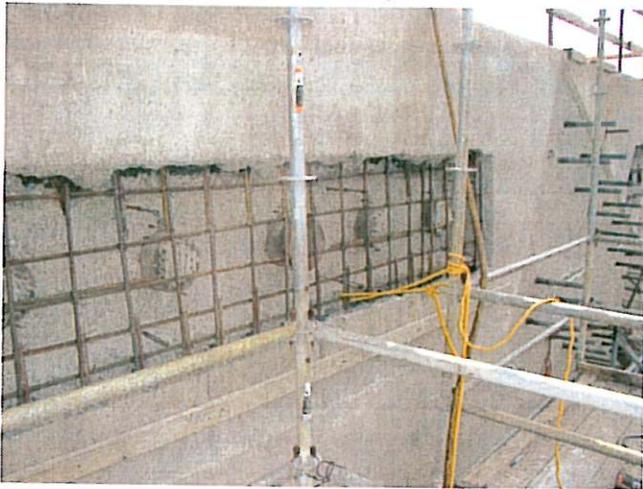
File Name:	Sept-28-2009 W2 Cap 010
Date:	09-28-09
By Int:	M Bruce

Description: Rebar placement at the north end CBT-16 to 22 blockout.

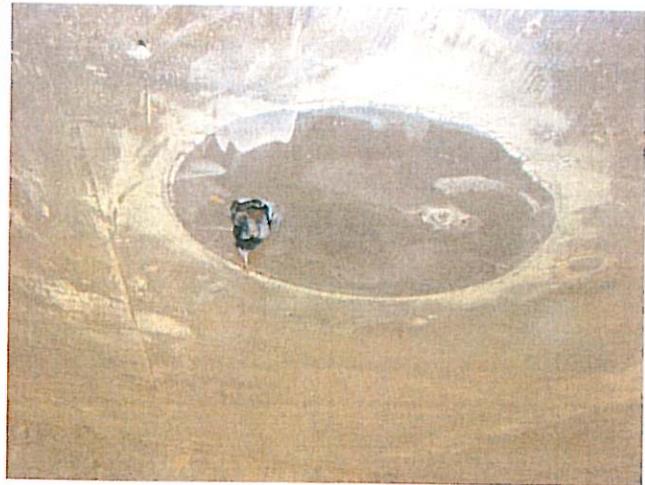
File Name:	Sept-28-2009 W2 Cap 011
Date:	09-28-09
By Int:	M Bruce

Description: The two vertical PT tendons where there was no grout in the drain tube were filled with Simpson Set 22 epoxy. The drain tube filled with epoxy is seen on the left with a foam plug so that the epoxy could cure in place.
