04-0120F4  
SFOBB SAS

ASSISTANT RESIDENT ENGINEER'S

**Description of Operations @ W2 Cap Beam:**

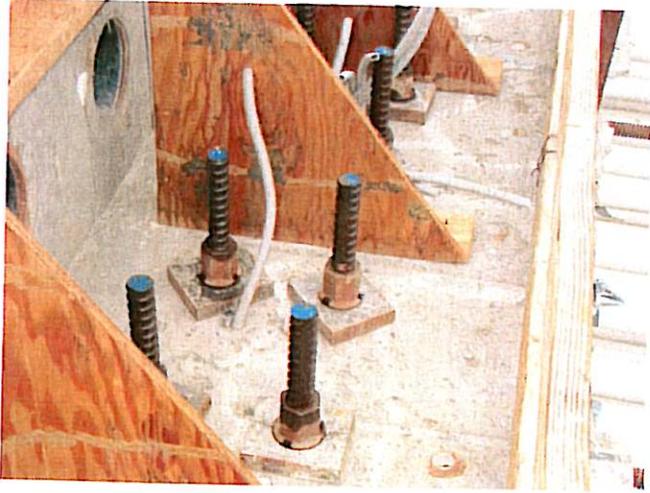
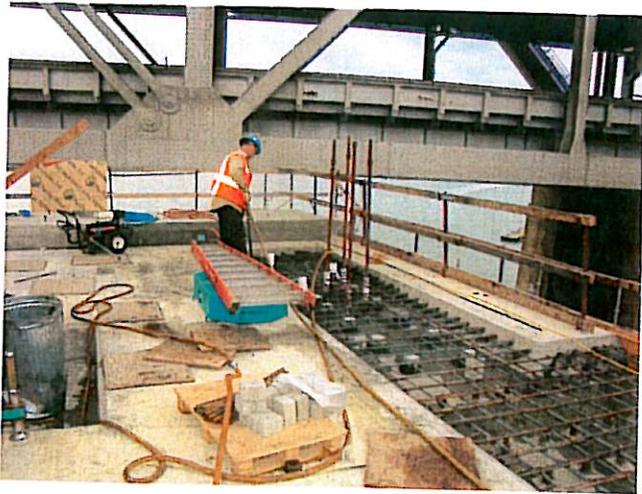
File Name:	Oct-12-2009 W2 Cap 001		
Date:	10-12-09	By Int:	M Bruce
<p>Description: It appears that ABF cleaned the rust off of the short vertical bars at W2E and W2W. ABF foreman Nigel Lohse and myself discussed further measures to protect this steel from corrosion until it is stressed a few years from now. The general process is to blow the ducts out with air, spray VPI powder, install valves on the grout tubes, remove the upper bar portion, and finally to install a plug.</p>			
File Name:	Oct-12-2009 W2 Cap 002		
Date:	10-12-09	By Int:	M Bruce
<p>Description: I informed ABF foreman Nigel Lohse to dewater the W2E vertical PT blockout. This has been a reoccurring problem at both vertical PT blockouts. ABF project manager Jim Davidson informed us via email that the concrete placement is scheduled Friday October 16<sup>th</sup>, 2009 for this blockout.</p>

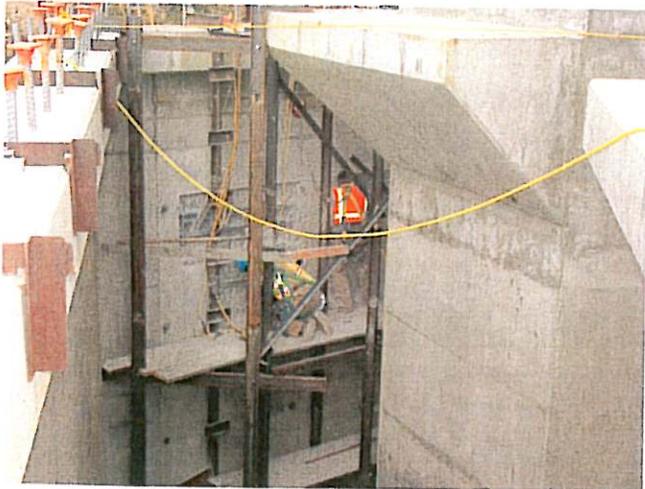
File Name:	Oct-12-2009 W2 Cap 003		
Date:	10-12-09	By Int:	M Bruce
Description: ABF laborers chipping the concrete for the new utility blockout in the W2W southeast retaining wall.

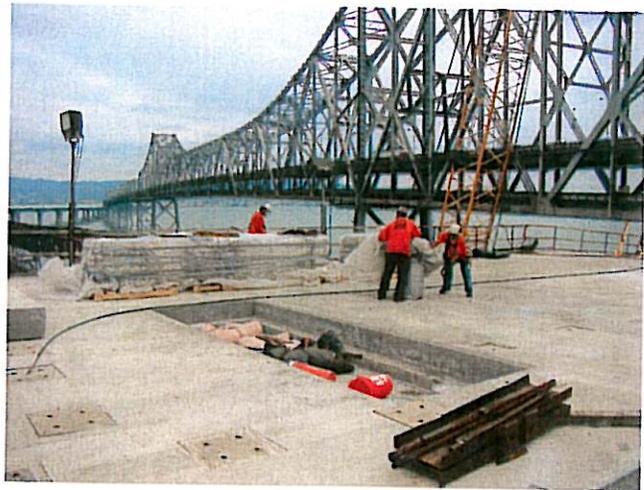
File Name:	Oct-12-2009 W2 Cap 006		
Date:	10-12-09	By Int:	M Bruce
Description: SDI ironworkers covering the four strand packs on the northeast end of the cap beam with plastic. As stated before heavy rains are anticipated for tomorrow.

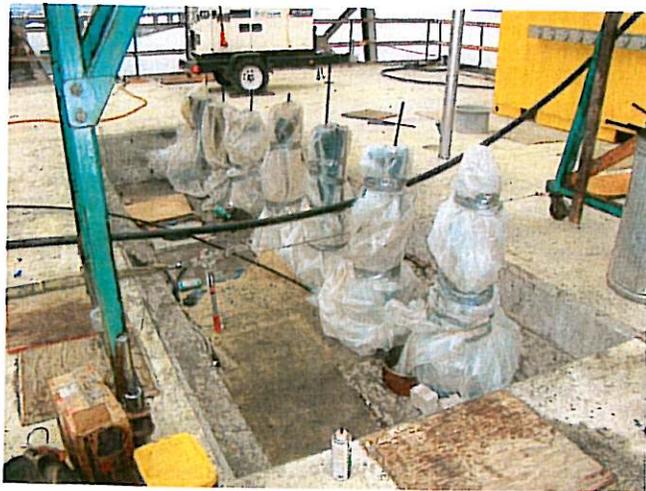
File Name:	Oct-12-2009 W2 Cap 008		
Date:	10-12-09	By Int:	M Bruce
Description: Seven cable tie down tendons at W2E that were covered with plastic. I made a point to the SDI ironworkers to cover the anchorheads as well as the exposed strands since there may be ponding in this blockout. This is most critical for tendon 7 (closest) where the anchor head is suspended off of the bearing plate. Also the plywood for cable tie down tendon number 6 was removed to prevent ponding in this blockout (no strand was placed yet)

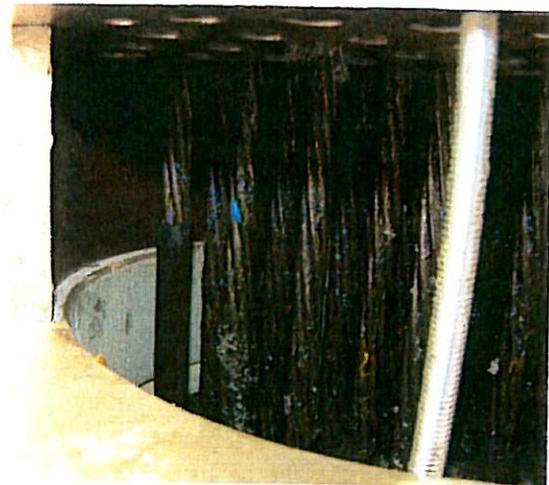
File Name:	Oct-12-2009 W2 Cap 009		
Date:	10-12-09	By Int:	M Bruce
Description: Exposed strand in the "grease box" for cable tie down tendon number 7 at W2E. Note the plastic sheathing on the far left hand strand, which will need to be cut for stressing.
