04-0120F4
SFOBB SAS

ASSISTANT RESIDENT ENGINEER'S

Description of Operations @ W2 Cap Beam:

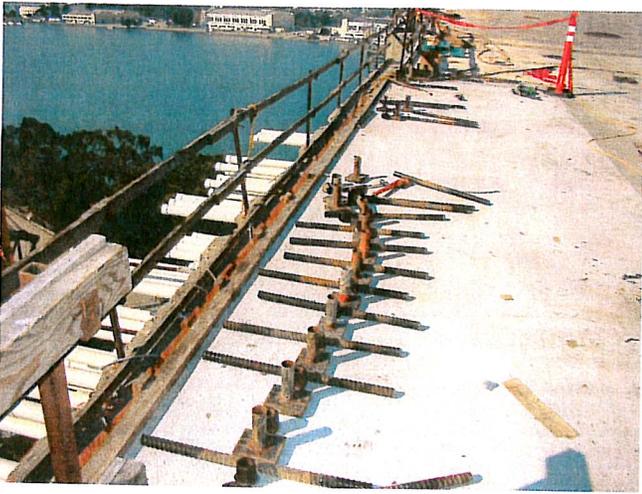
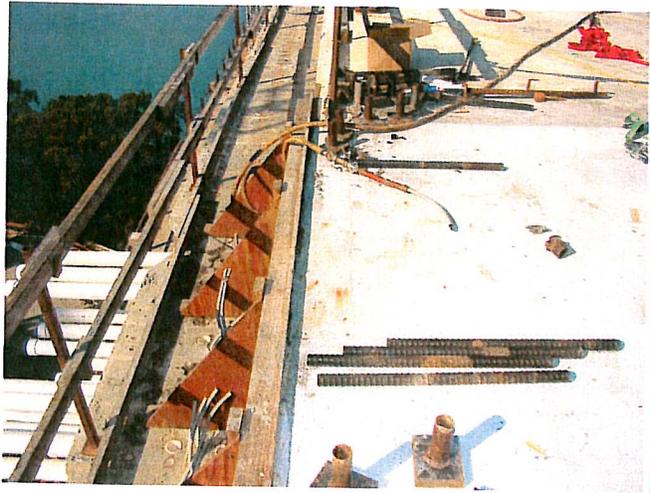
File Name:	Nov-04-2009 W2 Cap 002		
Date:	11-04-09	By Int:	M Bruce
Description: Top end of the short vertical PT bars at W2E were removed from the coupler. This was done to clean/remove any water or deleterious debris in the PT hardware.			
File Name:	Nov-04-2009 W2 Cap 004		
Date:	11-04-09	By Int:	M Bruce
Description: Compressor that was used during the accident with the ABF laborer. Blood can be seen on the concrete surface to the left. David Bradd was onsite when the incident happened. Apparently he was blowing out the PT hardware and was getting sprayed with water coming out the vertical bar hole. He used a bucket to block the hole to force the water out of the grout tubes. The bucket then acted as a projectile and hit him in the lip.

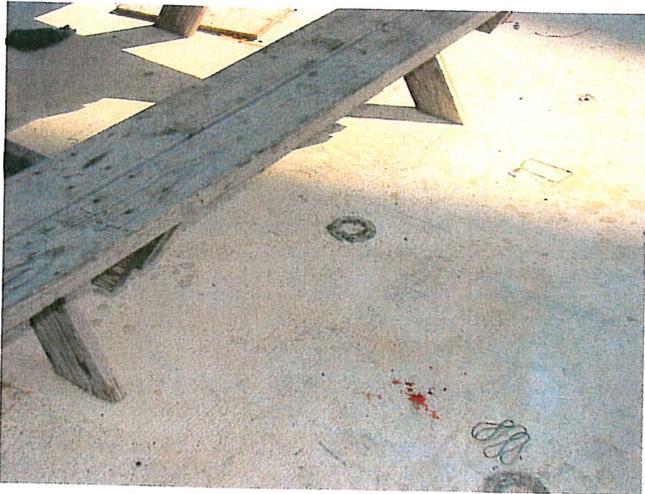
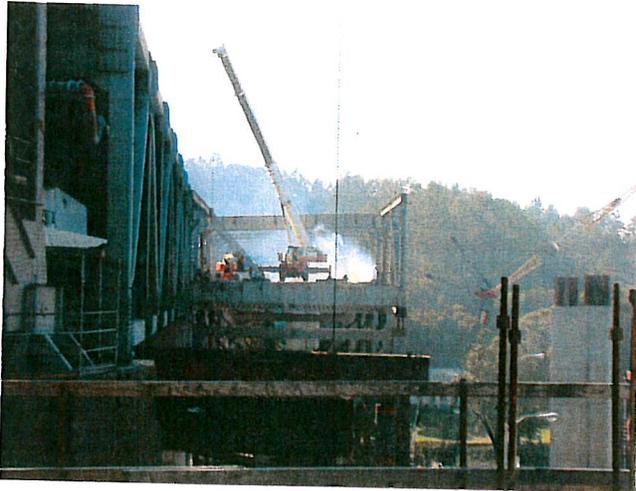
File Name:	Nov-04-2009 W2 Cap 005		
Date:	11-04-09	By Int:	M Bruce
Description: ABF laborer's blood on the concrete surface near the W2E construction joint with the OBG. It should be noted that ABF has no foreman or superintendent onsite to supervise the laborers since the T1 to YBI trestle construction has been in progress.			
File Name:	Nov-04-2009 W2 Cap 007		
Date:	11-04-09	By Int:	M Bruce
Description: Plumes of smoke from the demolition/cutting of the old bridge sections prior to the Labor Day detour. It is unknown if the air quality is being monitored. There is lead paint on this steel which is being cut.
