04-0120F4

SFOBB SAS

Date 11/25/2009

ASSISTANT RESIDENT ENGINEER'S

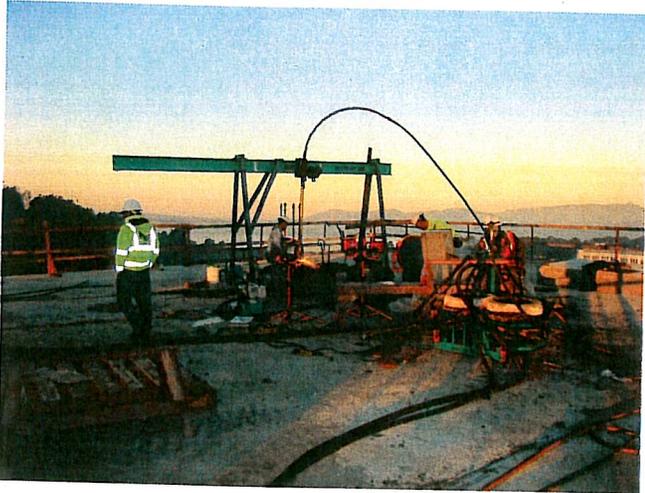
<table><tr> <td>File Name:</td> <td>Nov-25-2009 W2 Cap 002</td> <td>File Name:</td> <td>Nov-25-2009 W2 Cap 004</td> </tr><tr> <td colspan="2"> Description: SDI ironworkers pushing strand into cable tie down tendon #8 at W2W. This is the last tendon to have strand pushed completing this operation. </td> <td colspan="2"> Description: The upper anchorhead for cable tie down tendon E-11, which was stressed yesterday. It appears that all of the wedges have been seated. </td> </tr></table>

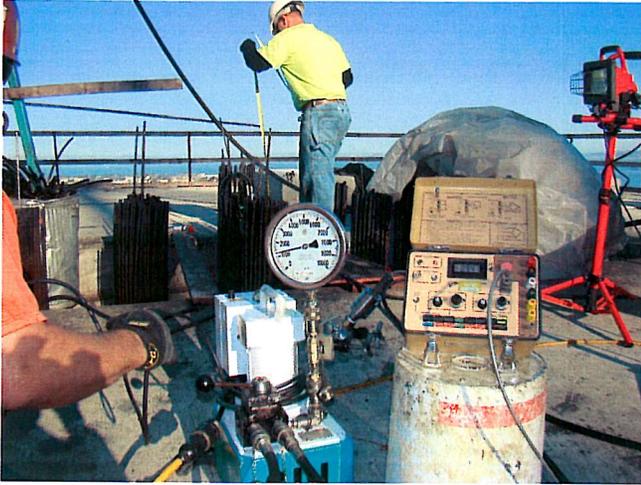
File Name:	Nov-25-2009 W2 Cap 009		
Date:	11-25-09	By Int:	M Bruce

Description: SDI ironworkers stressing a strand in cable tie down tendon W-4 to 30% P_{jack}. The corresponding pressure for 9.5kips on gauge 6-8-134A is approximately 1250psi. Measurements for elongation are taken at this point from the stressing plate to the end of the strand tail being stressed. The stressing plate has a 3/8" recess to allow for wedge movement while stressing.

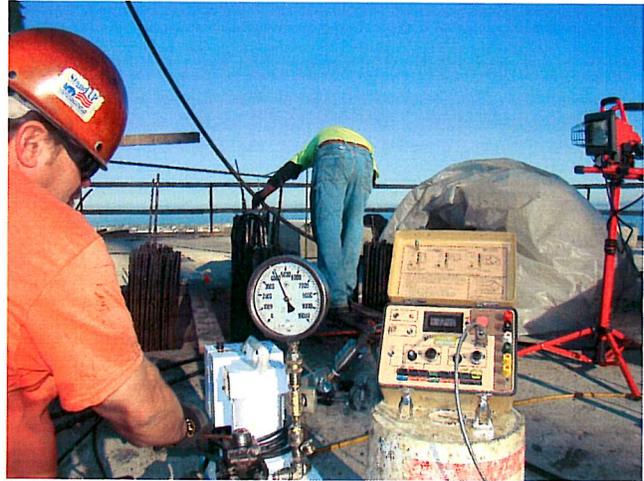
File Name:	Nov-25-2009 W2 Cap 010		
Date:	11-25-09	By Int:	M Bruce

Description: SDI ironworkers stressing a strand in cable tie down tendon W-4 to 100% P_{jack}. The corresponding pressure for 33kips on gauge 6-8-134A is approximately 4200psi. Measurements for elongation are taken again at this point from the stressing plate to the end of the strand tail being stressed. An additional measurement is taken for anchor set when the pressure is released from the monostrand jack.

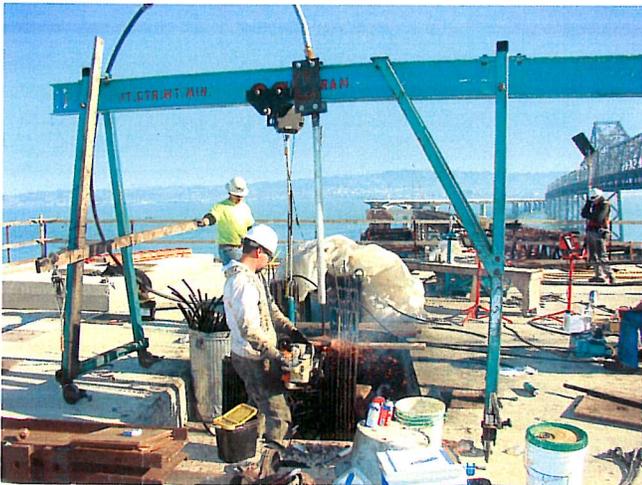
File Name:	Nov-25-2009 W2 Cap 013		
Date:	11-25-09	By Int:	M Bruce

Description: Cutting the last strand pushed for the cable tie down tendons into W-8.

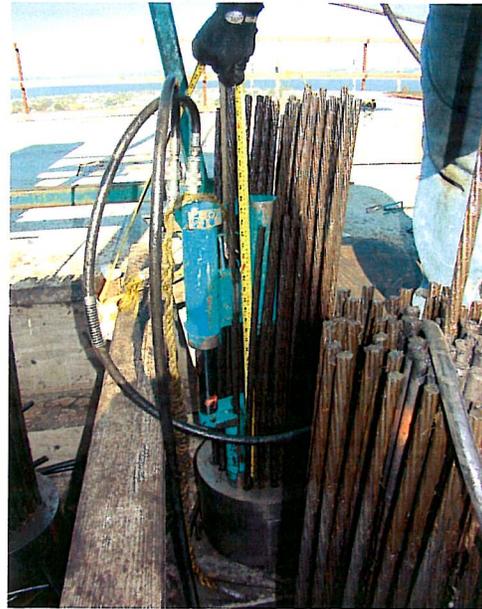
File Name:	Nov-25-2009 W2 Cap 015		
Date:	11-25-09	By Int:	M Bruce

Description: SDI ironworker measuring the elongation of the strand at W-4 after 100% P_{jack} from the stressing plate to the end of the strand tail.
