Job Stamp  
04-0120F4  
SFOBB SAS

ASSISTANT RESIDENT ENGINEER'S

**Description of Operations @ W2 Cap Beam:**

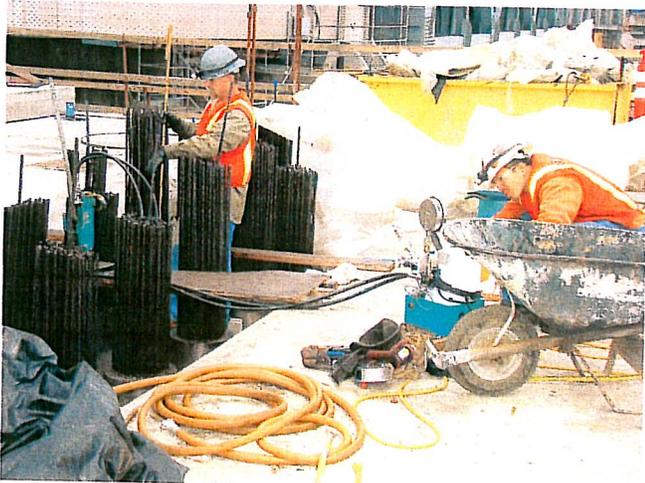
File Name:	Dec-02-2009 W2 Cap 004		
Date:	12-02-09	By Int:	M Bruce
Description: SDI ironworkers Bounthaby and Dave stressing strands with the monostrand ram for cable tie down tendon E-12.			
File Name:	Dec-02-2009 W2 Cap 007		
Date:	12-02-09	By Int:	M Bruce
Description: Strand tails (live end) of the cable tie down tendons at W2E. The strands were covered with plastic at the end of the day by the SDI ironworkers.

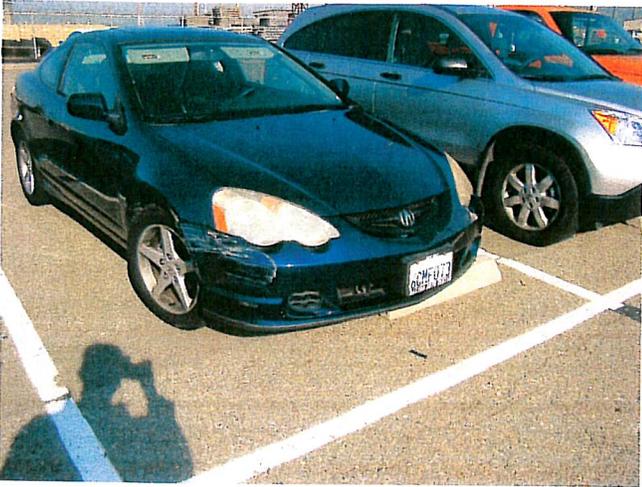
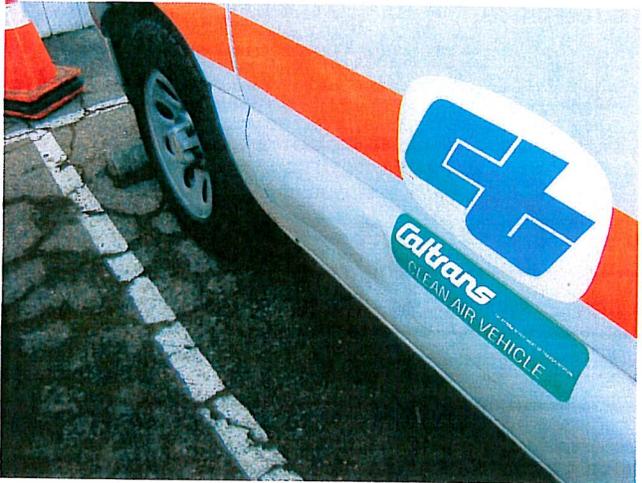
File Name:	Dec-01-2009 W2 Cap 001		
Date:	12-01-09	By Int:	M Bruce
Description: As I got into the truck assigned to me 7003478 this morning I noticed that there was a big dent in the driver side door. I didn't do this damage while operating the truck. As I walked through the parking lot I saw the vehicle shown above parked near the PIO. The car that is suspected of hitting/swiping the truck is this Blue Acura with a license plate number of 6CMF073.			
File Name:	Dec-01-2009 W2 Cap 002		
Date:	12-01-09	By Int:	M Bruce
Description: Damage done to the truck assigned to me 7003478. The dent matches the location on the Acura where the white paint marks are seen in the previous photo. There was no note left on the windshield of my truck.
