04-0120F4
SFOBB SAS

ASSISTANT RESIDENT ENGINEER'S

Description of Operations @ W2 Cap Beam:

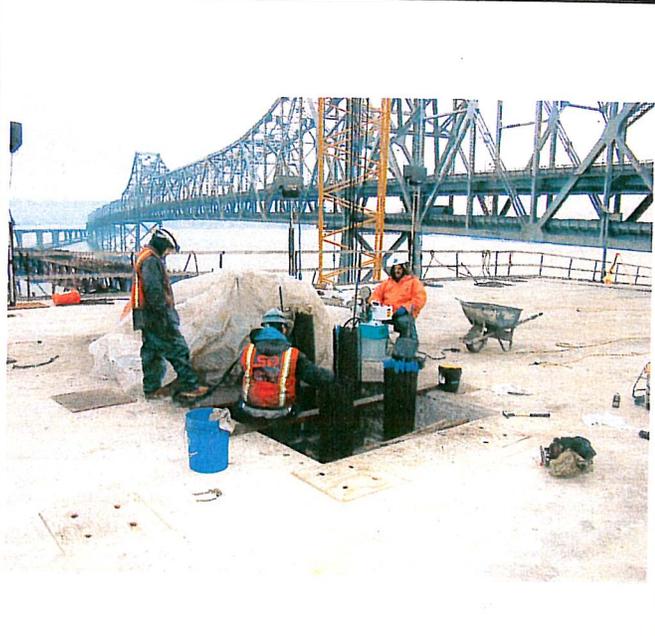
File Name:	Dec-10-2009 W2 Cap 002		
Date:	12-10-09	By Int:	M Bruce
Description: Stressing strands for cable tie down tendon W-2.			
File Name:	Dec-10-2009 W2 Cap 003		
Date:	12-10-09	By Int:	M Bruce
Description: Top of the W2 cap beam as stressing the cable tie down tendons is the only operation in progress at this location.
