04-0120F4
SFOBB SAS

ASSISTANT RESIDENT ENGINEER'S

Description of Operations @ W2 Cap Beam:

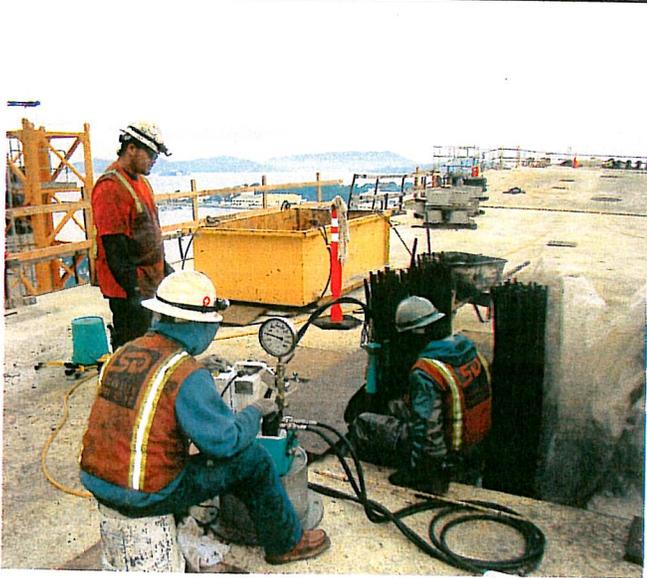
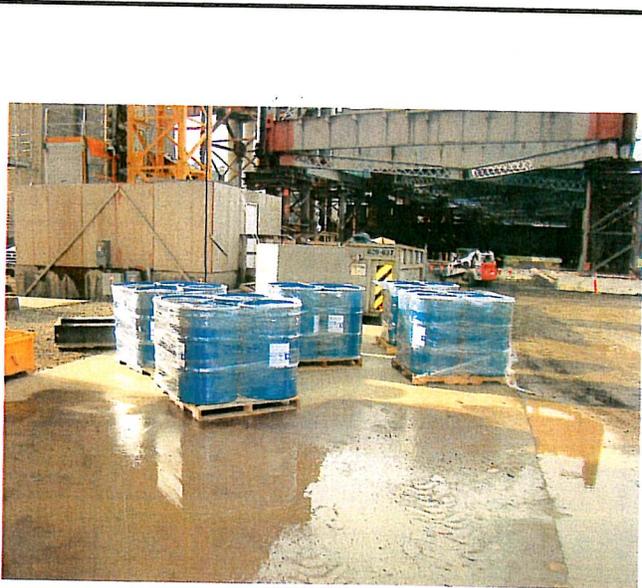
File Name:	Dec-15-2009 W2 Cap 001	File Name:	Dec-15-2009 W2 Cap 002
Date:	12-15-09	By Int:	M Bruce
Description: Sdi ironworkers stressing the last cable tie down strand 9.1 of E-8.		Description: Barrels of grease shipped onsite for injection near the upper and lower anchorheads of the cable tie down tendons. The grease to be used is "Red-I PTCable Grease" NLGI Grade #2.

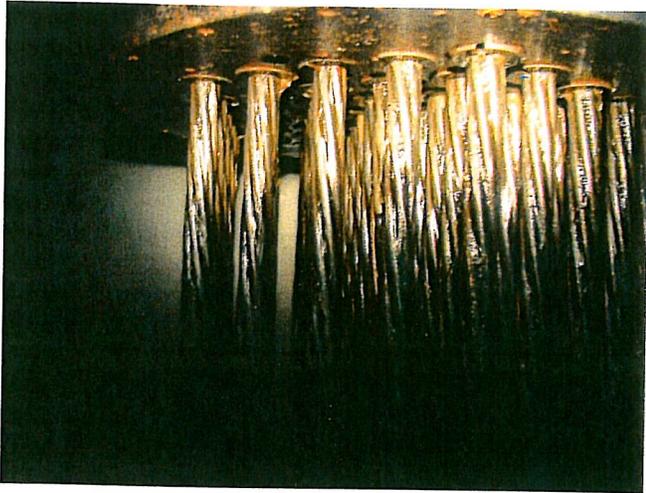
File Name:	Dec-15-2009 W2 Cap 005
Date:	12-15-09
By Int:	M Bruce

Description: Side view of the dead end anchorhead of cable tie down tendon E-9. It appears that all of the wedges have seated properly in the anchorhead. All 28 dead end anchorheads were checked to ensure that the wedges were seated prior to cutting any live end strand tails. The wedges were checked from the side view as well as from the bottom as seen in the next photo.

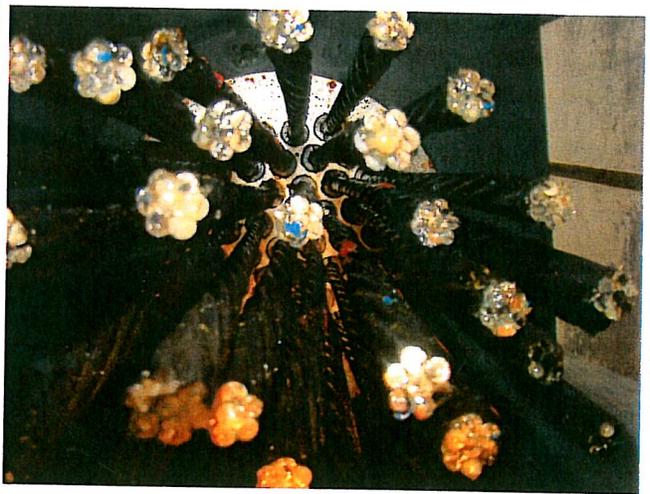
File Name:	Dec-15-2009 W2 Cap 008
Date:	12-15-09
By Int:	M Bruce

Description: Looking up at the dead end anchorhead of cable tie down tendon E-9. This was done for all 28 dead end anchorheads. There were no major issues with the wedges or strands. However it should be noted that water was dripping from some dead end wedges/strand tails/anchorheads. This water was presumably coming from up top where it has yet to be fully sealed.

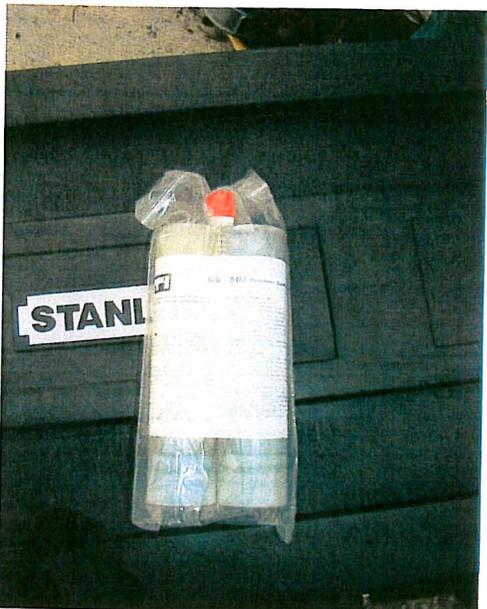
File Name:	Dec-15-2009 W2 Cap 010
Date:	12-15-09
By Int:	M Bruce

Description: Epoxy used to seal the grease box located below the upper anchorhead of the cable tie downs. The epoxy used was Hilti CS-500 Polyurea. The epoxy was heated in the tool box prior to placement to make the material more viscous to flow better on the grease box surface.

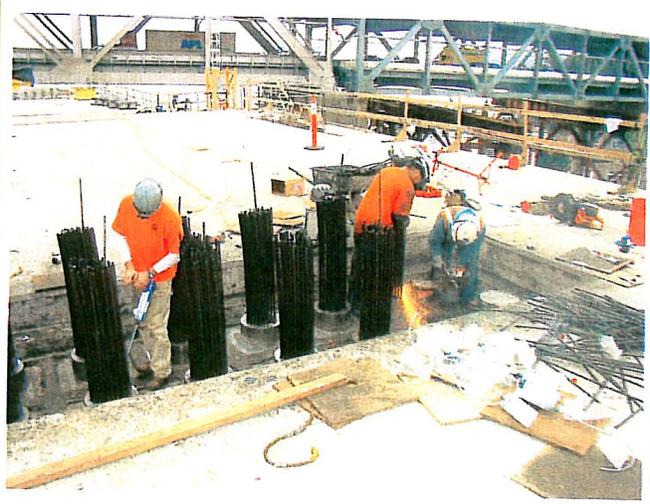
File Name:	Dec-15-2009 W2 Cap 014
Date:	12-15-09
By Int:	M Bruce

Description: SDI ironworkers injecting epoxy through the upper anchorhead to the "grease box" and cutting "live-end" strand tails for cable tie down tendon W-9.
