SFOBB SAS

ASSISTANT RESIDENT ENGINEER'S

Description of Operations @ W2 Cap Beam:

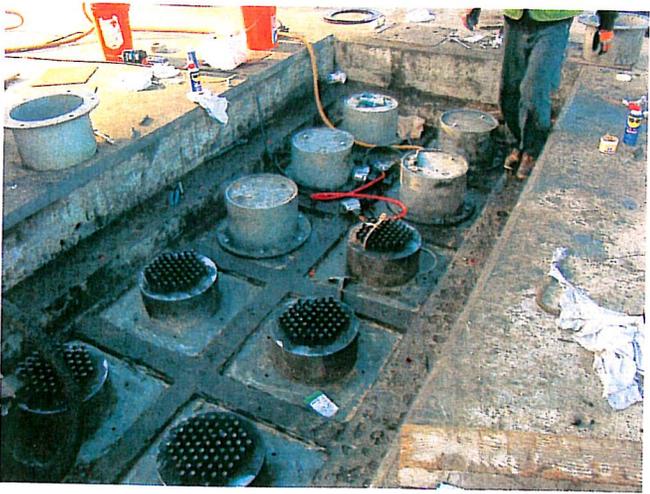
Date:	12-18-09	By Int:	M Bruce
Description: Cut strand tails for cable tie down tendons and grease cap placement at W2W. As mentioned above the ironworkers had to ream holes in the upper grease caps and bearing plates to make the nut fit.		File Name:	Dec-18-2009 W2 Cap 002
Date:	12-18-09	By Int:	M Bruce
Description: Grease in the barrel which had become more thick due to cool temperature.

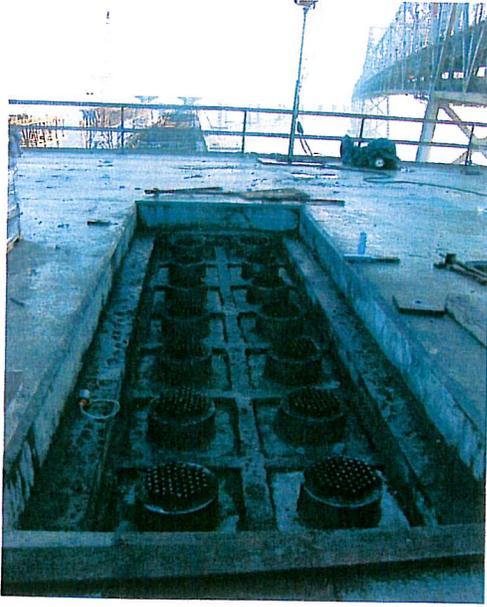
File Name: Dec-18-2009 W2 Cap 004

Description: Cut strand tails for cable tie down tendons at W2E. The approximate length of the live end strand tails was 50mm after cutting for all cable tie down tendons at W2E.

- Continued to grind/clean off debris on the upper cable tie down bearing plate surfaces at W2E.
- Cut the remaining "live-end" strand tails at W2E for the following cable tie down tendons E-1 to E-3, and E-8 to E-10 approximately 2 inches above the upper anchorhead.

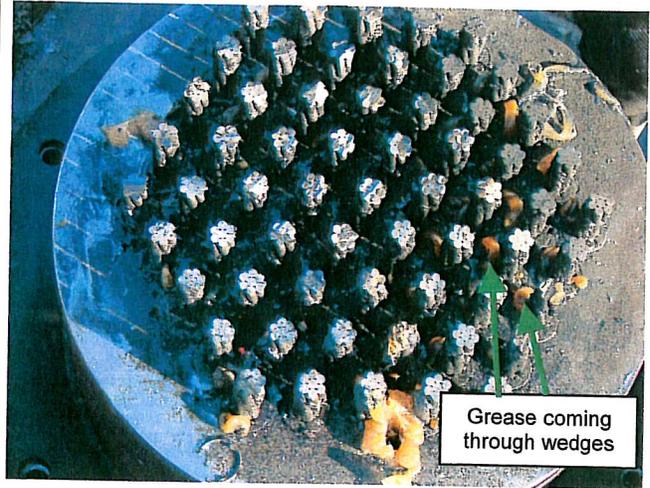
File Name: Dec-18-2009 W2 Cap 005

Description: Grease coming through the wedges at a cable tie down anchorhead at W2W.

- Injected grease in the upper anchorheads for cable tie down tendons tendons W-3, W-4, W-5, W-9 and W-10. It took approximately 40 minutes on average to inject grease from the upper anchorhead to the grease box located 8 inches below the bottom face. The grease is not viscuous which is difficult to pump therefore taking longer than possible to complete this operation. Also grease was injected into the upper grease cap for W-10.
