04-0120F4
SFOBB SAS

ASSISTANT RESIDENT ENGINEER'S

Description of Operations @ W2 Cap Beam:

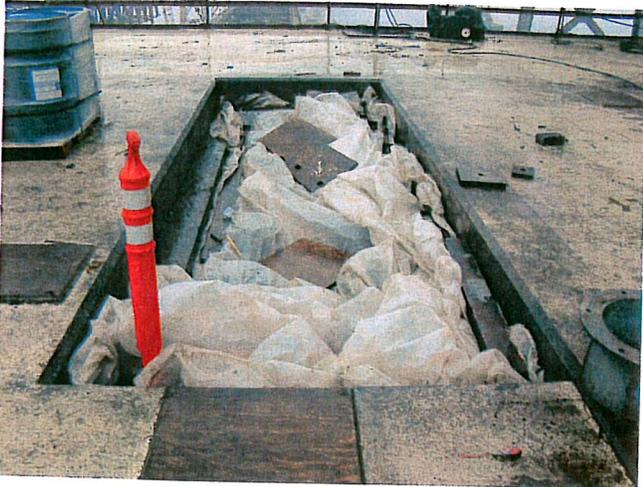
File Name:	Dec-21-2009 W2 Cap 001		
Date:	12-21-09	By Int:	M Bruce
Description: Cable tie down blockout at W2E where no grease has been injected in the upper anchorhead or caps placed. Plastic was placed over the anchorheads and bearing plates prior to those operations.

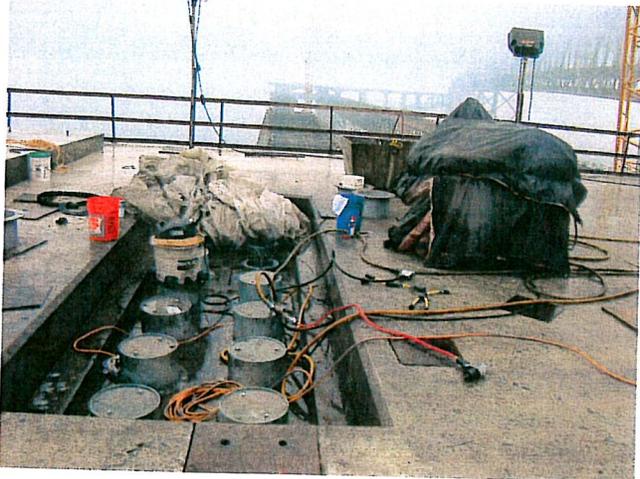
File Name:	Dec-21-2009 W2 Cap 003		
Date:	12-21-09	By Int:	M Bruce
Description: Injecting grease into the W-12 upper anchorhead. The barrels of grease were covered and some standing water was seen near the previously placed grease caps.
