04-0120F4

SFOBB SAS

ASSISTANT RESIDENT ENGINEER'S

Description of Operations @ W2 Cap Beam:

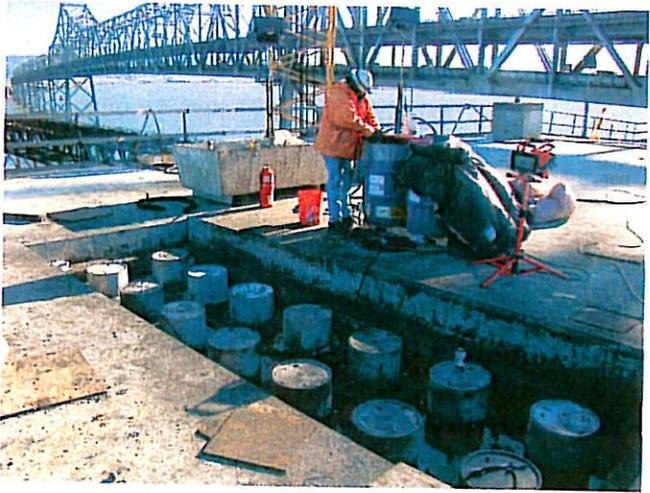
| File Name: | Dec-22-2009 W2 Cap 001 | File Name: | Dec-22-2009 W2 Cap 003 |

| Description: Injecting grease into the grease caps placed over the upper anchorhead at W2W. SDI ironworkers used a heating straps placed around the grease barrels and a mixing paddle to make the grease more viscous. | | Description: Grease coming out of the outlet vent for the upper grease cap of W-1 prior to sealing with the plug nut. | |

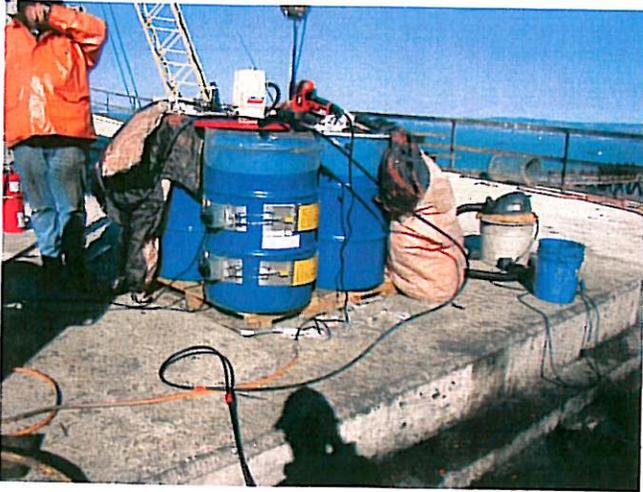
| File Name: | Dec-22-2009 W2 Cap 004 |

Description: Mobilized grease barrels at W2E and began grease-injecting operations. Two heat bands can be seen around the grease barrel. Heating the grease has increased the pumping speed and therefore production of this operation.

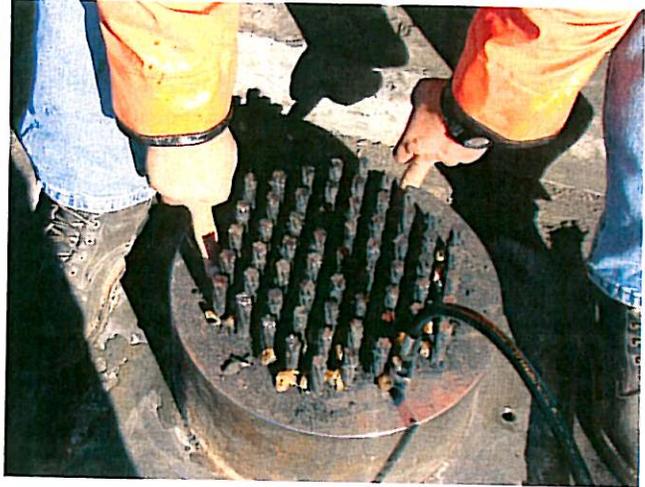
| File Name: | Dec-22-2009 W2 Cap 005 |

Description: Grease coming out of the upper anchorhead wedges of cable tie down tendon E-7.

- Injected grease in the upper anchorheads for cable tie down tendons W-7, W-14, E-7, and got 1/2 way on E-14. It took approximately 40 minutes on average to inject grease from the upper anchorhead to the grease box located 8 inches below the bottom face. Also injected grease in all the upper grease caps (second phase) at W2W except W-10. It took approximately 30 minutes on average to inject grease from the bearing plate to the top of the grease cap.
- Continued to work on banding the sheathing components at the bottom of the cable tie down tendons per sheet TD-002 Detail 4 in Submittal 85. Yesterday the ironworkers worked at W2E and today at W2W.
- Completed placing upper grease caps over anchorheads at W2W. The ironworkers had to ream holes in the bearing plate and grease caps to get the nuts shipped onsite to fit.
