Daily Diary Report by Bid Item

Diary #: 095 Const Calendar Day: 310 Date: 15-Jul-2010 Thursday

04-0120F4
 04-SF-80-13.2/13.9
 Self-Anchored
 Suspension Bridge

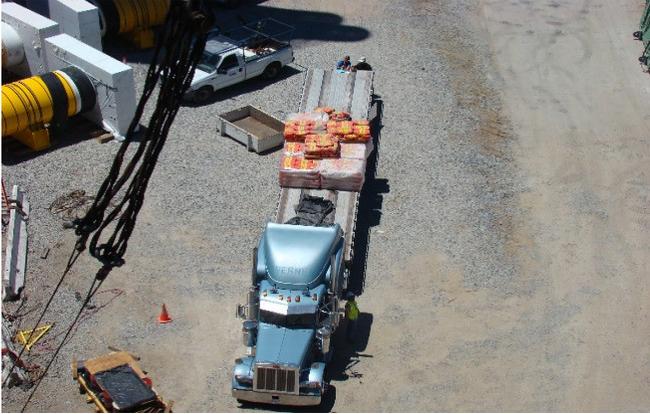
As the plastic was unwrapped some the grout bags had tears in the bags and didn't appear to be well compacted.

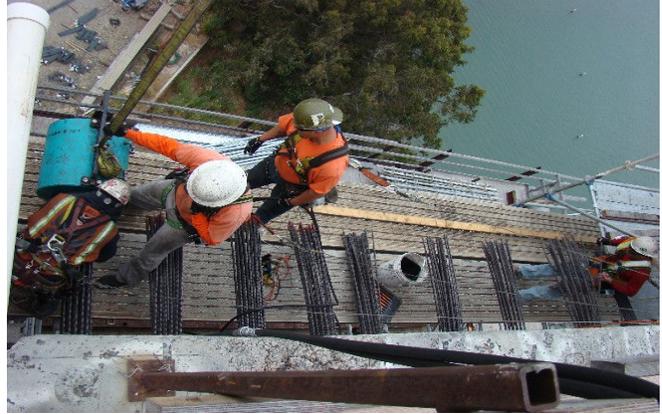
SDI ironworkers stressing a WB continuity tendon and placing anchorheads/wedges on the live end tails a WB continuity tendons.

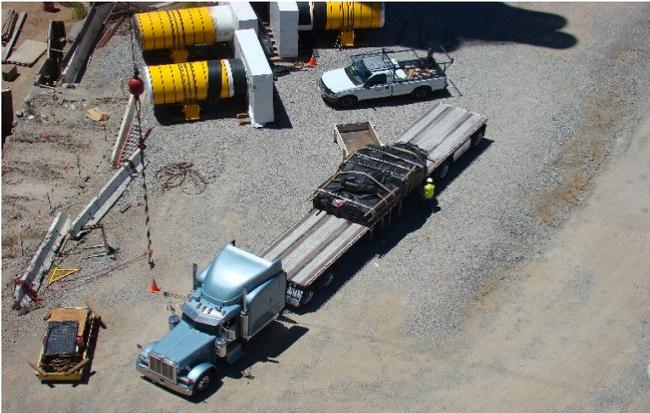
Shipment of grout pallets from an SDI job in Colorado with black plastic wrapping. Notice the tear in the lower portion of the wrapping.

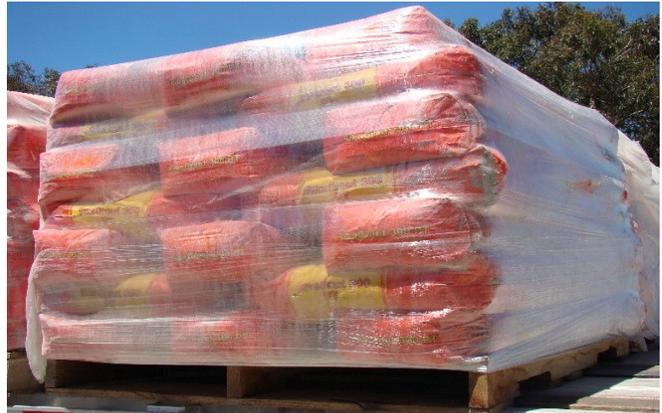
Tears seen in the grout bags where the date on the bags was
06/18/2010
