Daily Diary Report by Bid Item

Contract No.: 04-0120F4

04-0120F4
 04-SF-80-13.2/13.9
 Self-Anchored
 Suspension Bridge

04-0120F4 Bid Item: 034 X-W2C-BCT.034 E-W Line Cross Over W2 Cap Cap Beam Continuity Tendons
 SCHWAGER DAVIS INC.

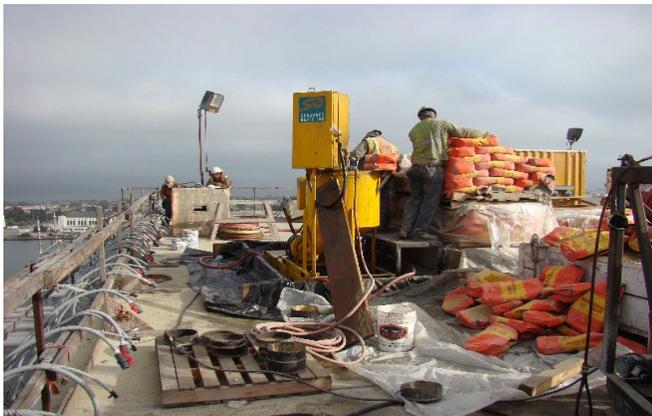
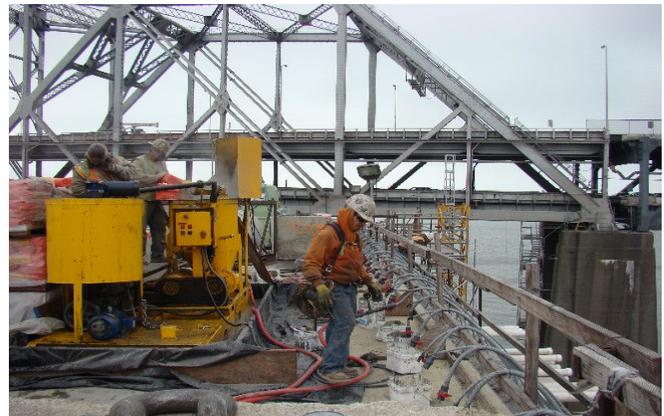
Grouting operation setup for the WA continuity tendons.

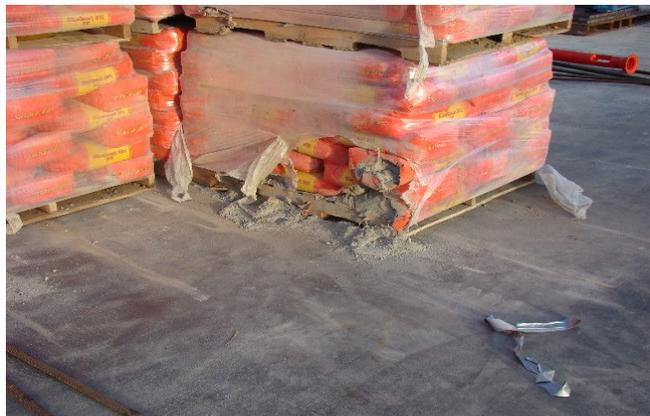
From 7:10am to 8:46am SDI ironworkers used approximately 5+ pallets of grout (40 bags a pallet) with the date 06/18/10 on the bag. The continuity tendons grouted from this time interval was W42A to W23A. The ironworkers were warned about using grout from the bags with this date. These were the bags shipped from Colorado to the SAS jobsite. It appeared that the bags were exposed to the weather prior upon arriving at the jobsite. A pallet of grout with the date 07/15/10 was used on continuity tendons W22A to W19A. Grout bags with the dates 06/18/10 were used for W18A to W7A from 9:26am to 10:11am. The remainder of the grouting was done with grout bags having the date of 07/15/10 on the bags from 10:11am to 10:58am.

Broken bags of grout sent from an SDI project in Colorado. The date on the bags was 06/18/10.
