**Daily Diary Report by Bid Item**

Contract No.: 04-0120F4

04-0120F4  
 04-SF-80-13.2/13.9  
 Self-Anchored  
 Suspension Bridge

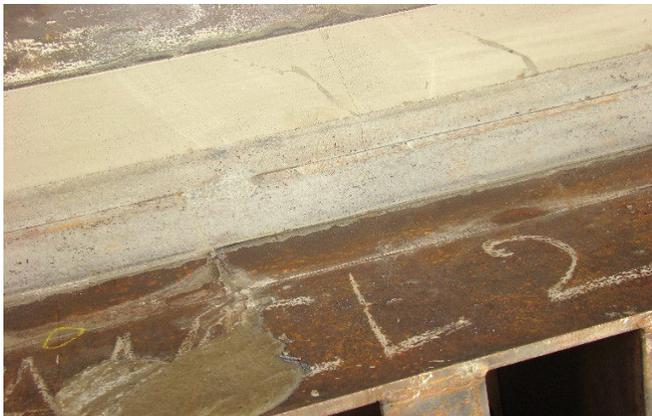
Minor crack seen on the top edge between the L and 2. A few cracks like this one were seen possibly due to anchor bolt blockouts.

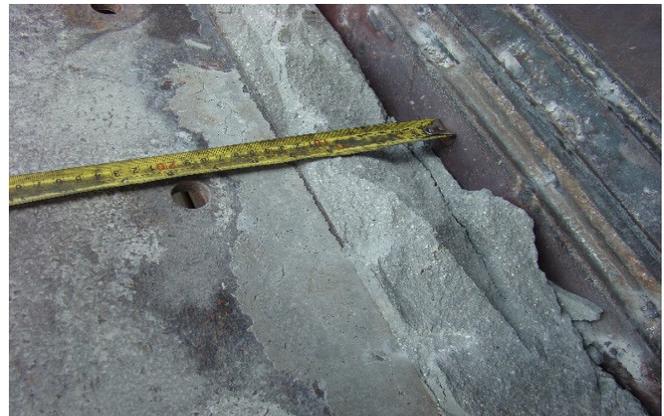
Measured grout pad thickness was 115mm +/- 5mm, also at the Panel joints the fractured grout appeared to be heterogenous.

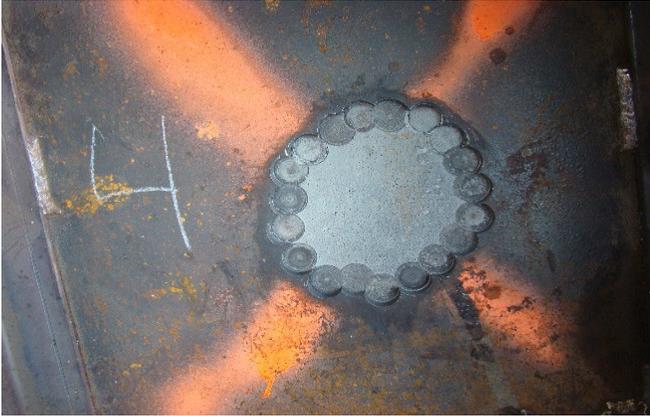
Exposed grout pad surface of the mock-up number 4 on Panel 2. Per ASTM C1339 the surface area passes the subjective visual test with minimal voids.

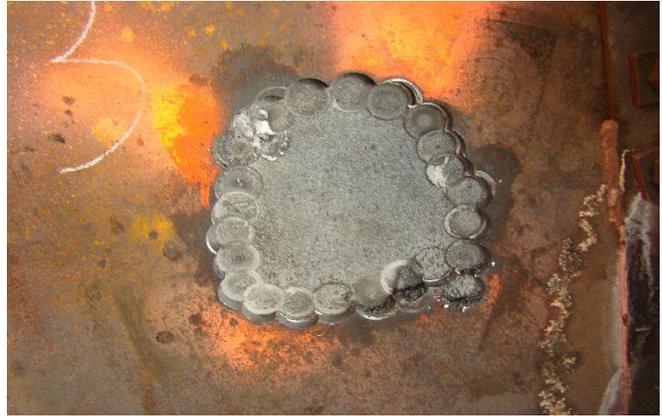
Exposed grout pad mock-up number 3 on Panel 2. Per ASTM C1339 the surface area passes the subjective visual test with minimal voids.

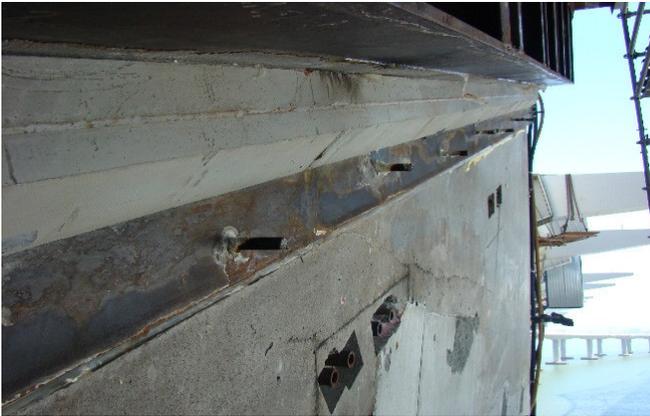
Bottom edge of Panel 3 where the grout appeared to be fully consolidated.

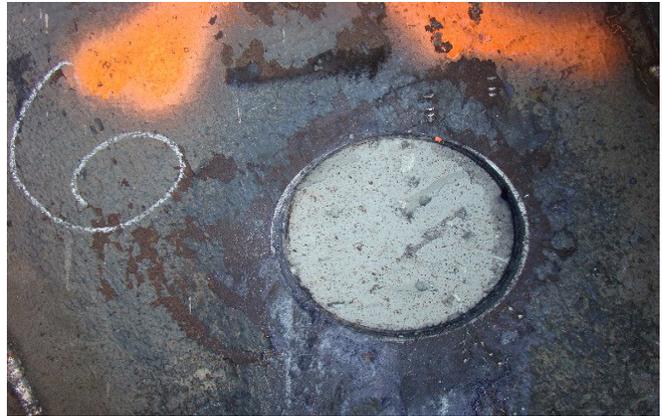
Exposed grout pad mock-up surface number 6 on Panel 3. This was the worst case surface area in my opinion with a few visible surface area voids.

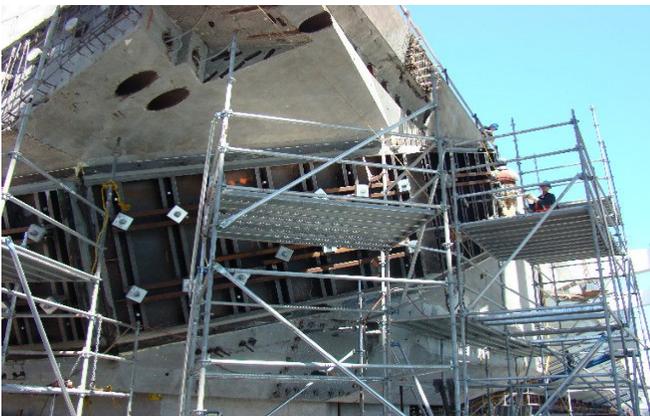
ABF ironworkers preparing to remove Panel 3 of the grout pad mock-up at the W2E Deviation Saddle
