Daily Diary Report by Bid Item

Diary #: 157 Const Calendar Day: 399 Date: 12-Oct-2010 Tuesday
 Inspector Name: Bruce, Matt Title: Transportation Engineer
 Inspection Type: Continuous
 Shift Hours: 07:00 am 04:30 pm Break: 00:30 Over Time: 01:00

04-0120F4
 04-SF-80-13.2/13.9
 Self-Anchored
 Suspension Bridge

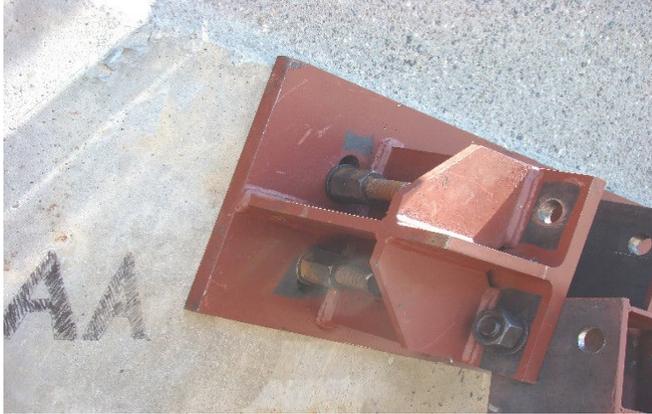
Bracket for the W2W1 west deviation saddle segment which had additional holes drilled in the base plate.

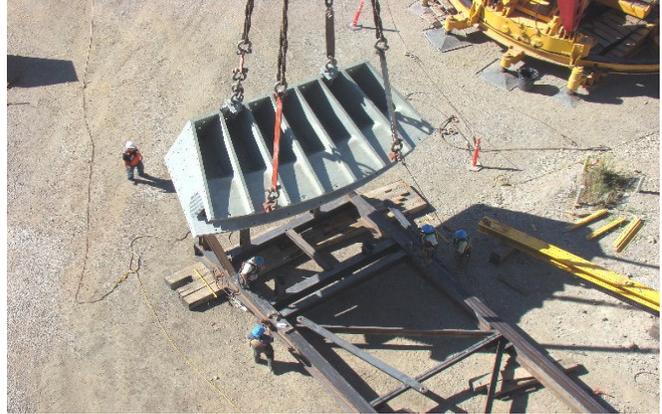
ABF ironworkers placing the W2W1 west deviation saddle segment on the cradle.

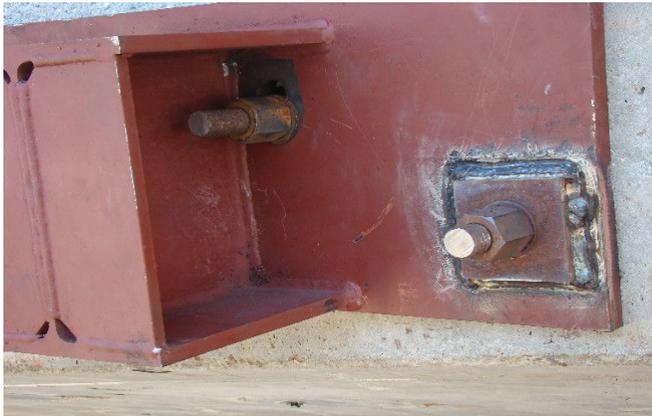
Steel bearing plate welded to the same bracket base plate to mitigate any slipping.

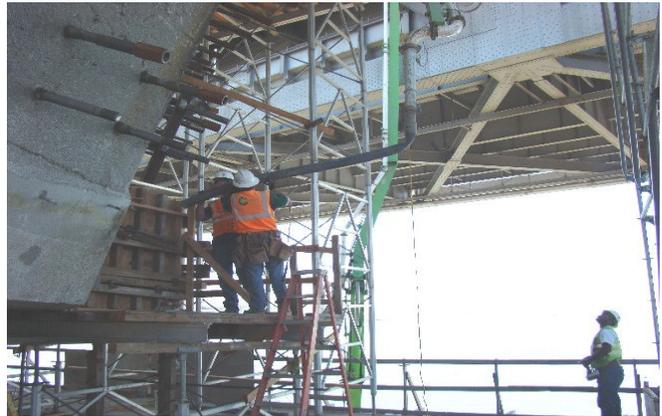
Conco placing SCC in the lower southwest bikepath pedestal blockout.

- See Lalit and Alex Schmidt's diaries for ABF and Concos labor, equipment, and operations at the W2 cap beam. Conco placed SCC mix design number 1417325 for the three bikepath pedestal blockouts mentioned above. The concrete temperature was 84F with an ambient temperature of 88F and a slump flow of 29.5 inches. Two sets of cylinders for compressive strength were made for 28 and 56 days.

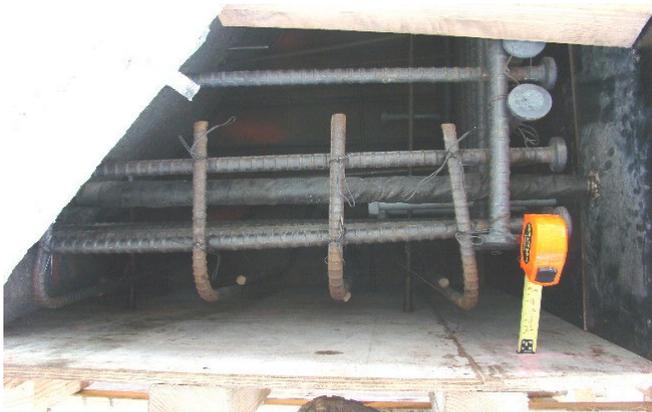
- 1.) Excess cover of 7" from the vertical row of #25 T-Head female couplers for the west side of the lower southwest bikepath pedestal blockout. The solution was to add 4 #19 vertical "U" bars to confine the side concrete and provide tensile resistance. This will mitigate cracking at the west side of the blockout. It is unknown whether or not CMC-RS verified the torque of 200Lb-ft on the upper female coupler as they were instructed.

Four #19 vertical 'U' bars were added to the lower southwest bikepath

pedestal blockout since the side cover was 7 inches before the rebar was added.

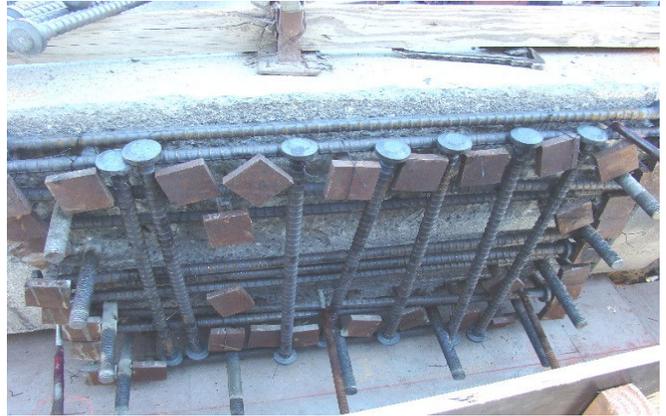
- Placed #25 double T-Head bars in the upper southwest bikepath pedestal blockout, see photo below.

Rebar placement of the #25 double T-Heads at the upper southwest bikepath pedestal blockout

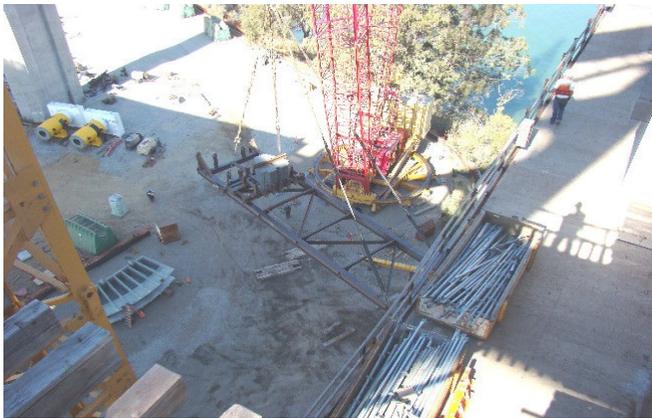
Trial pick with the cradle and counterweight to be used for the west deviation saddle segment W2W1.

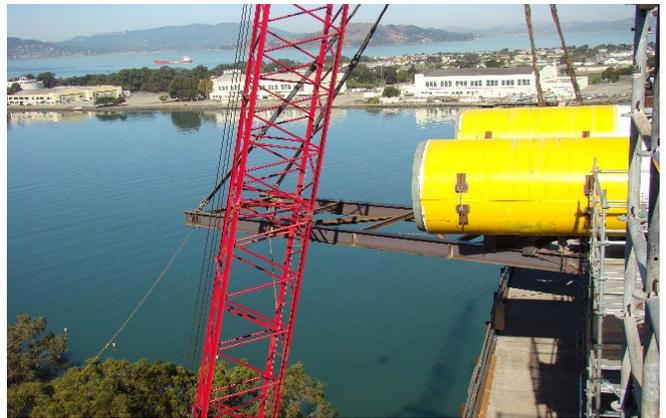
Trial pick with the cradle to be used for the west deviation saddle segment W2W1.

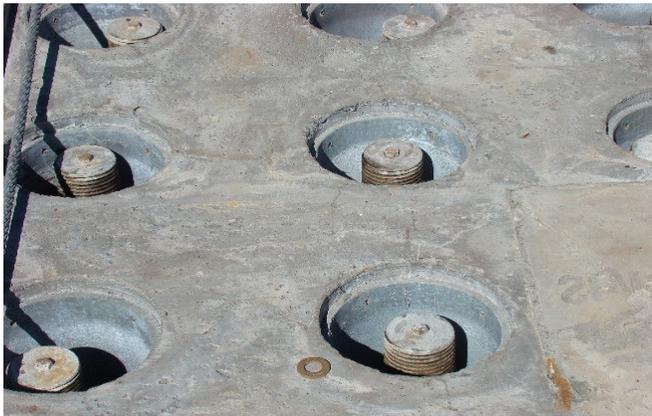
- Met in the field with Brian Boal, Paul Jefferson, and Alex Schmidt to discuss and inspect the condition of the previously installed anchor rods for two shear keys (over the columns) at the E2 cap beam. Also visually inspected the alignment of the corrugated ducts for the other shear keys and bearings as it relates to the templates to be fabricated for CCO 166.
 - Resolved issues related to the 3 (2 lower, upper west) bikepath pedestal blockouts located on the south end of the W2 cap beam. Issues related to the pedestals were the following:

Rust accumulated on the anchor rods at the E2 cap beam where standing water was observed in the X-Strong pipe blockout.

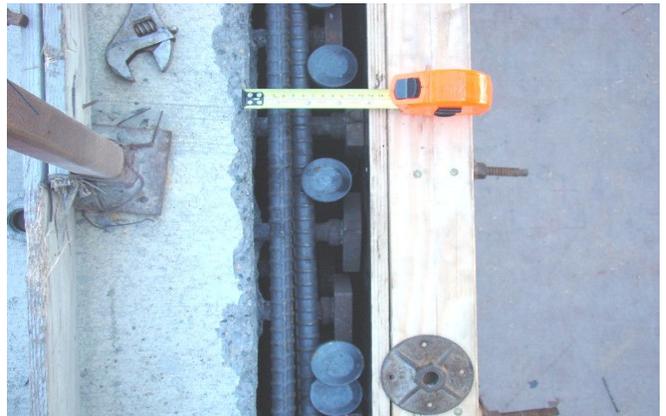
- 3.) The top row of previously embedded #25 T-Heads for the upper southwest bikepath pedestal blockout had an inch or no cover to the forms. The forms couldn't be moved since enough room on the previously embedded anchor bolts were needed to accommodate the 20mm grout pad, 20mm plate and anchor rod nut. The T-Heads were left alone since the rebar at this location is critical to resist the tensile loads of the bikepath bracket when subjected to moment.

Looking down on the upper southwest bikepath pedestal blockout where some of the T-Heads were in contact with the forms.

It should be noted that all issues were discussed with ABF project manger Jim Davidson and TY-Lin designer James Duxbury was informed of issue number three. See photos below for additional comments and details related to the three issues described.
