Daily Diary Report by Bid Item

Diary #: 239 Const Calendar Day: 525 Date: 15-Feb-2011 Tuesday
 Inspector Name: Bruce, Matt Title: Transportation Engineer
 Inspection Type: Continuous
 Shift Hours: 07:00 am 04:30 pm Break: 00:30 Over Time: 01:00

04-0120F4
 04-SF-80-13.2/13.9
 Self-Anchored
 Suspension Bridge

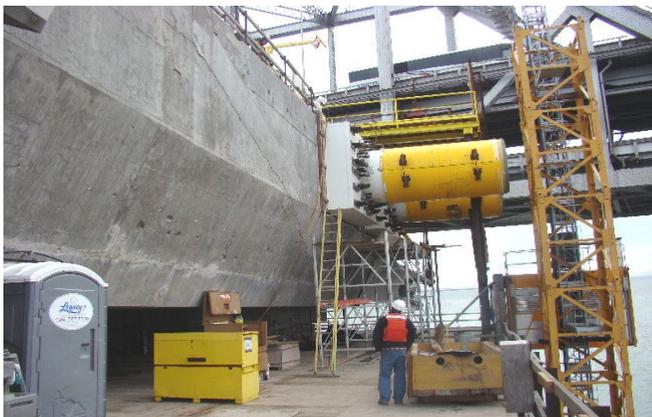
Conco carpenters in the process of using an air compressor to blowout and clean the dust inside the W2E Hinge K grout pad forms.

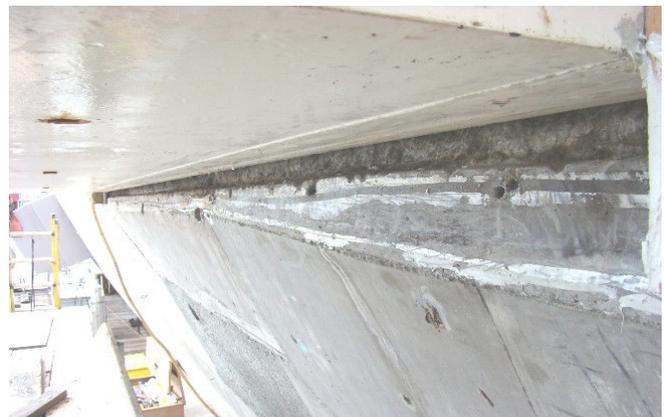
North W2E Hinge K bottom grout pad forms that were removed to blow out the EMACO 503 dust and other deleterious materials from the

forms.

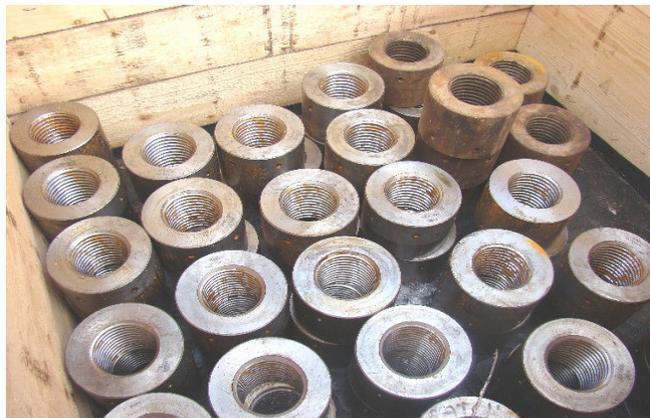
Macalloy rod nuts with visible rust seen on the threads of the nuts.

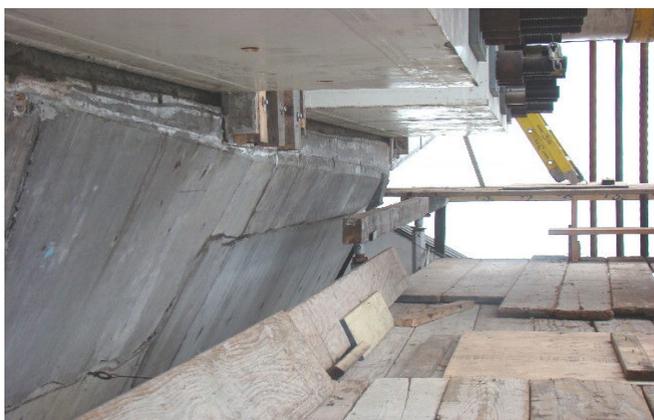
Bottom forms removed for the W2E Hinge K grout pad for cleaning where a grey dust was seen while the Conco carpenters blewout the forms.
