### SAS Superstructure

Location: 04-SF-80-13.2 / 13.9

## Daily Diary Report by Bid Item

04-0120F4  
04-SF-80-13.2/13.9  
Self-Anchored  
Suspension Bridge

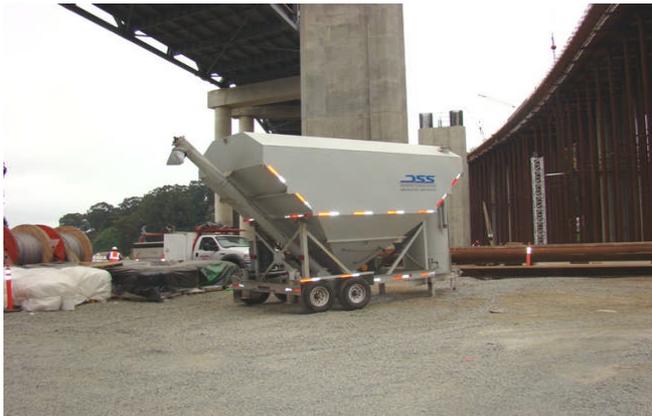
Mixer is onsite for the Hinge K box grouting operation adjacent to the Masterflow 1205 superbags of grout on YBI west of the W2 cap beam.

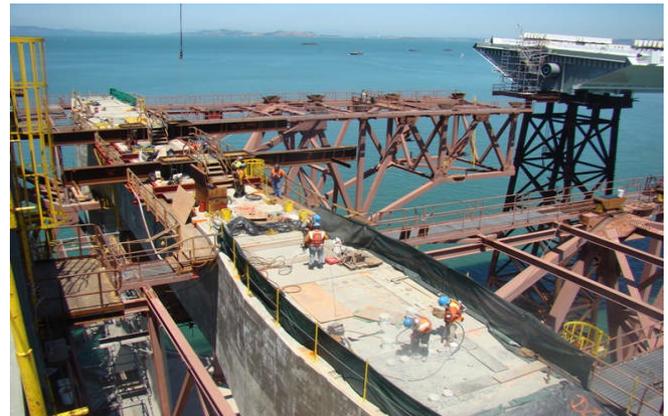
ABF laborers chipping concrete that is underneath the Shear Keys and Bearings since the concrete was too high for the required grout pad thickness.

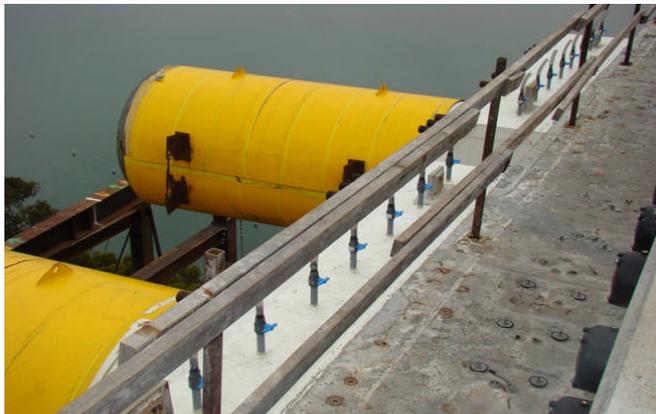
Outlet grout tubes connected to the W2W Hinge K pipe beam assembly boxes.

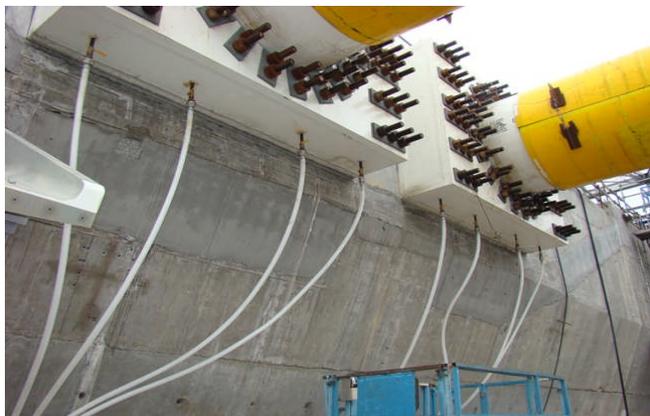
Inlet grout tubes connected to the W2W Hinge K pipe beam assembly boxes.
