**Daily Diary Report by Bid Item**

Contract No.: 04-0120F4

04-0120F4  
 04-SF-80-13.2/13.9  
 Self-Anchored  
 Suspension Bridge

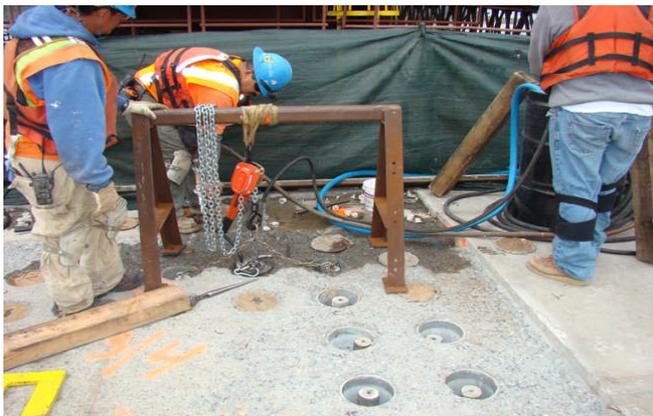
ABF laborers using an compressed air from the opposite direction of the original tests (RFI 2518) from the grout inlet at a S2 Shear Key anchor rod.

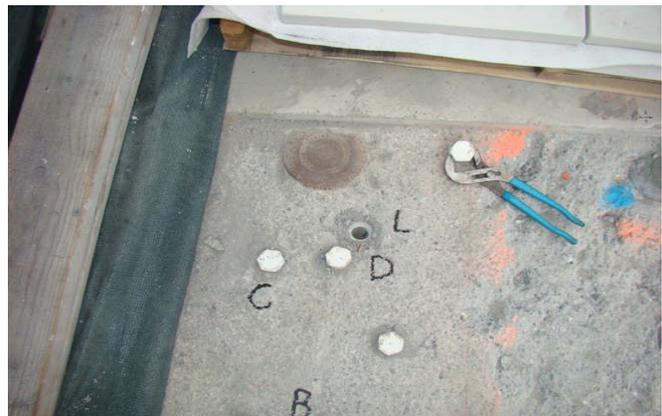
The grout inlet for the S1 Shear Key anchor rod blockout labeled "L" where the PVC pipe was found to have debris or been broken.

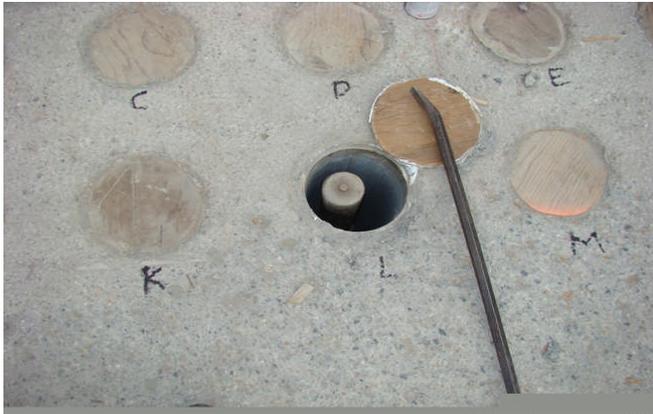
An anchor rod breakout inspected with the boroscope where water was found at the bottom of the breakout and yet to be cleaned by the ABF laborers.

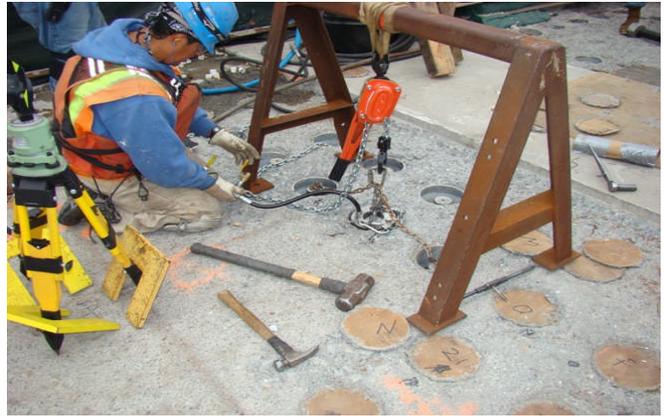
ABF laborer using compressed air to force the water out of an anchor rod breakout at the E2E column (S2) Shear Key.
