SAS Superstructure

Daily Diary Report by Bid Item

Diary #: 438 Const Calendar Day: 798 Date: 15-Nov-2011 Tuesday

04-0120F4
04-SF-80-13.2/13.9
Self-Anchored
Suspension Bridge

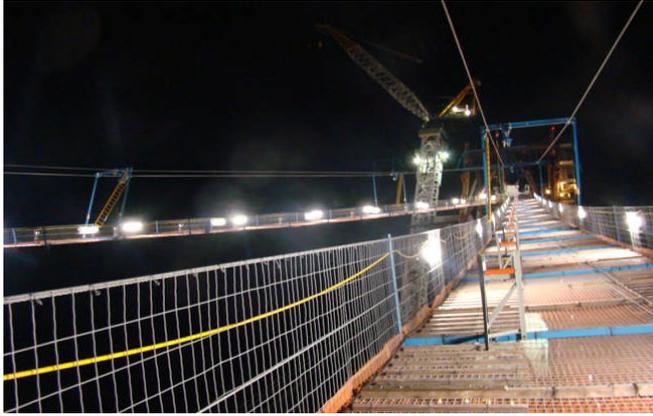
View from the south backspan catwalk at the centerline of cable strand number 1 to the top of the tower.

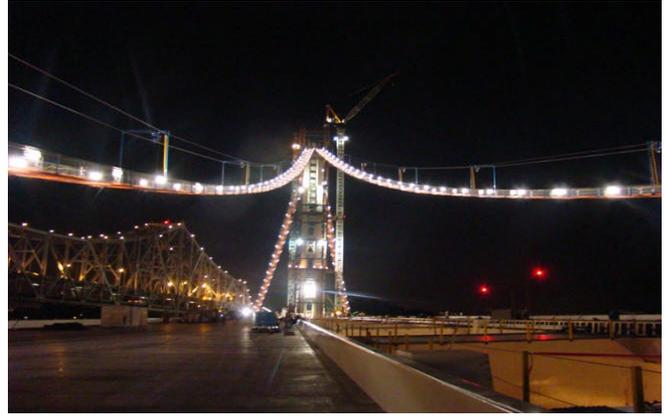
Location on the deck where trig leveling is being done on the mainspan catwalks.

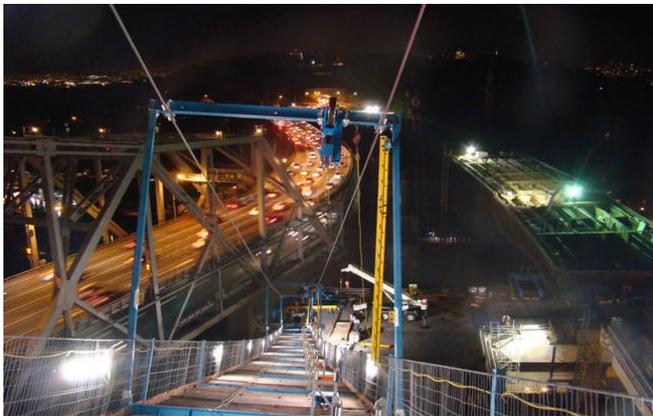
View from the south backspan catwalk at the centerline of cable strand number 1 to the W2 cap beam where trig leveling is being done.

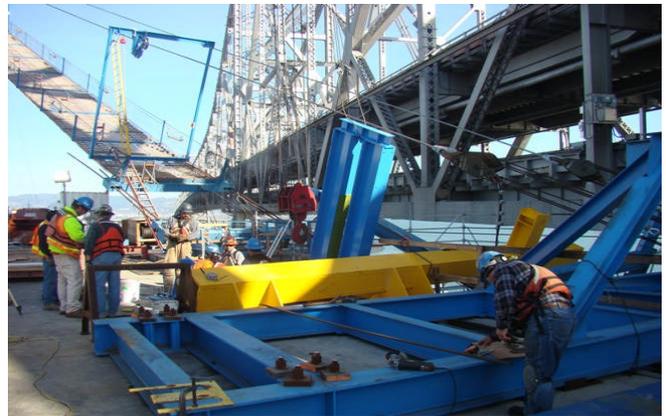
ABF surveyors and ironworkers working on installing the secondary hauling system floating arm at the south end of the W2 cap beam.

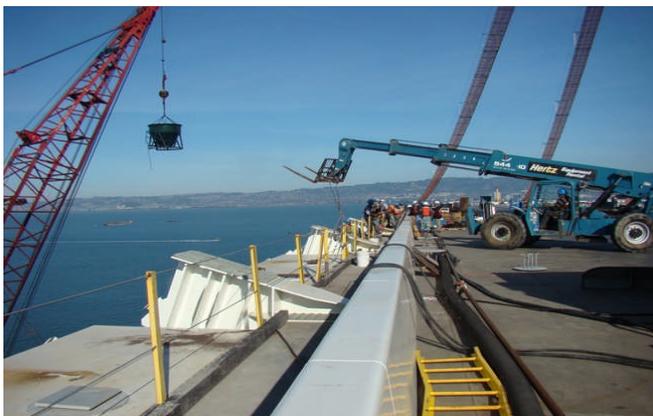
Continuing placement of the counterweight concrete.

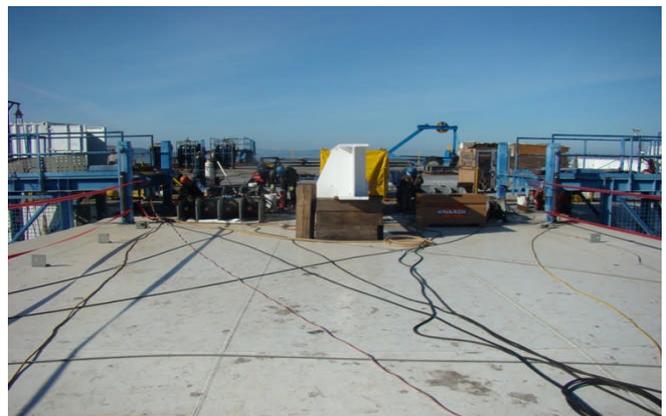
ABF ironworkers beginning to drill holes in the OBG at the top of the north splice joint after jacking/prestressing of CB19.
