SAS Superstructure

Daily Diary Report by Bid Item

Contract No.: 04-0120F4

04-0120F4
04-SF-80-13.2/13.9
Self-Anchored
Suspension Bridge

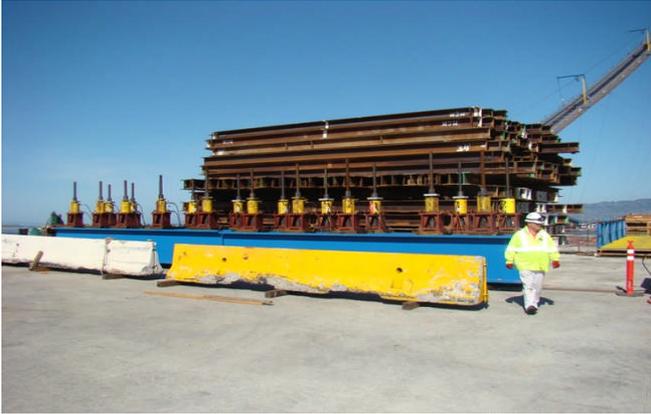
The counterweight steel beams placed on the end of the YBITS W-Line bridge and the tie-down jacks in place ready for the pulldown operations.

- Continued to work on the survey plan for the scheduled Hinge K tie down operation tomorrow, see photos below for more details.

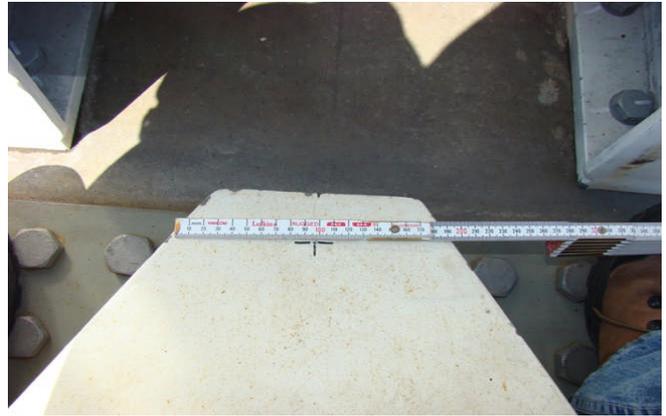
Original punchmark placed on an E-Line suspender bracket before going to the W-Line and repositioning the punchmark on the suspender bracket.

- Set punchmarks with Bob Brignano and Sami Dauok on the suspender brackets for an upcoming survey on these structural members. The initial punchmarks set on the suspender bracket with Bob were along the E-Line from panel point 102 to 42. The first set of survey points done with Bob were offset from the inboard side/edge of the suspender flange at the centerline ($150\text{mm} / 2 = 75\text{mm}$) to 50mm up the flange. At panel point 42 Bob had to attend to his ordinary cable work at the east end. Sami then assisted me with placing the same survey points up to the W2 cap beam.

When we completed the E-Line suspender brackets and went to the W-Line brackets it was discovered that MEP pipes conflicted with setting survey points in the same location. At this point I decided to reposition the survey point on the suspender bracket. The new point would be placed at the centerline of the tapered section break.

The new survey point is offset from the inboard side/edge of the suspender flange at the centerline ($730\text{mm} / 2 = 365\text{mm}$) to 580mm up the flange. For suspender brackets 104 and 106 the survey point was placed 500mm from the back edge of the bracket plate on the OBG and at the centerline where the dimension is $1100\text{mm} / 2 = 550\text{mm}$. The suspender brackets at panel points 108 and 110 haven't been placed yet on the side of the OBG. However a survey point was still set in the third row of the bolt pattern at the centerline of the pattern.

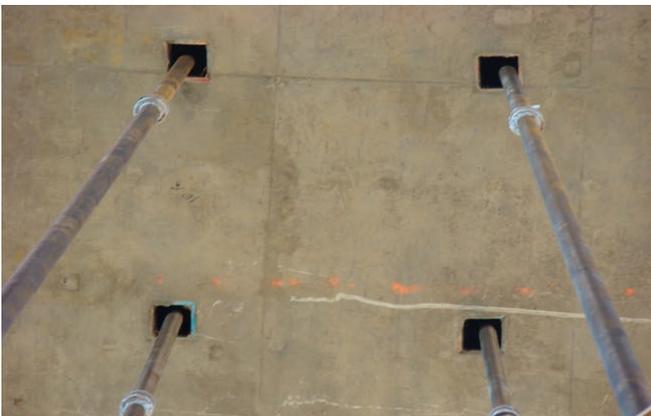
Close up of the tie-rod anchors where a few were hard-up against the blockout concrete as seen on the right column of tie rods.

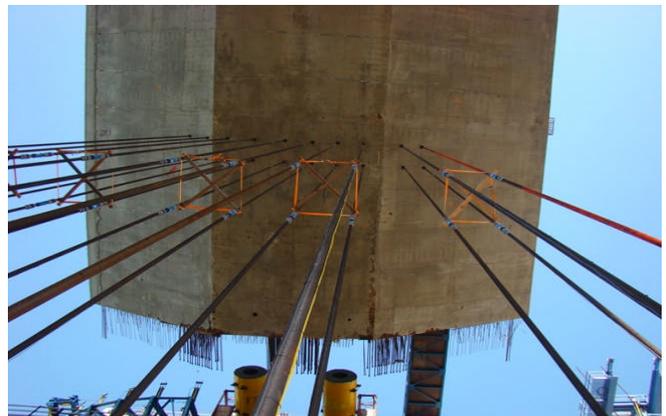
View from below of the tie down rods coming through the YBITS W-Line bridge.

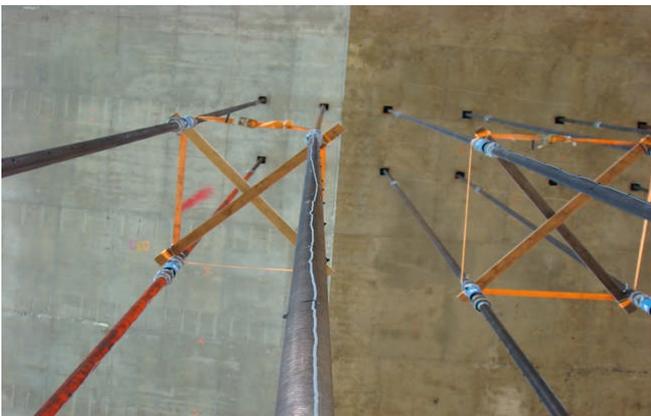
The condition of a few tie rods prior to removing the counterweight steel beams were bowed and appeared not to be plumb prior to loading.

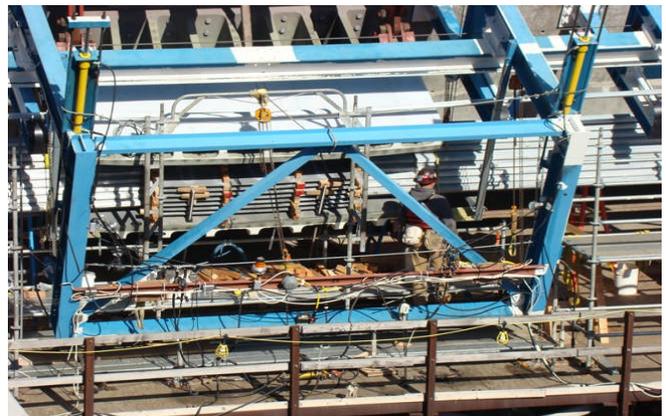
View of the west jacking saddle looking east from the YBITS W-Line bridge where this location will provide a feasible line of sight.

- Began to work on a plan for surveying the west jacking saddle from the YBITS W-Line bridge since the line of sight from TWL270 has deteriorated. The control point TWL270 was used to originally set the jacking saddle.
