SAS Superstructure

Daily Diary Report by Bid Item

Diary #: 285 Const Calendar Day: 962 Date: 27-Apr-2012 Friday
Inspector Name: Wright, Doug Title: Transportation Engineer
Inspection Type: Continuous
Shift Hours: 06:50 AM 05:30 PM Break: 00:30 Over Time: 02:00
Federal ID:
Location:
Reviewer: Schmitt, Alex Approved Date: Status: Submit

04-0120F4
04-SF-80-13.2/13.9
Self-Anchored
Suspension Bridge

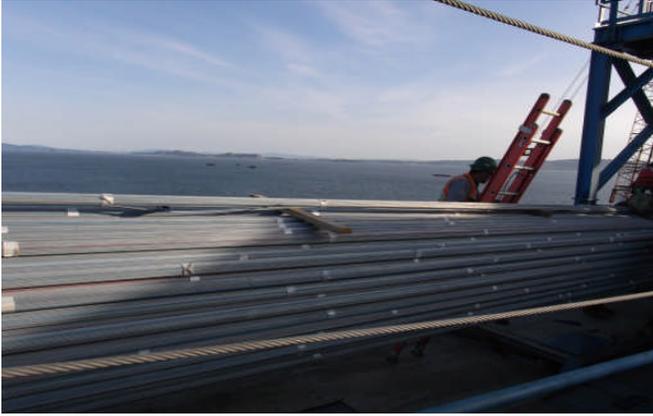
- From 07:00 until 08:10, the crew was chasing slack wires at the bottom of the North main-span. See attached photos.

Slack wires at the bottom of main-span - before being chased out

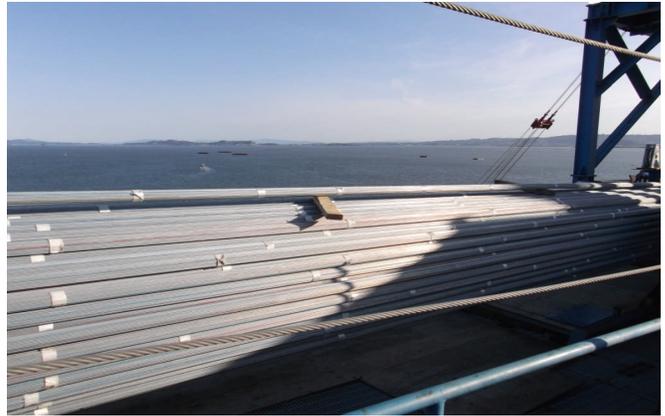
Strands at bottom of main-span - after slack wires chased out
