**SAS Superstructure**

**Daily Diary Report by Bid Item**

Diary #: 293 Const Calendar Day: 972 Date: 07-May-2012 Monday  
Inspector Name: Wright, Doug Title: Transportation Engineer  
Inspection Type: Intermittent  
Shift Hours: 07:00 AM 04:45 PM Break: 00:30 Over Time: 01:00  
Federal ID:  
Location:  
Reviewer: Schmitt, Alex Approved Date: Status: Submit

04-0120F4  
04-SF-80-13.2/13.9  
Self-Anchored  
Suspension Bridge

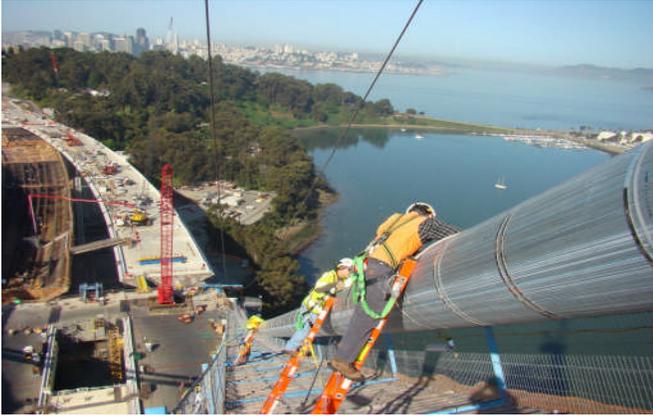
- From 07:30 until 10:00, we (Matt Bruce, Victor Altamarano, & I) continued checking the CB layout on the North side-span. The CB locations & top-center of Cable had previously been checked. Today, we checked the layout marks for CB rotation (arc length from top-center of Cable) & the 1.5m reference lines. All of the checks were OK.

Cable Band layout survey checks on the North side-span
