SAS Superstructure

Daily Diary Report by Bid Item

Diary #: 307 Const Calendar Day: 987 Date: 22-May-2012 Tuesday

04-0120F4
04-SF-80-13.2/13.9
Self-Anchored
Suspension Bridge

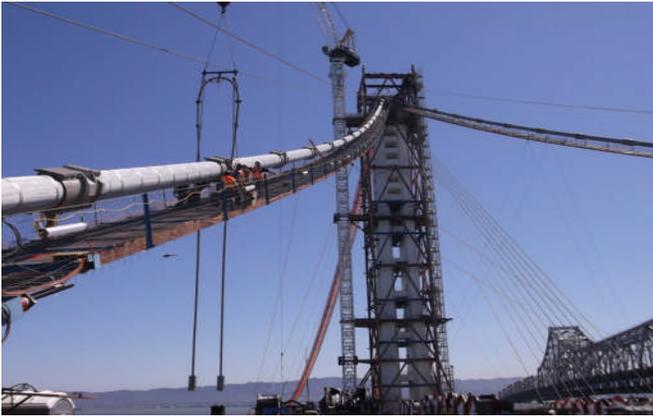
Suspender 12N-downhill being hoisted into place

- From 09:00 until 10:30, Aaron's crew was laying out the uphill & downhill suspender ropes to CB 12N.
- From 10:30 until 11:40, they used the 888 crane to pick the uphill & downhill suspender ropes at PP12N. No damage was done during the installation, & the suspenders were installed properly with the center marks aligned with the top CB groove.

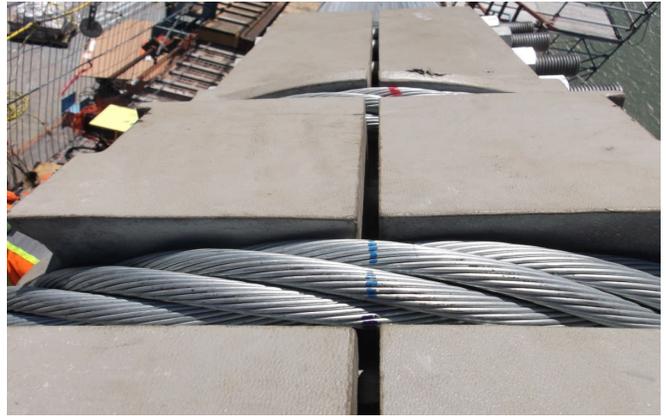
- From 13:45 until 14:30, they used the 888 crane to pick the uphill & downhill suspender ropes at PP10N. No damage was done during the installation. The center mark on the uphill suspender was aligned with the CB top groove. Originally, the center mark on the downhill suspender was aligned with the CB top groove, but it shifted when installing the uphill suspender. It is now mis-aligned by about 25mm. ABF Engineer Adam Reed said that they planned to correct its position later.

Suspender ropes at top of CB at PP10N (uphill aligned, but downhill not aligned by about 25mm)

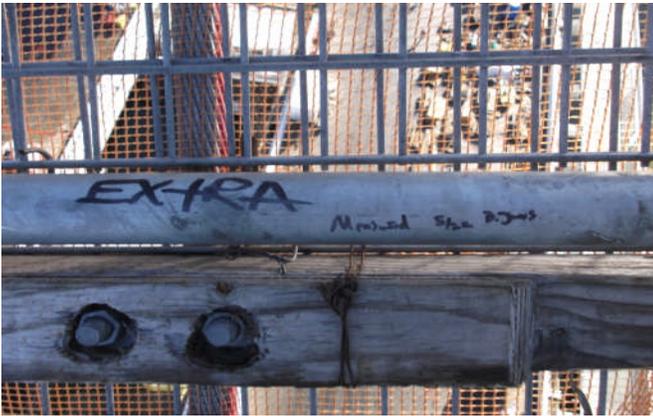
- From 08:20 until 08:55, James' crew was tensioning the CB bolts at PP26S.
- Note: they brought out a spare bolt to replace bolt 26S5 that had bad threads. I spoke with ABF Engineer Ben Jones, & he told me that they had done the extensometer measurement on the unstressed length of this spare bolt earlier this morning. See attached photo.

Spare bolt used in place of 26s5 which had bad threads

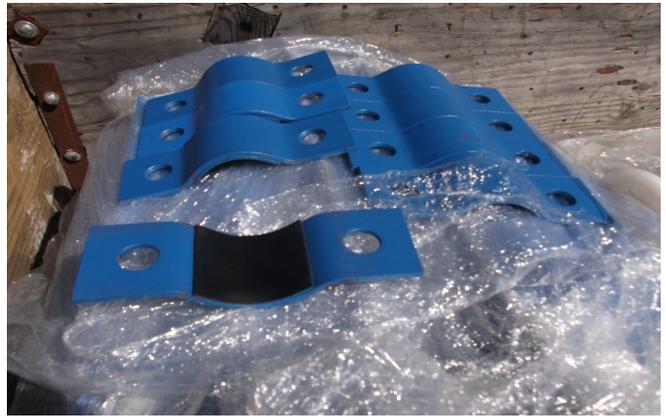
Clamps for rigging suspender ropes with neoprene pads in areas that contact the suspender
